Lorencito Canyon Mine, C-1996-084, December 8, 2021 Inspection Report

PERMIT INFORMATION

Permit Number: C-1996-084 Mine Name: Lorencito Canyon Mine Operator: New Elk Coal Company, LLC Operator Address: Mr. Mark Gray 12250 Highway 12 Weston, CO 81091	County: Las Animas Operation Type: Surface Permit Status: Permanent Cessation Ownership: Private
	Operator Representative Present: Vince Massorotti
Operator Representative Signature: (Field Issuance Only)

Inspection Start Date: December 8, 2021 Inspection Start Time: 11:45 Inspection End Date: December 8, 2021 Inspection End Time: 13:45		Inspection Type: Coal Partial Inspection Inspection Reason: Normal I&E Program Weather: Clear	
Joint Inspection Agency: None		Joint Inspection Contacts: None	
Post Inspection Agency: None		Post Inspection Contacts: None	
Inspector(s): Jared Ebert	Inspector's Signature:

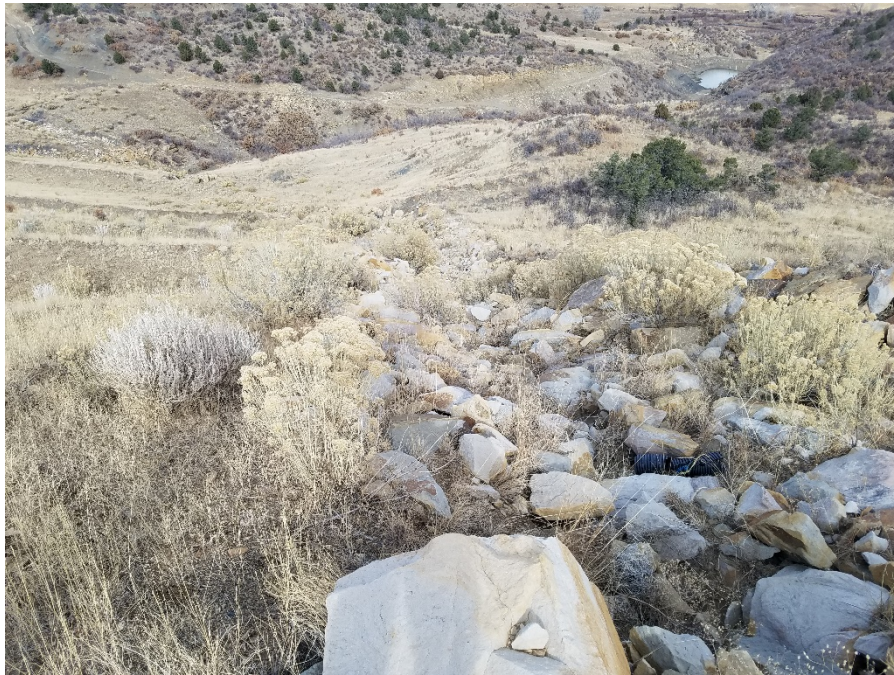
Fill 008 was observed. The fill is well vegetated and appears stable. No hazardous conditions or instability issues were observed. Drainage Ditches D84 and D83 were walked. These are steep, rock lined, channels. Overall these channels appeared stable and functional. Several steep slopes were observed in the channel. NECC monitors these channels and conducts maintenance of them periodically.

Figure 1. Ditch D83 on the south side looking north.

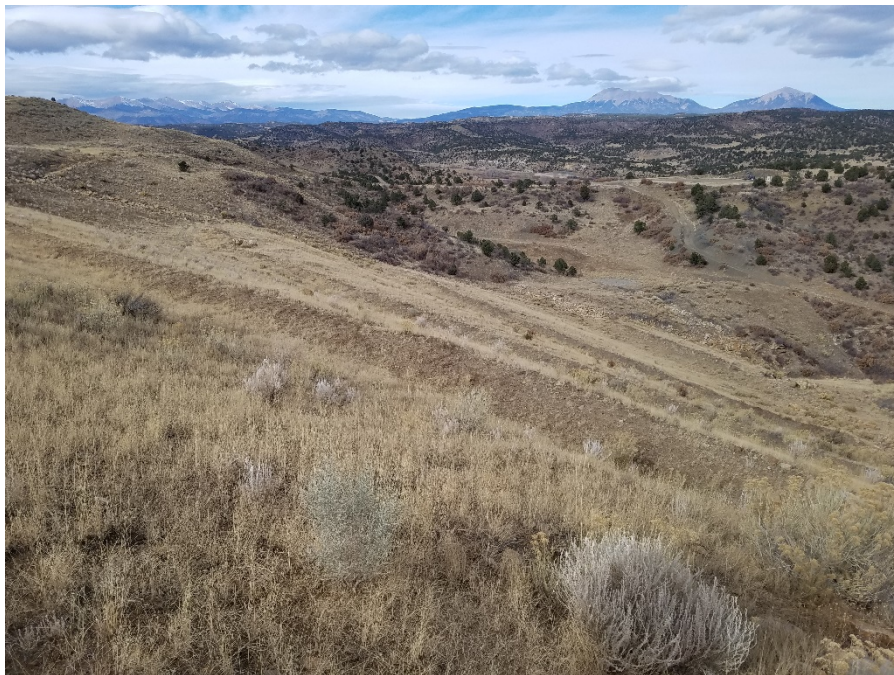
Figure 2. Fill 008

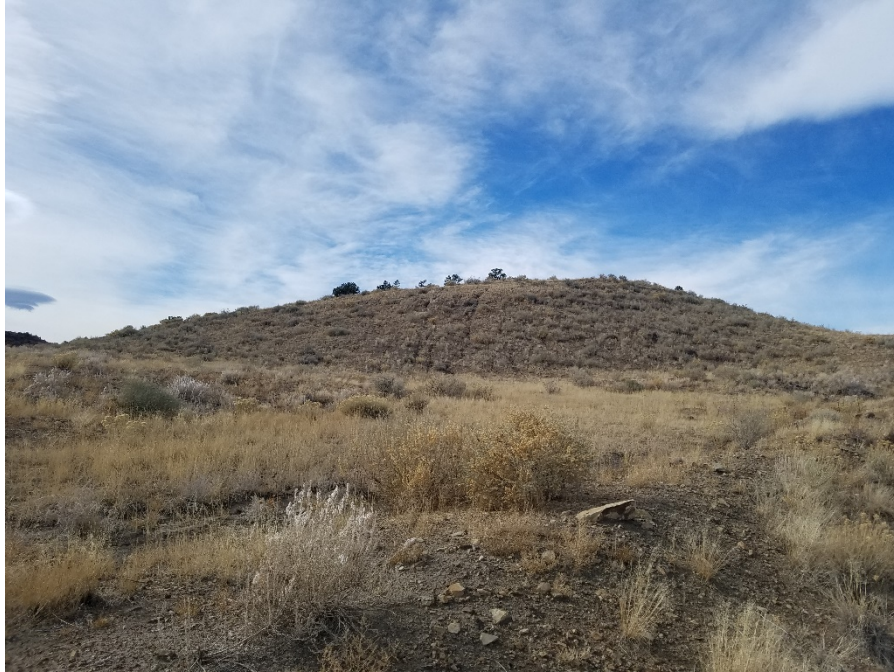
An area reported to have been revegetated in 2004, 2005, and 2006 located west of Fill 008 was observed. This area consists of the side of rounded peak, and the aspect of the reclaimed area is east. The vegetation consisted of a diverse number of grasses, forbs and shrubs. Several small rills were observed on the steeper portions of the slope of the peak. Mr. Massorotti indicated that brush would be placed in these rills to help stabilize them.

Figure 3. 2004, 2005 and 2006 revegetated area. From the east side looking west.
