**COLORADO**  
Division of Reclamation,  
Mining and Safety  
Department of Natural Resources

**PERMIT INFORMATION**

<b>Permit Number:</b> C-1981-041 <b>Mine Name:</b> Roadside Portals <b>Operator:</b> Snowcap Coal Company, Inc. <b>Operator Address:</b> MS Tonya Hammond P.O. Box 1430 Palisade, CO 81526	<b>County:</b> Mesa <b>Operation Type:</b> Underground <b>Permit Status:</b> Active <b>Ownership:</b> Private
	<b>Operator Representative Present:</b>  Tonya Hammond Casey Koenig
<b>Operator Representative Signature:</b> (Field Issuance Only)

<b>Inspection Start Date:</b> December 8, 2021 <b>Inspection Start Time:</b> 13:20 <b>Inspection End Date:</b> December 1, 2021 <b>Inspection End Time:</b> 13:56		<b>Inspection Type:</b> Coal Partial Inspection <b>Inspection Reason:</b> Normal I&E Program <b>Weather:</b> Raining	
<b>Joint Inspection Agency:</b>  None		<b>Joint Inspection Contacts:</b>  None	
<b>Post Inspection Agency:</b>  None		<b>Post Inspection Contacts:</b>  None	
<b>Inspector(s):</b>  Clayton Wein	<b>Inspector's Signature:</b>  <i>Clayton Wein</i>		<b>Signature Date:</b>  12/9/2021

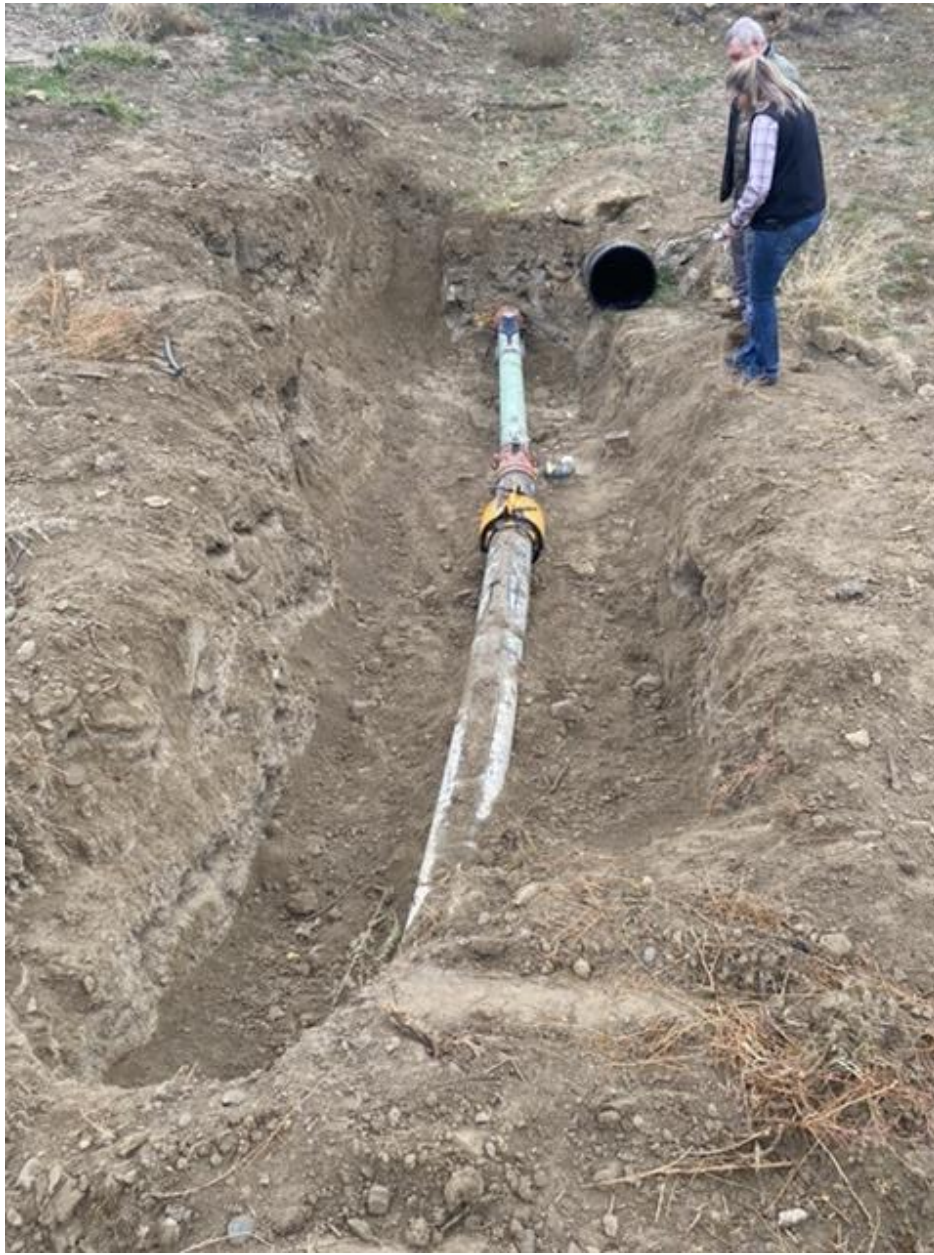
**Photo 1:**

The discharge outlet 016 was visited during the inspection. The gauge on the outlet had been replaced recently, but was exhibiting fluctuating readings since the installation. The outlet had maintenance performed on it since the Division's November 2021 inspection. The maintenance involved removing the old section of pipe at the meter and replacing it with a longer pipe (Photo 1). The pipe is a 6 in diameter pipe. The previous 6 inch pipe was too close to the up-gradient connection to an 8 in diameter pipe. This was creating turbulence, resulting in the fluctuating readings at the meter. During the inspection the new section of pipe was still uncovered and scheduled to be buried by the end of the week, weather permitting. Once covered the path into the maintenance area will be roughened and seeded (Photo 2). The maintenance work was observed to have created minimal disturbance, and no off site impacts were noted. The meter was functioning and gave a reading between 122 and 126 gpm. The other method SCC is implementing to record flow measurements was to connect the meter to an external battery for power supply while taking readings. This resulted in a smaller fluctuation in the instantaneous flow readings, less than a 5 gpm fluctuation.

The new section of pipe at the 016 discharge outlet.

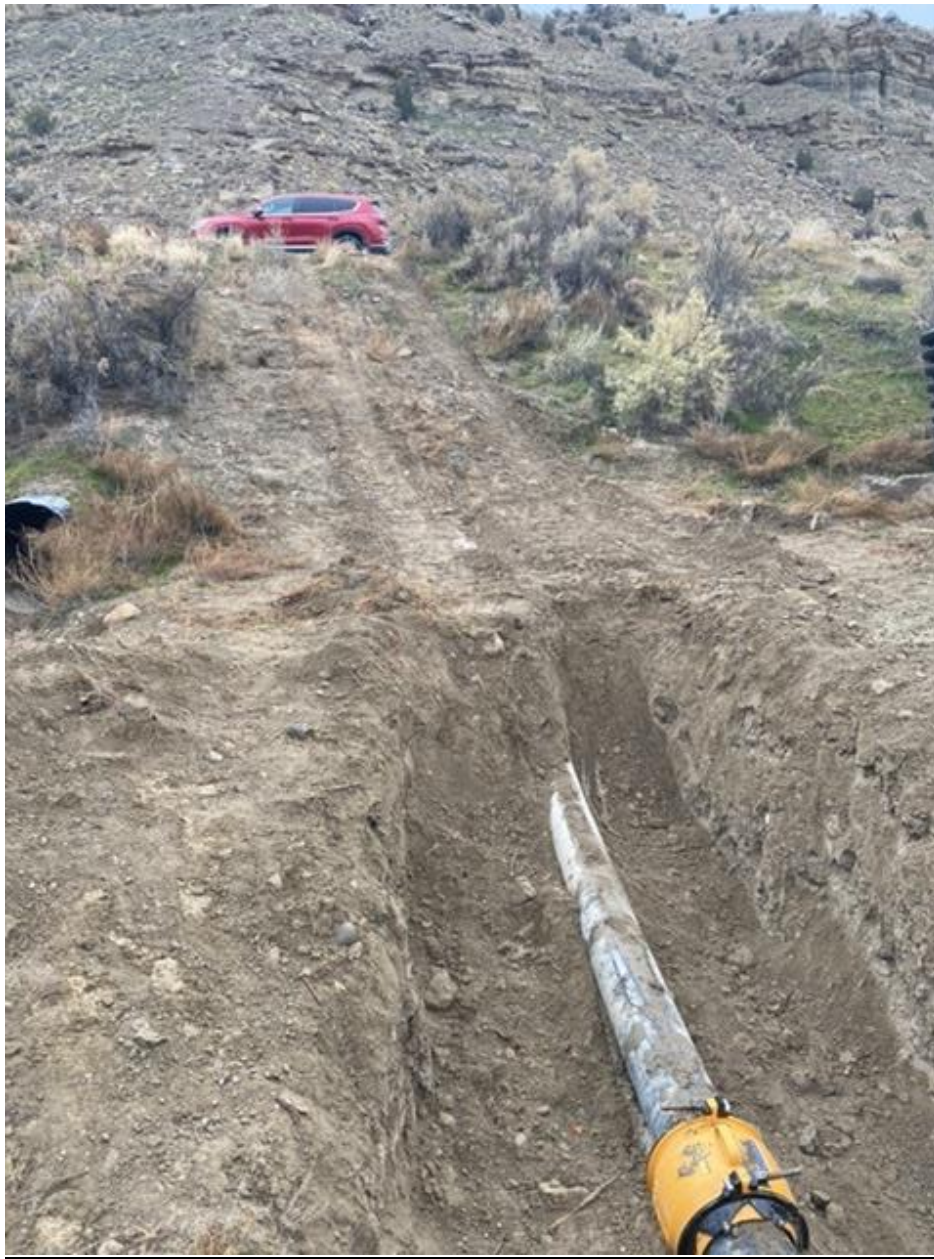
**Photo 2:** The pathway into the 016 maintenance area had minimal disturbance created to access the site.

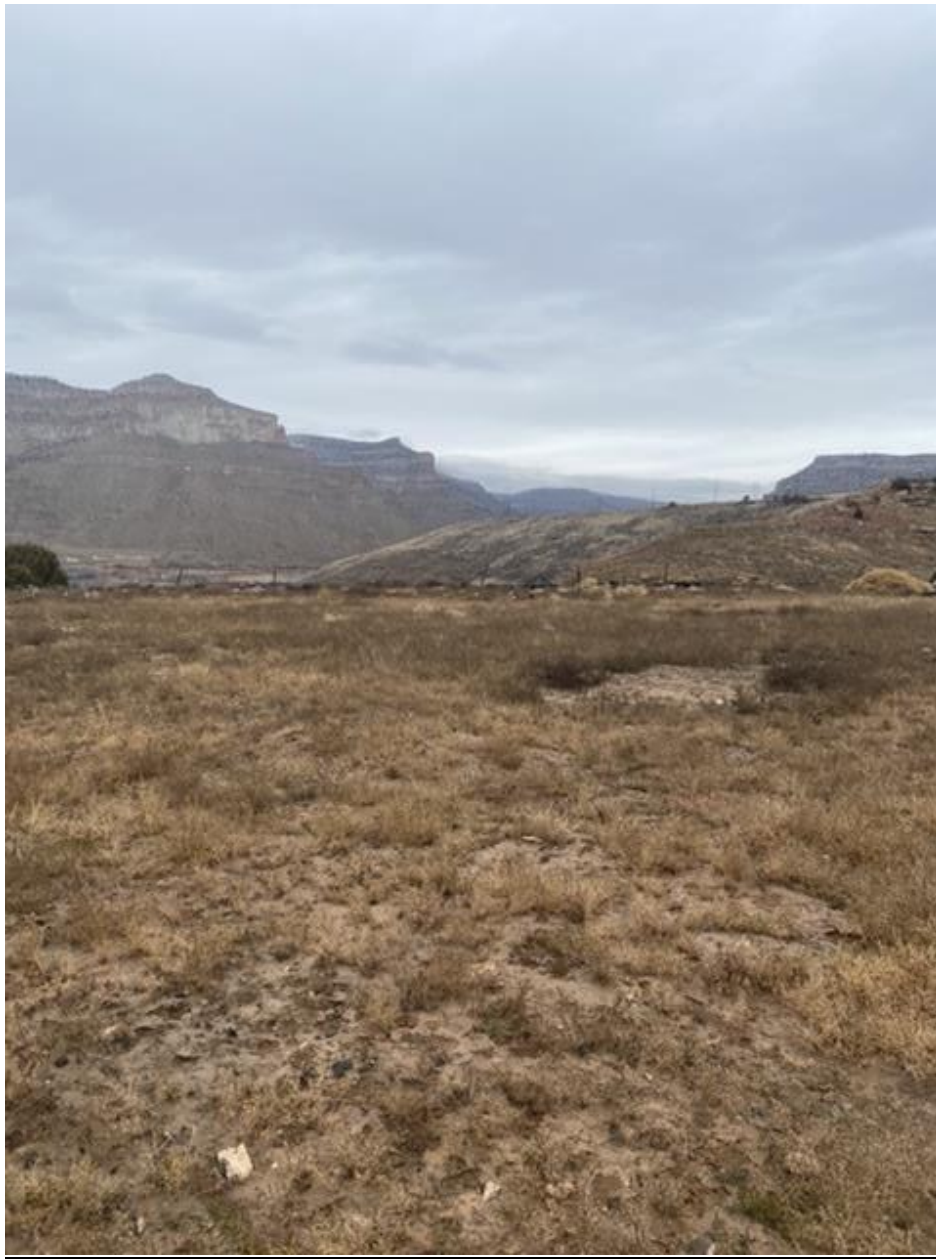
The remaining disturbance associated with the Roadside Mine permit is approximately 0.4 acres located on Tract 71. The site was stable with vegetative cover (Photo 3). The sediment logs were in good condition and located on the edge of the down-gradient boundary of the disturbance. No off site impacts were observed. The disturbance boundary markers were in place and one located at the entrance to the disturbed area has a mine ID sign on it.

**Photo 3:** The TR-69 Repair Area. The photo was taken looking to the northeast.
