MINERALS PROGRAM INSPECTION REPORT PHONE: (303) 866-3567

MINE NAME:		MINE/PROSPECTING ID#:	MINERAL:	COUNTY:
Bohnen Pit		M-1991-071	Sand and gravel	Kit Carson
INSPECTION TYPE:		INSPECTOR(S):	INSP. DATE:	INSP. TIME:
Surety Release Inspection		Elliott Russell	November 9, 2021	12:00
OPERATOR:		OPERATOR REPRESENTATIVE:	TYPE OF OPERATION:	
Kit Carson County		Dave Hornung	110c - Construction Limited Impact	
REASON FOR INSPECTION:		BOND CALCULATION TYPE:	BOND AMOUNT:	
Surety Release Requested		None	No Bold Held	
DATE OF COMPLAINT:		POST INSP. CONTACTS:	JOINT INSP. AGENCY:	
NA		None	None	
WEATHER:	INSPECTOR'S SIGNATURE:		SIGNATURE DATE:	
Clear	At Pmill		December 9, 2021

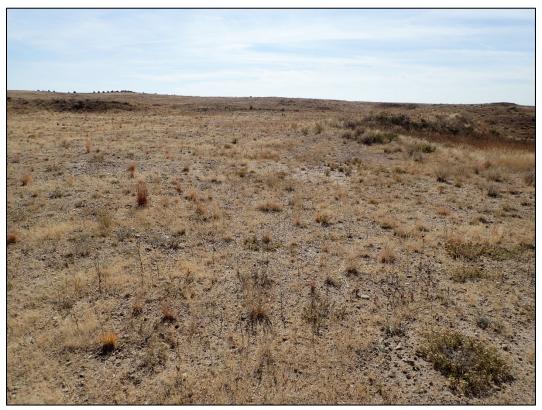
Photo 1. Sample photo of reclaimed mine disturbance; looking south.

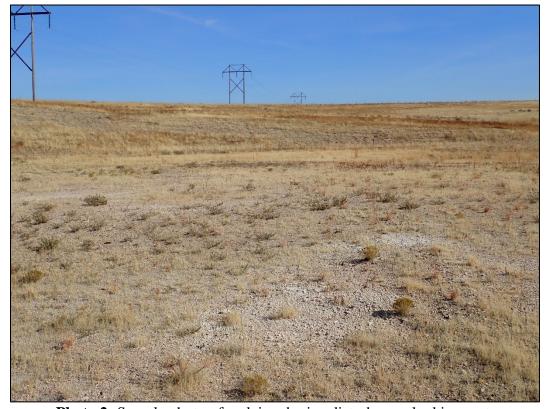
Photo 2: Sample photo of reclaimed mine disturbance; looking east.

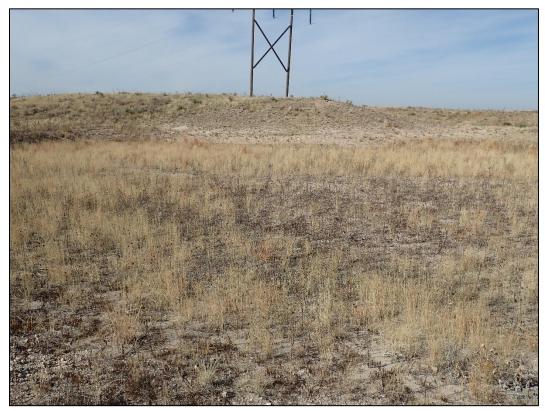
Photo 3. Sample photo of reclaimed mine disturbance; looking west.
