**RE: Permit No. M-1980-244; Cripple Creek & Victor Gold Mining Company; Cresson Project;  
Inspection Report Response: August 10, 2021**

**RE: August 3<sup>rd</sup> Rain Event Geomembrane Washout and Repairs**

## FIELD DAILY PROGRESS REPORT

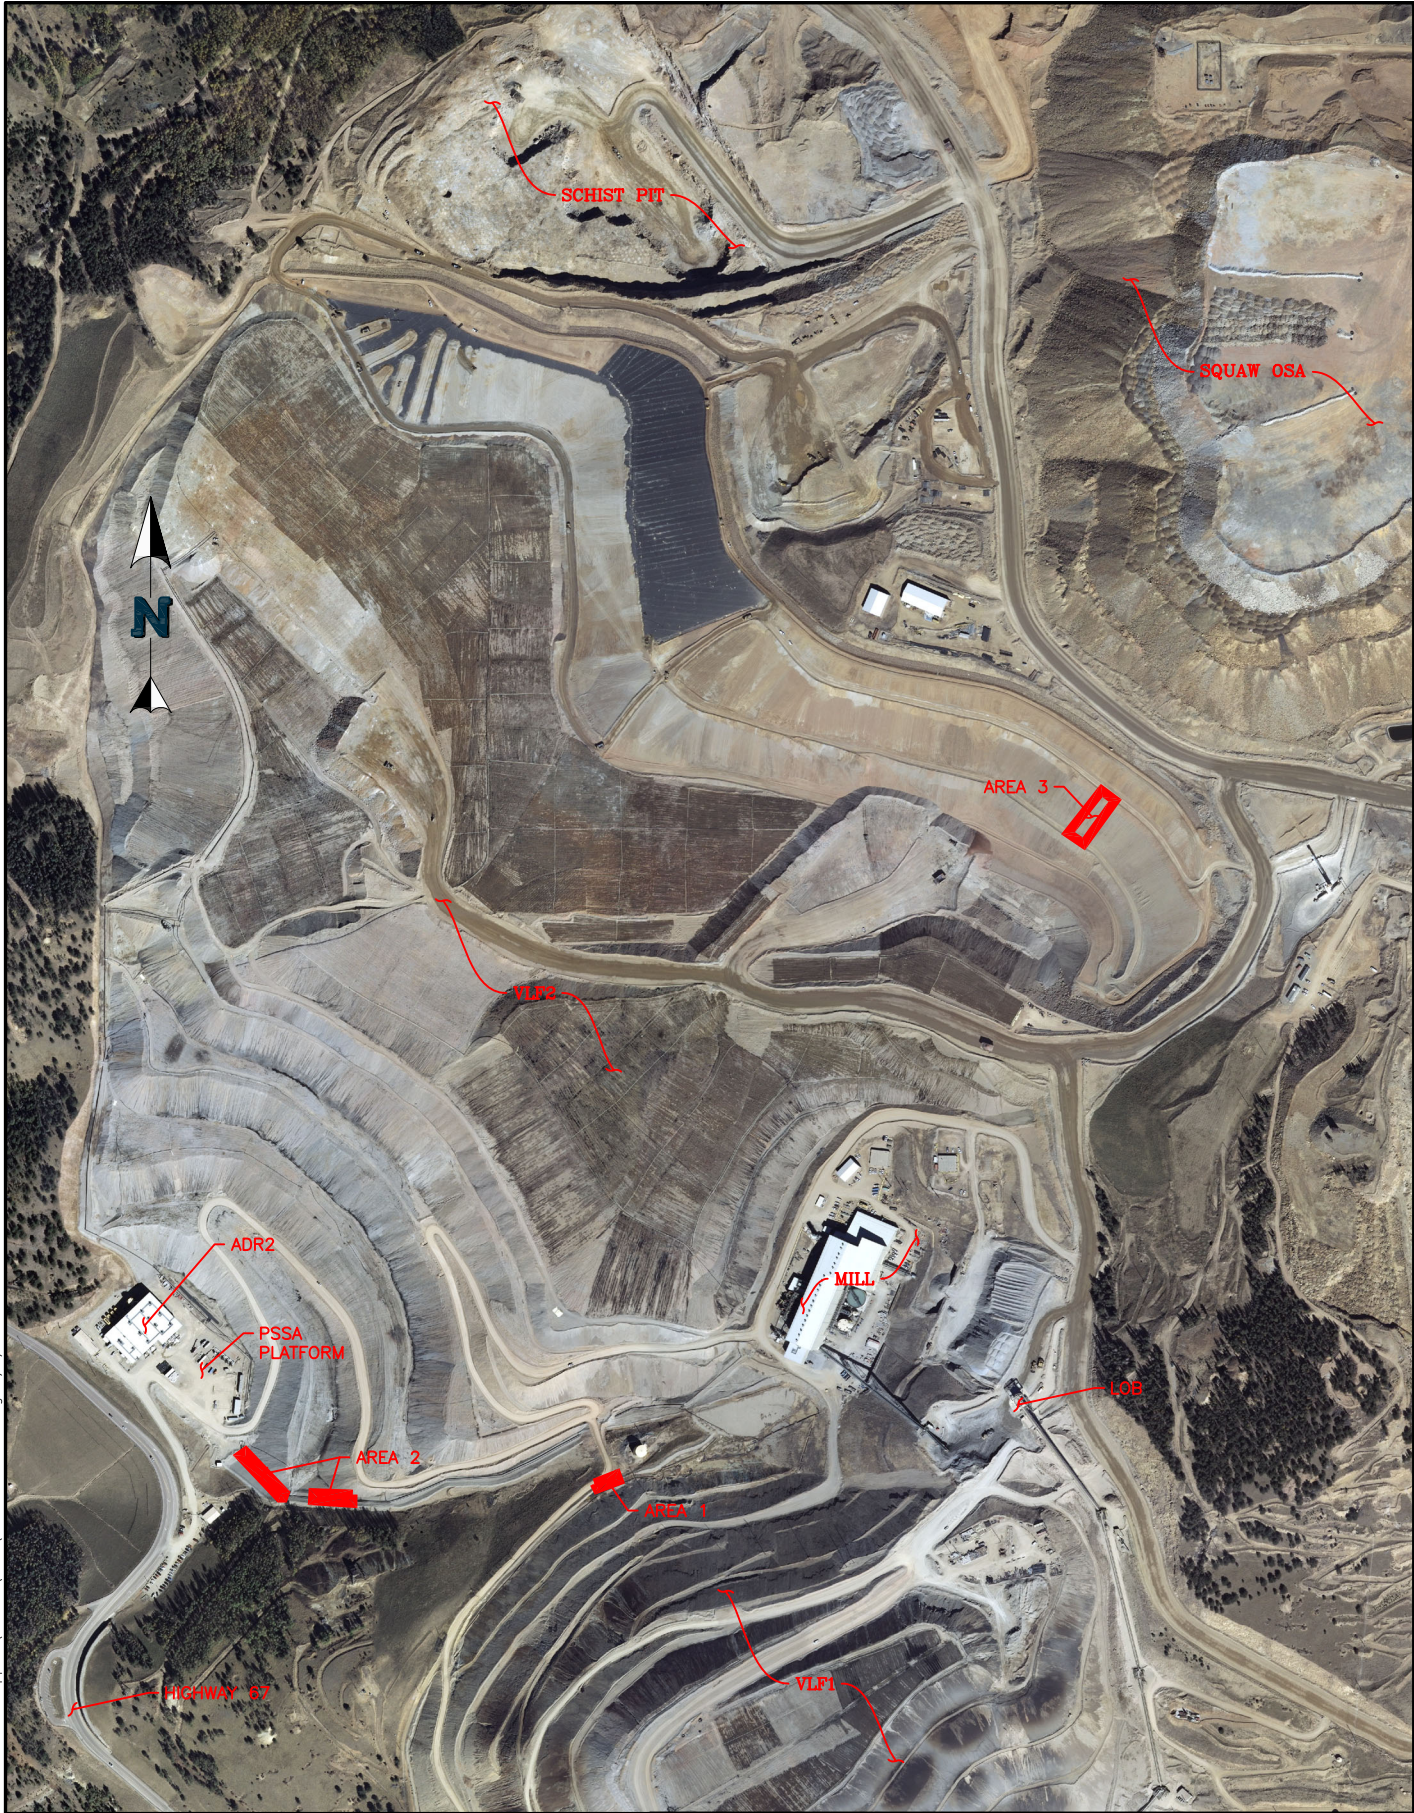
<b>NewFields</b>		CLIENT	CRIPPLE CREEK & VICTOR GOLD MINING COMPANY	
PROJECT		GEOMEMBRANE VISUAL INSPECTION, AUGUST 4, 2021		
TITLE		PLAN VIEW		FILENAME
		APPROXIMATE LOCATION OF VISUAL INSPECTIONS		0106.049.022F
		FIGURE NO.	REVISION	
		1	A

On August 3, 2021, starting around 4:00 pm, a rain event occurred at the Cripple Creek & Victor Gold Mine (CC&V) and lasted until approximately 11:00 pm. The resulting stormwater runoff caused erosion of the Drain Cover Material (DCF) and exposed geomembrane liner in three locations on VLF1 and VLF2; See Figure 1.

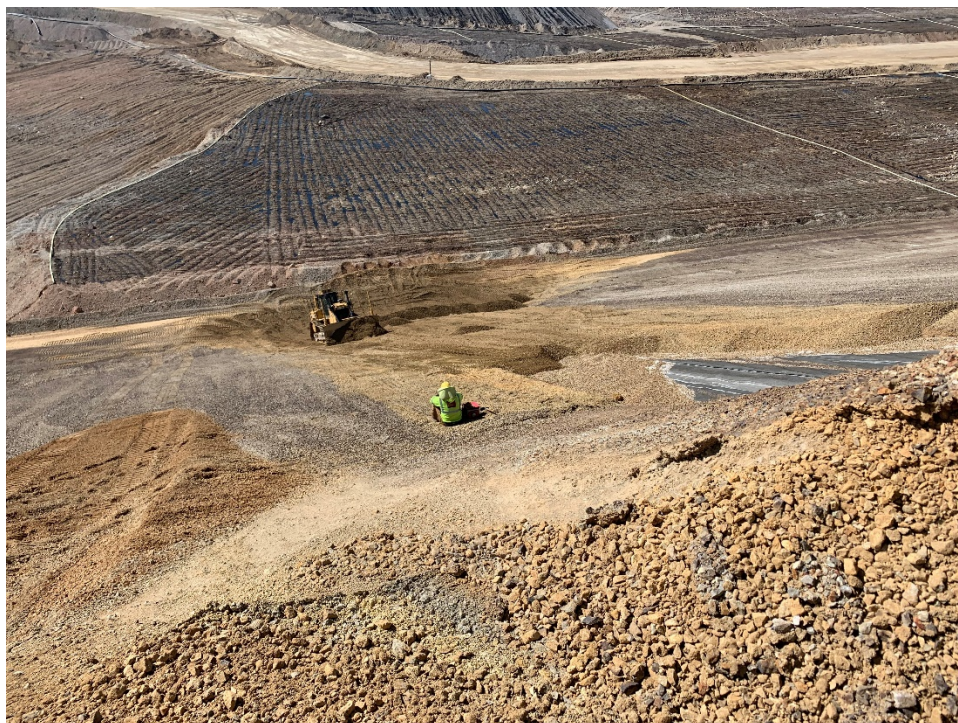
**Placement of DCF material with laborer monitoring lift thickness**

Tezak pushed displaced DCF material from the 10,050' elevation up to the 10,150' bench, covering the exposed geomembrane on 09/17/2021. The material was placed in a minimum 28-inch loose lift thickness. Ground personnel monitored material thickness as it was placed with tape measures.

- Tezak personnel repaired the erosion of the DCF on VLF 2B. DCF material was pushed in a 26" to 28" lift from the 10,050' bench up to the 10,150' bench by a D6 LGP dozer. A Laborer and NewFields personnel monitored the lift thickness and material as it was placed. The material was the originally placed material that had eroded to the bottom of the slope or was in place as the construction berm and haul road. NewFields and Tezak personnel also inspected exposed geomembrane for damage before it was covered. No damage was found. The general repair location was approximately UTM 4287405N 486464E.

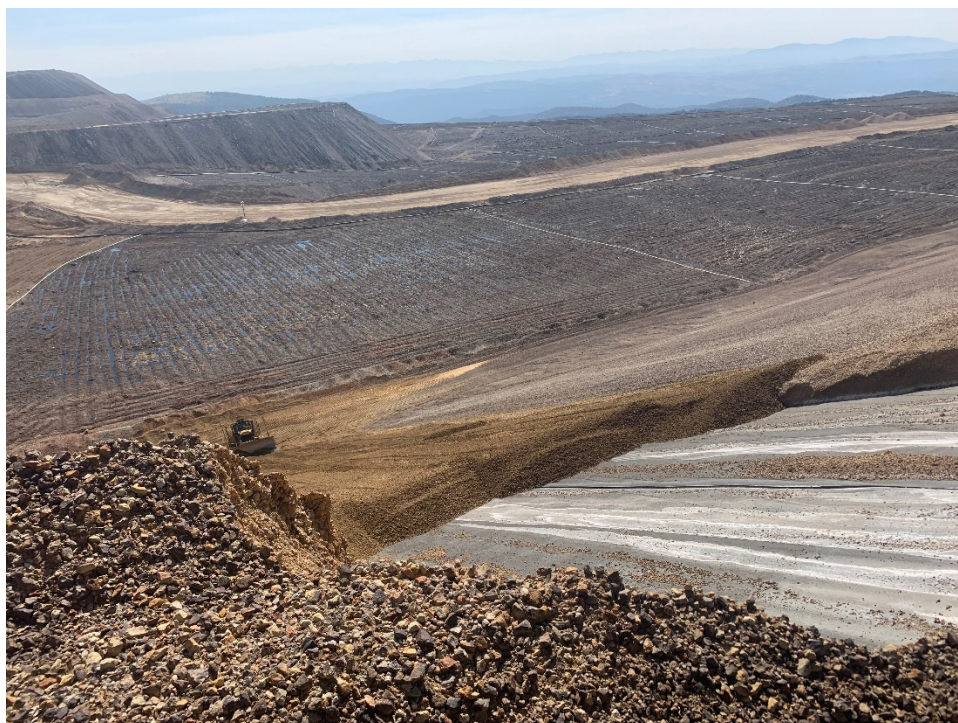
**Progress of DCF matrial placement**

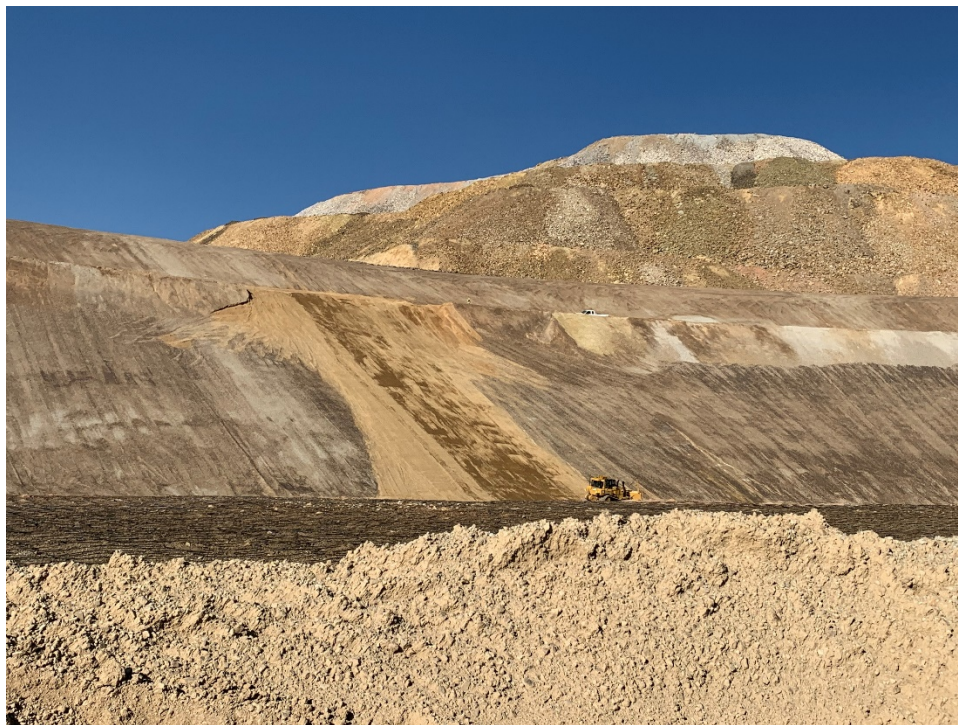
**Completion of the DCF erosion repair**

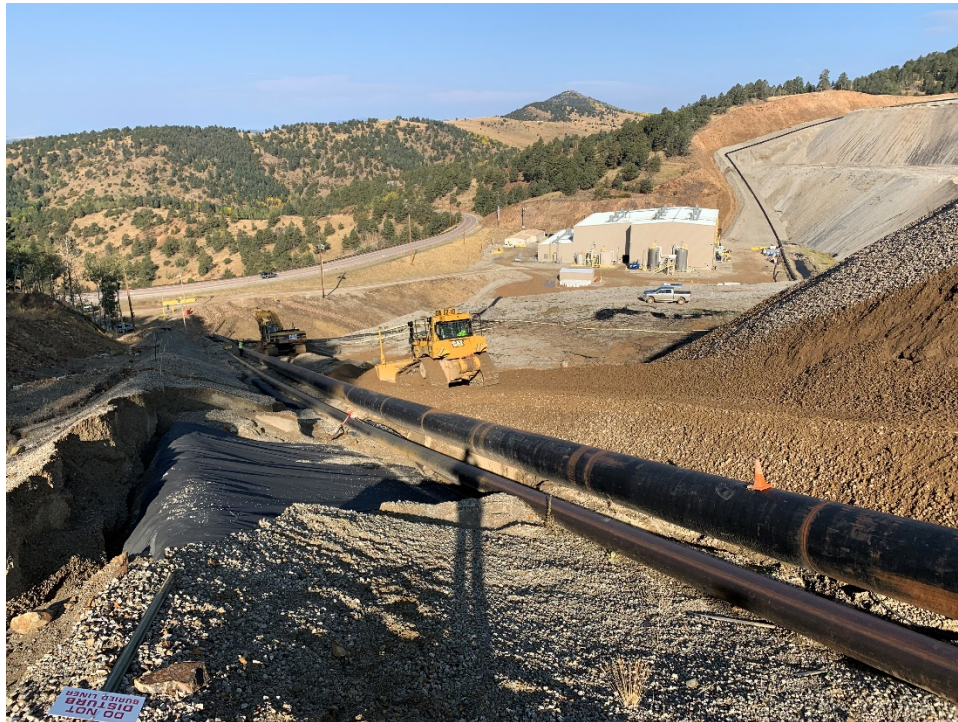
**Borrowing spent ore material for solution pipe ballasting**

- Tezak personnel and equipment began to backfill underneath ballasting the suspended carbon steel solution pipes on the washout above the ADR2/PSSA plant pad. Tezak and NewFields personnel would shovel and sweep loose material off the geomembrane surface, inspect the surface, and if no damage was found, would begin to backfill. Any damage found on the geomembrane surface was marked with sandbags and not covered. A D6 LGP dozer, 320 excavator, and skid steer borrowed spent ore material locally and placed it next to the solution pipes. Tezak personnel on the ground shoveled the spent ore material under the solution pipes and tamped in the material with shovel handles for stability.

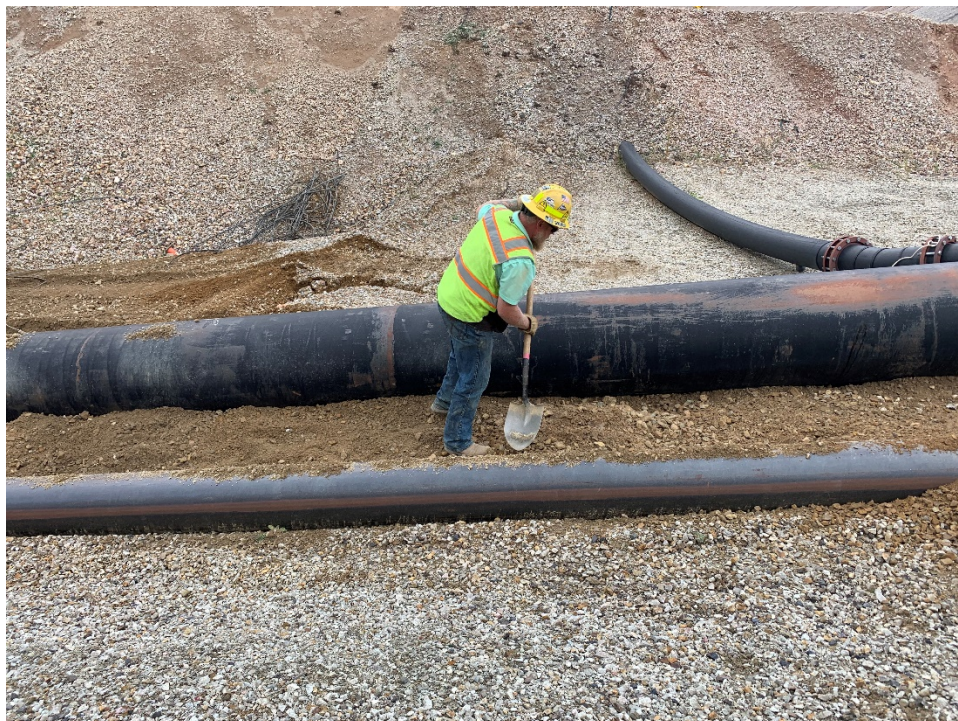
**Placing spent ore material for solution pipe ballasting**

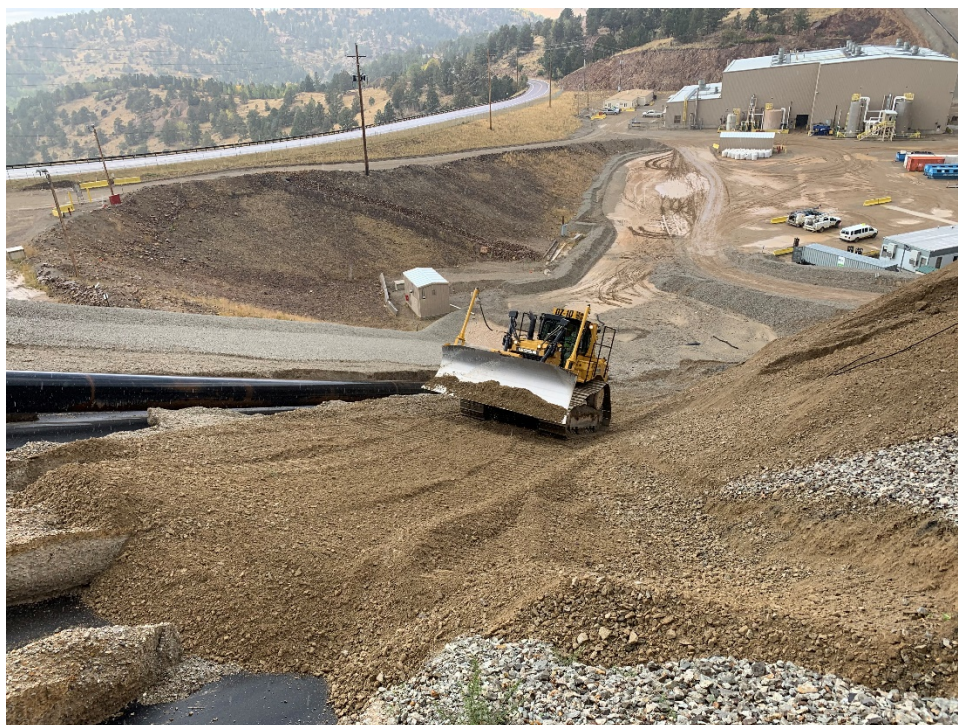
**Placing spent ore material over exposed geomembrane**

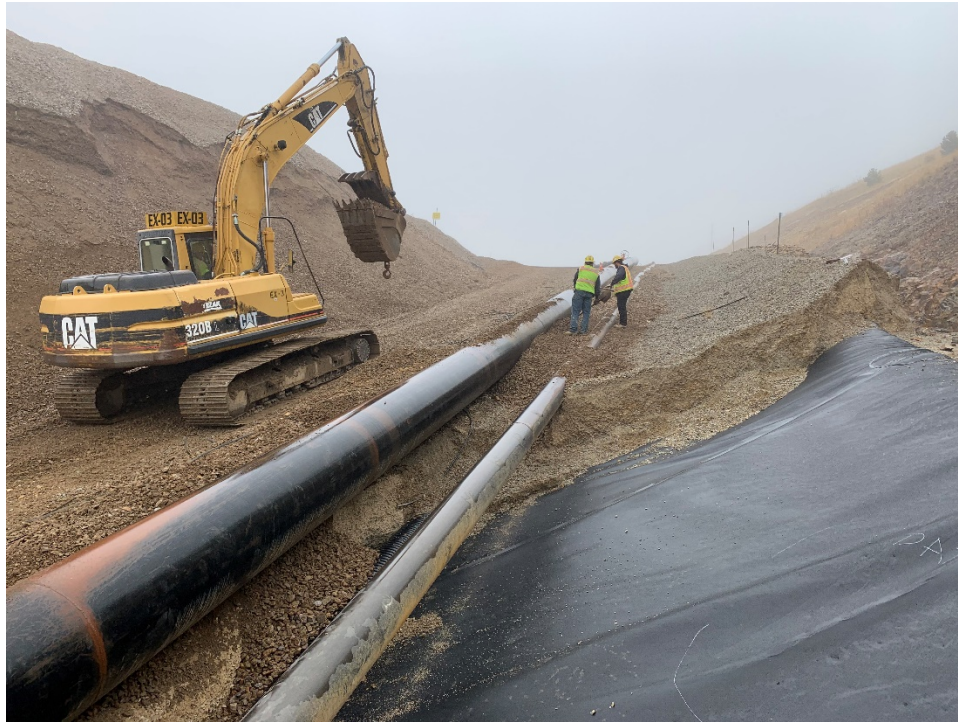
**Placing spent ore material for solution pipe ballasting**

- Tezak personnel and equipment continued to backfill underneath ballasting the suspended carbon steel solution pipes on the washout above the ADR2/PSSA plant pad. Tezak and NewFields personnel would shovel and sweep loose material off the geomembrane surface, inspect the surface, and if no damage was found, would begin to backfill. Any damage found on the geomembrane surface was marked with sandbags and not covered. A D6 LGP dozer, 320 excavator, and skid steer borrowed spent ore material locally and placed it next to the solution pipes. Tezak personnel on the ground shoveled the spent ore material under the solution pipes and tamped in the material with shovel handles for stability.

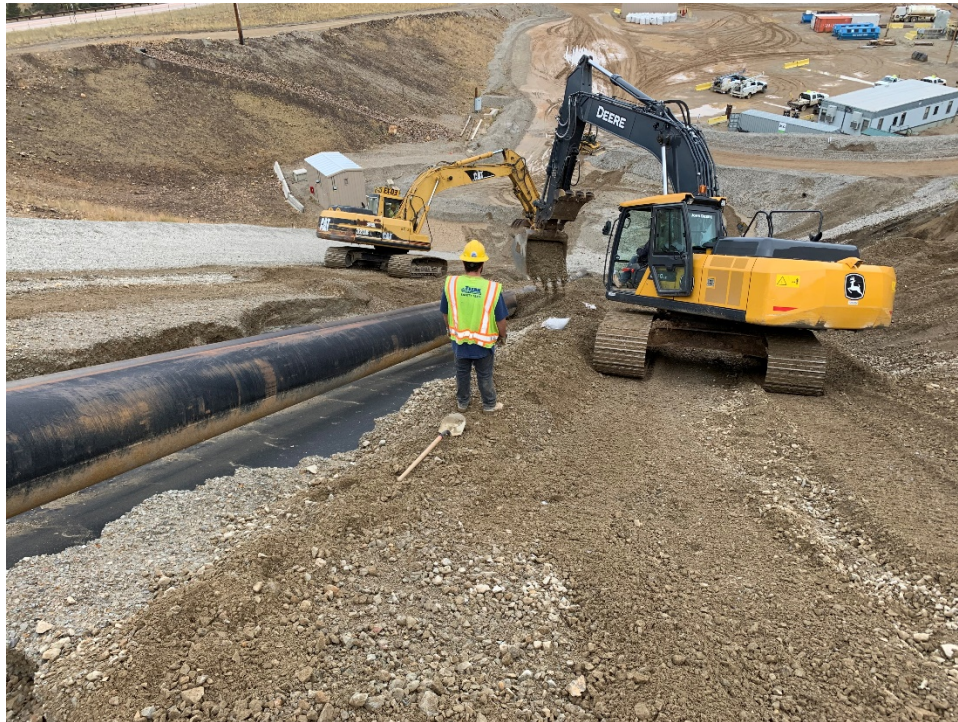
- The 30-inch solution line was raised 14 inches to 20 inches above the geomembrane surface on the washout above the ADR2/PSSA pad. The line had originally been installed on 24 inches of DCF cover. The steepness of the work area and weight of the solution line were causing the equipment to reach practical limits. It was recommended to not put any further stress on the solution line and backfill it at its current location. Larger equipment was not recommended due to typical CC&V project specifications relating to Drain Cover Fill/Spent Ore cover thickness over geomembrane and equipment PSI limits.

**Placement of spent ore material with laborer monitoring**

- Tezak personnel and equipment continued to backfill underneath ballasting the suspended carbon steel solution pipes on the washout above the ADR2/PSSA plant pad. Tezak and NewFields personnel would shovel and sweep loose material off the geomembrane surface, inspect the surface, and if no damage was found, would begin to backfill. Any damage found on the geomembrane surface was marked with sandbags and not covered. A D6 LGP dozer, 320 excavator, and skid steer borrowed spent ore material locally and placed it next to the solution pipes. Tezak personnel on the ground shoveled the spent ore material under the solution pipes and tamped in the material with shovel handles for stability.

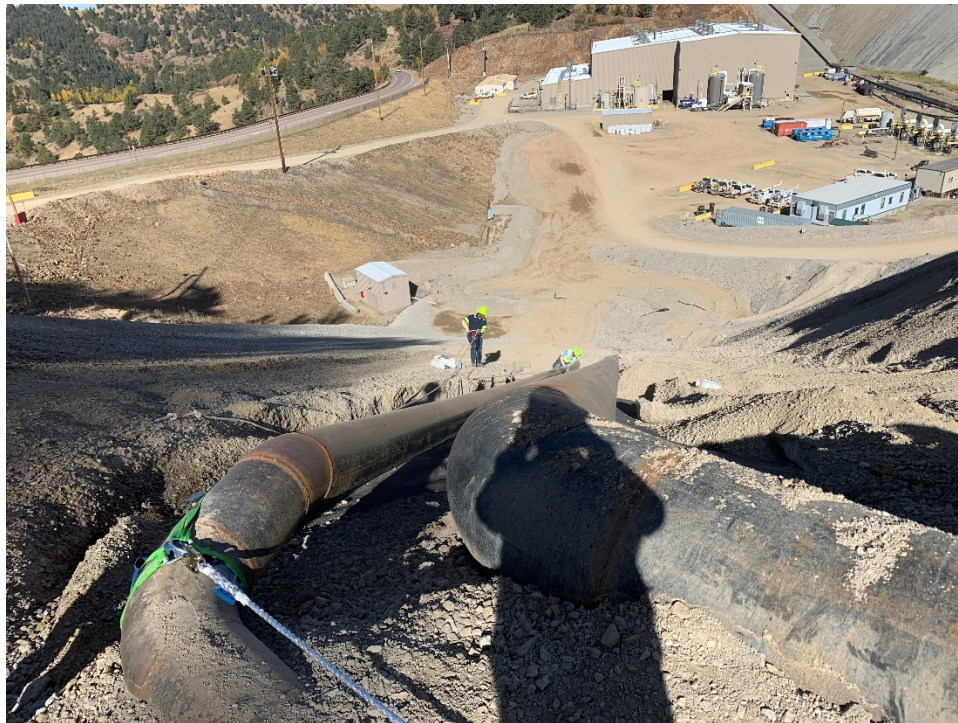
Upon visual inspection of the geomembrane, NewFields noted damage in the geomembrane where oversized material from stormwater check dams had washed on to the geomembrane. NewFields also found damage to the exposed geomembrane under the steel header pipes on the steep slope above the

**Repair of damaged geomembrane above the ADR2/PSSA Pad**

- AEG personnel repaired the damaged geomembrane above the ADR2/PSSA pad during the shift. A trial weld was conducted with and extrusion weld of existing and new geomembrane. The trial weld passed per project specifications and AEG began the repairs. Any damage to the liner surface that did not go completely through the geomembrane was extrusion welded with beads. Any damage to the liner surface that went completely through the geomembrane surface was covered with a patch. Vacuum box testing was conducted on all repairs with passing results. NewFields personnel inspected and verified that all damage to the geomembrane surface had been repaired and approved the remaining areas of exposed geomembrane to be covered with spent ore.

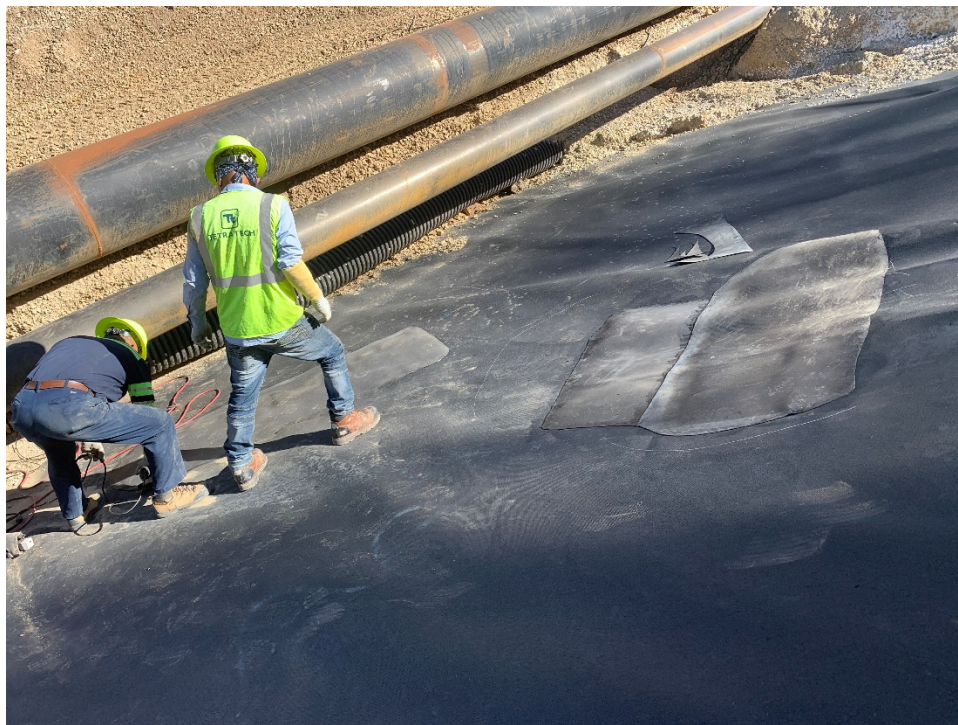
**Repair of geomembrane above the ADR2/PSSA pad**

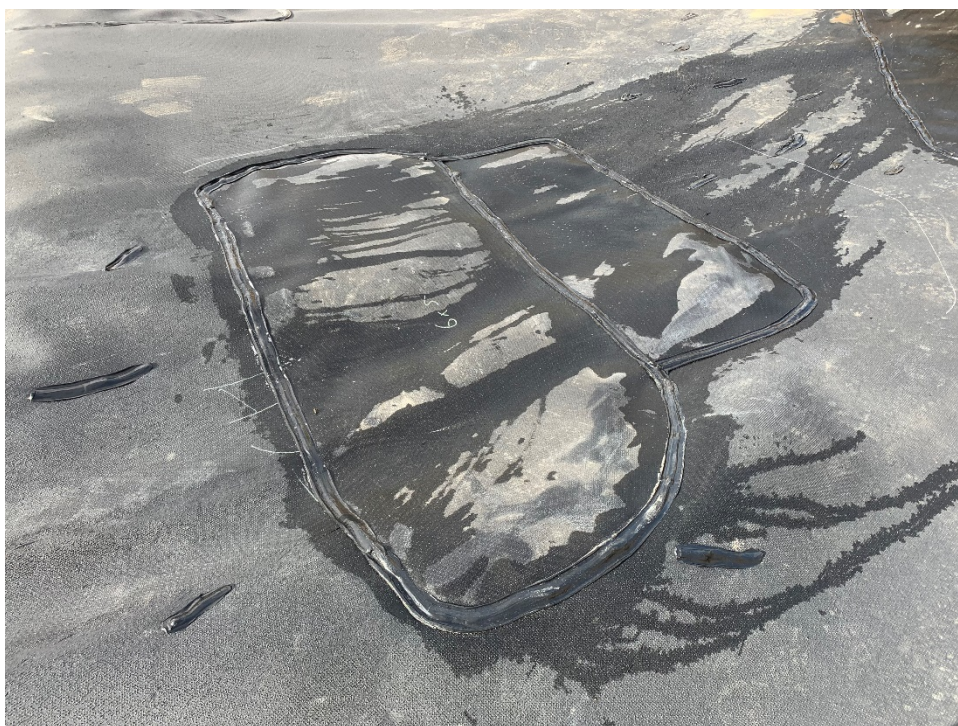
**Completed geomembrane patch and beads above the ADR2/PSSA pad**

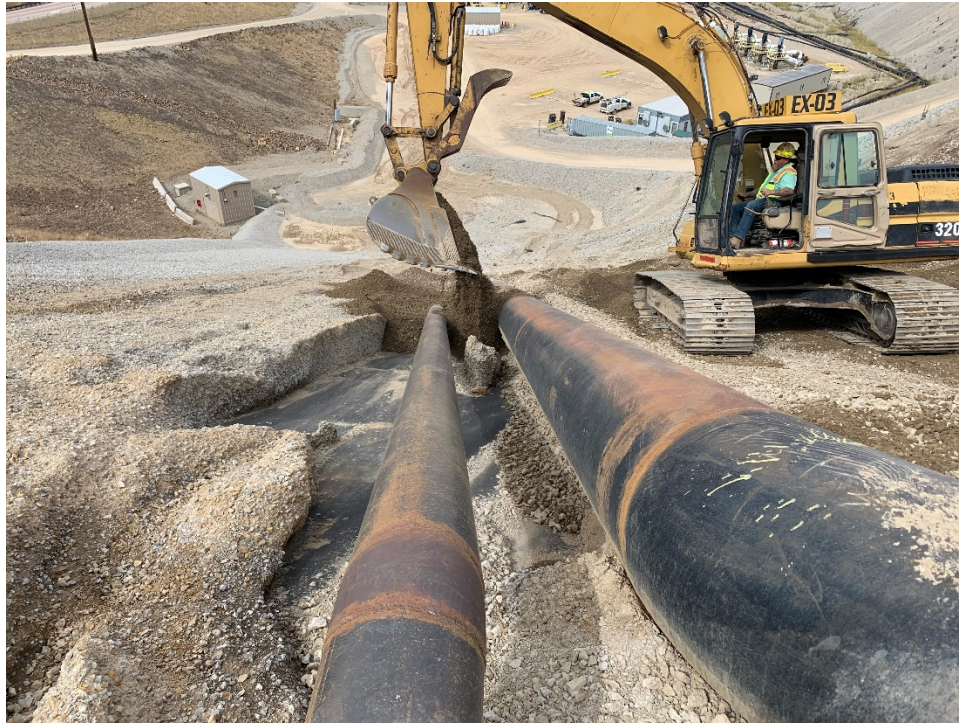
**Placement of spent ore material**

- Tezak personnel and equipment continued to backfill underneath ballasting the suspended carbon steel solution pipes and cover geomembrane on the washout above the ADR2/PSSA plant pad. Tezak and NewFields personnel would shovel and sweep loose material off the geomembrane surface, inspect the surface, and if no damage was found, would begin to backfill. Any damage found on the geomembrane surface was marked with sandbags and not covered. A D6 LGP dozer, 320 excavator, and skid steer borrowed spent ore material locally and placed it next to the solution pipes. Tezak personnel on the ground shoveled the spent ore material under the solution pipes and tamped in the material with shovel handles for stability. Tezak completed the Spent Ore placement under the pipes and covered most of the exposed geomembrane during the shift. No Spent Ore was placed off containment.

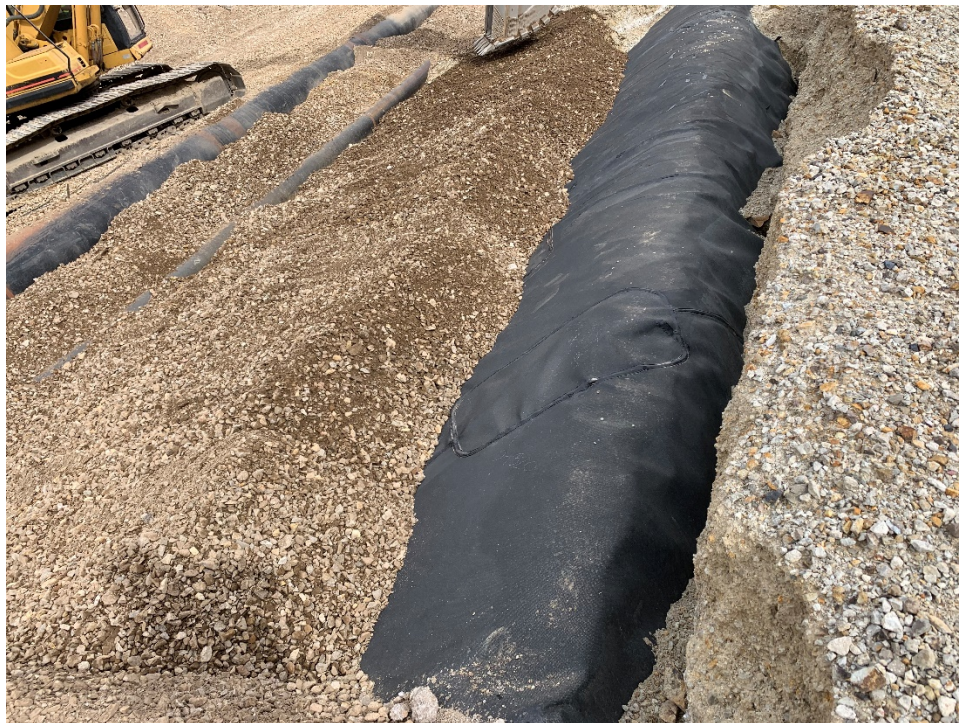
**Placement of spent ore limits, exposed anchor trench**

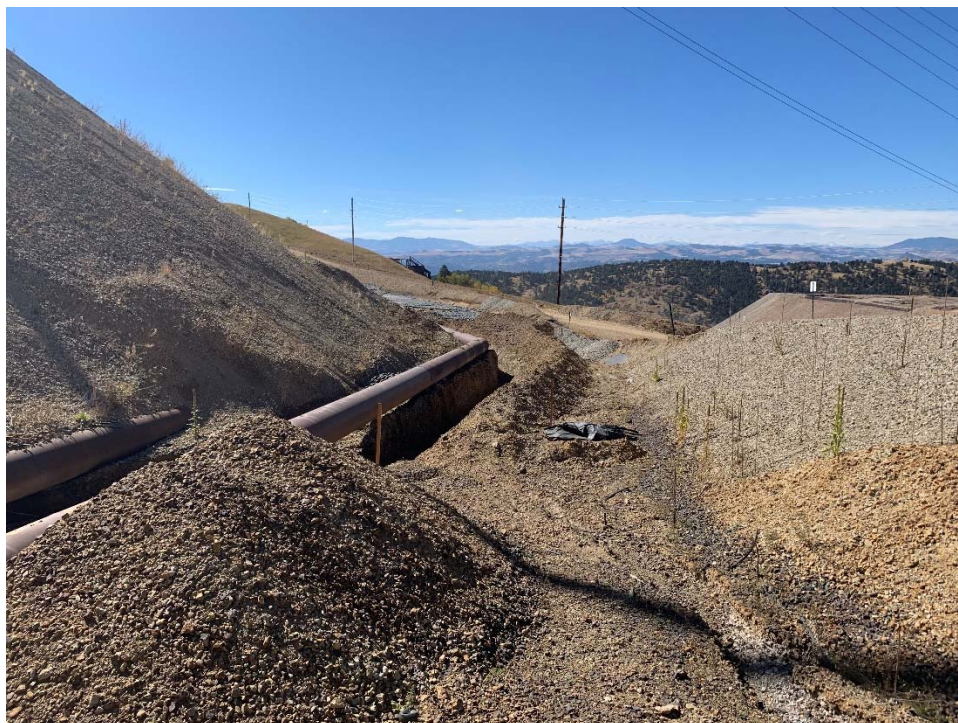
- NewFields personnel visually inspected the area of VLF1 where storm water had displaced DCF and exposed geomembrane during the August 3<sup>rd</sup> storm event. All of the exposed geomembrane had been re-covered with DCF material in an approximate 28 inch loose lift.

**VLF 1 area of inspection**

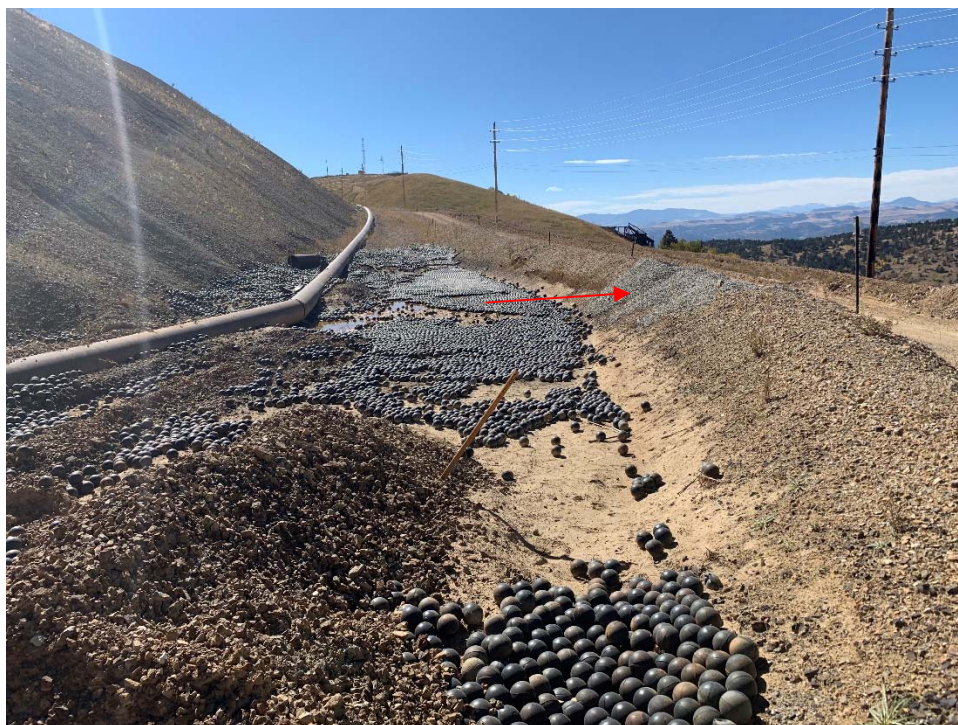
The stormwater runoff from the storm caused the surface water to rise above the VLF1 Phase 1 Perimeter Berm and anchor trench west of the mill. The runoff washed away the DCF covering the anchor trench and allowed the stormwater down an adjacent unnamed gulch. NewFields personnel visually inspected the exposed geomembrane, and didn't observe any damage (i.e., damage or other areas of concern) to the liner.

**VLF 1 DCF displacement area with re-covered geomembrane**

CC&V personnel and equipment placed material from locally sourced DCF in the anchor trench. The exposed geomembrane was covered in an approximate 28-inch loose lift of the DCF material.

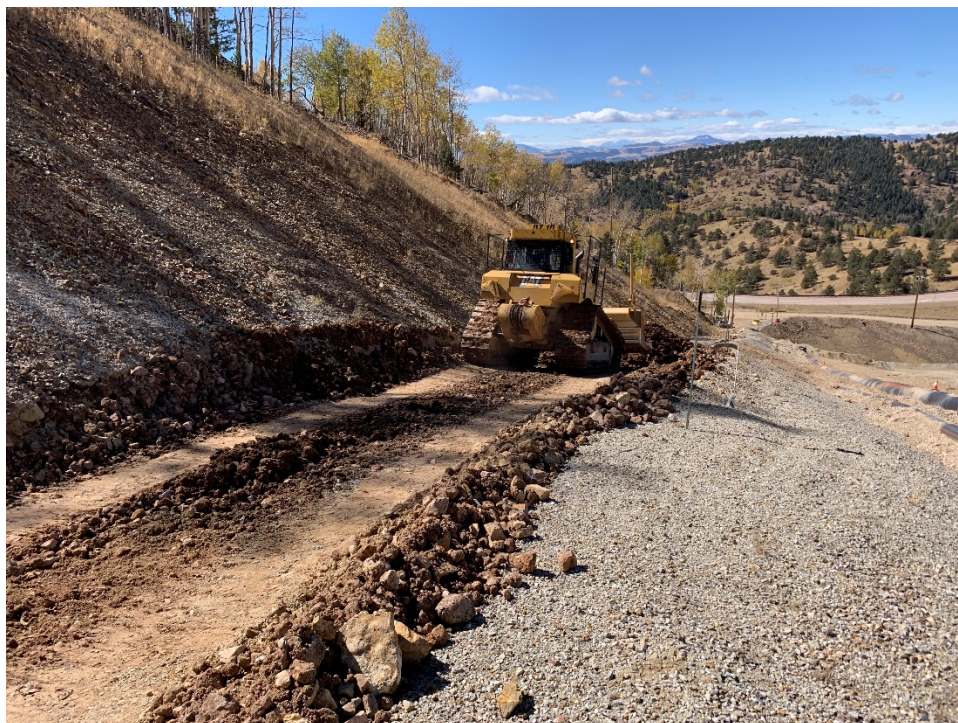
**Placement of overburden material outside of the VLF2 anchor trench**

Tezak placed backfill material along the VLF 2 Phase 1 anchor trench, filling in the erosion off geomembrane between the anchor trench and the adjacent slope. Material was compacted as it was placed with the haul traffic. Check ponds and check dams were established along the unnamed gulch, with final surface grading directed away from the VLF2 Phase 1 anchor trench.

- Tezak and Conely personnel placed backfill material along the VLF2 Phase 1 anchor trench above the ADR2/PSSA pad, filling in the erosion off geomembrane between the anchor trench and the adjacent slope. 40-ton Volvo haul trucks transported overburden material from the Dump 1 SLF processing site to a D6 dozer. Material was compacted as it was placed with the haul traffic. Check ponds and check dams were re-established along the unnamed gulch, with final surface grading and structure outlets directed away from the VLF2 Phase 1 anchor trench.
- Tezak and Conely personnel placed crushed stemming material as DCF along the remaining area of exposed liner above the ADR2/PSSA pad. The recovering of exposed geomembrane is complete.

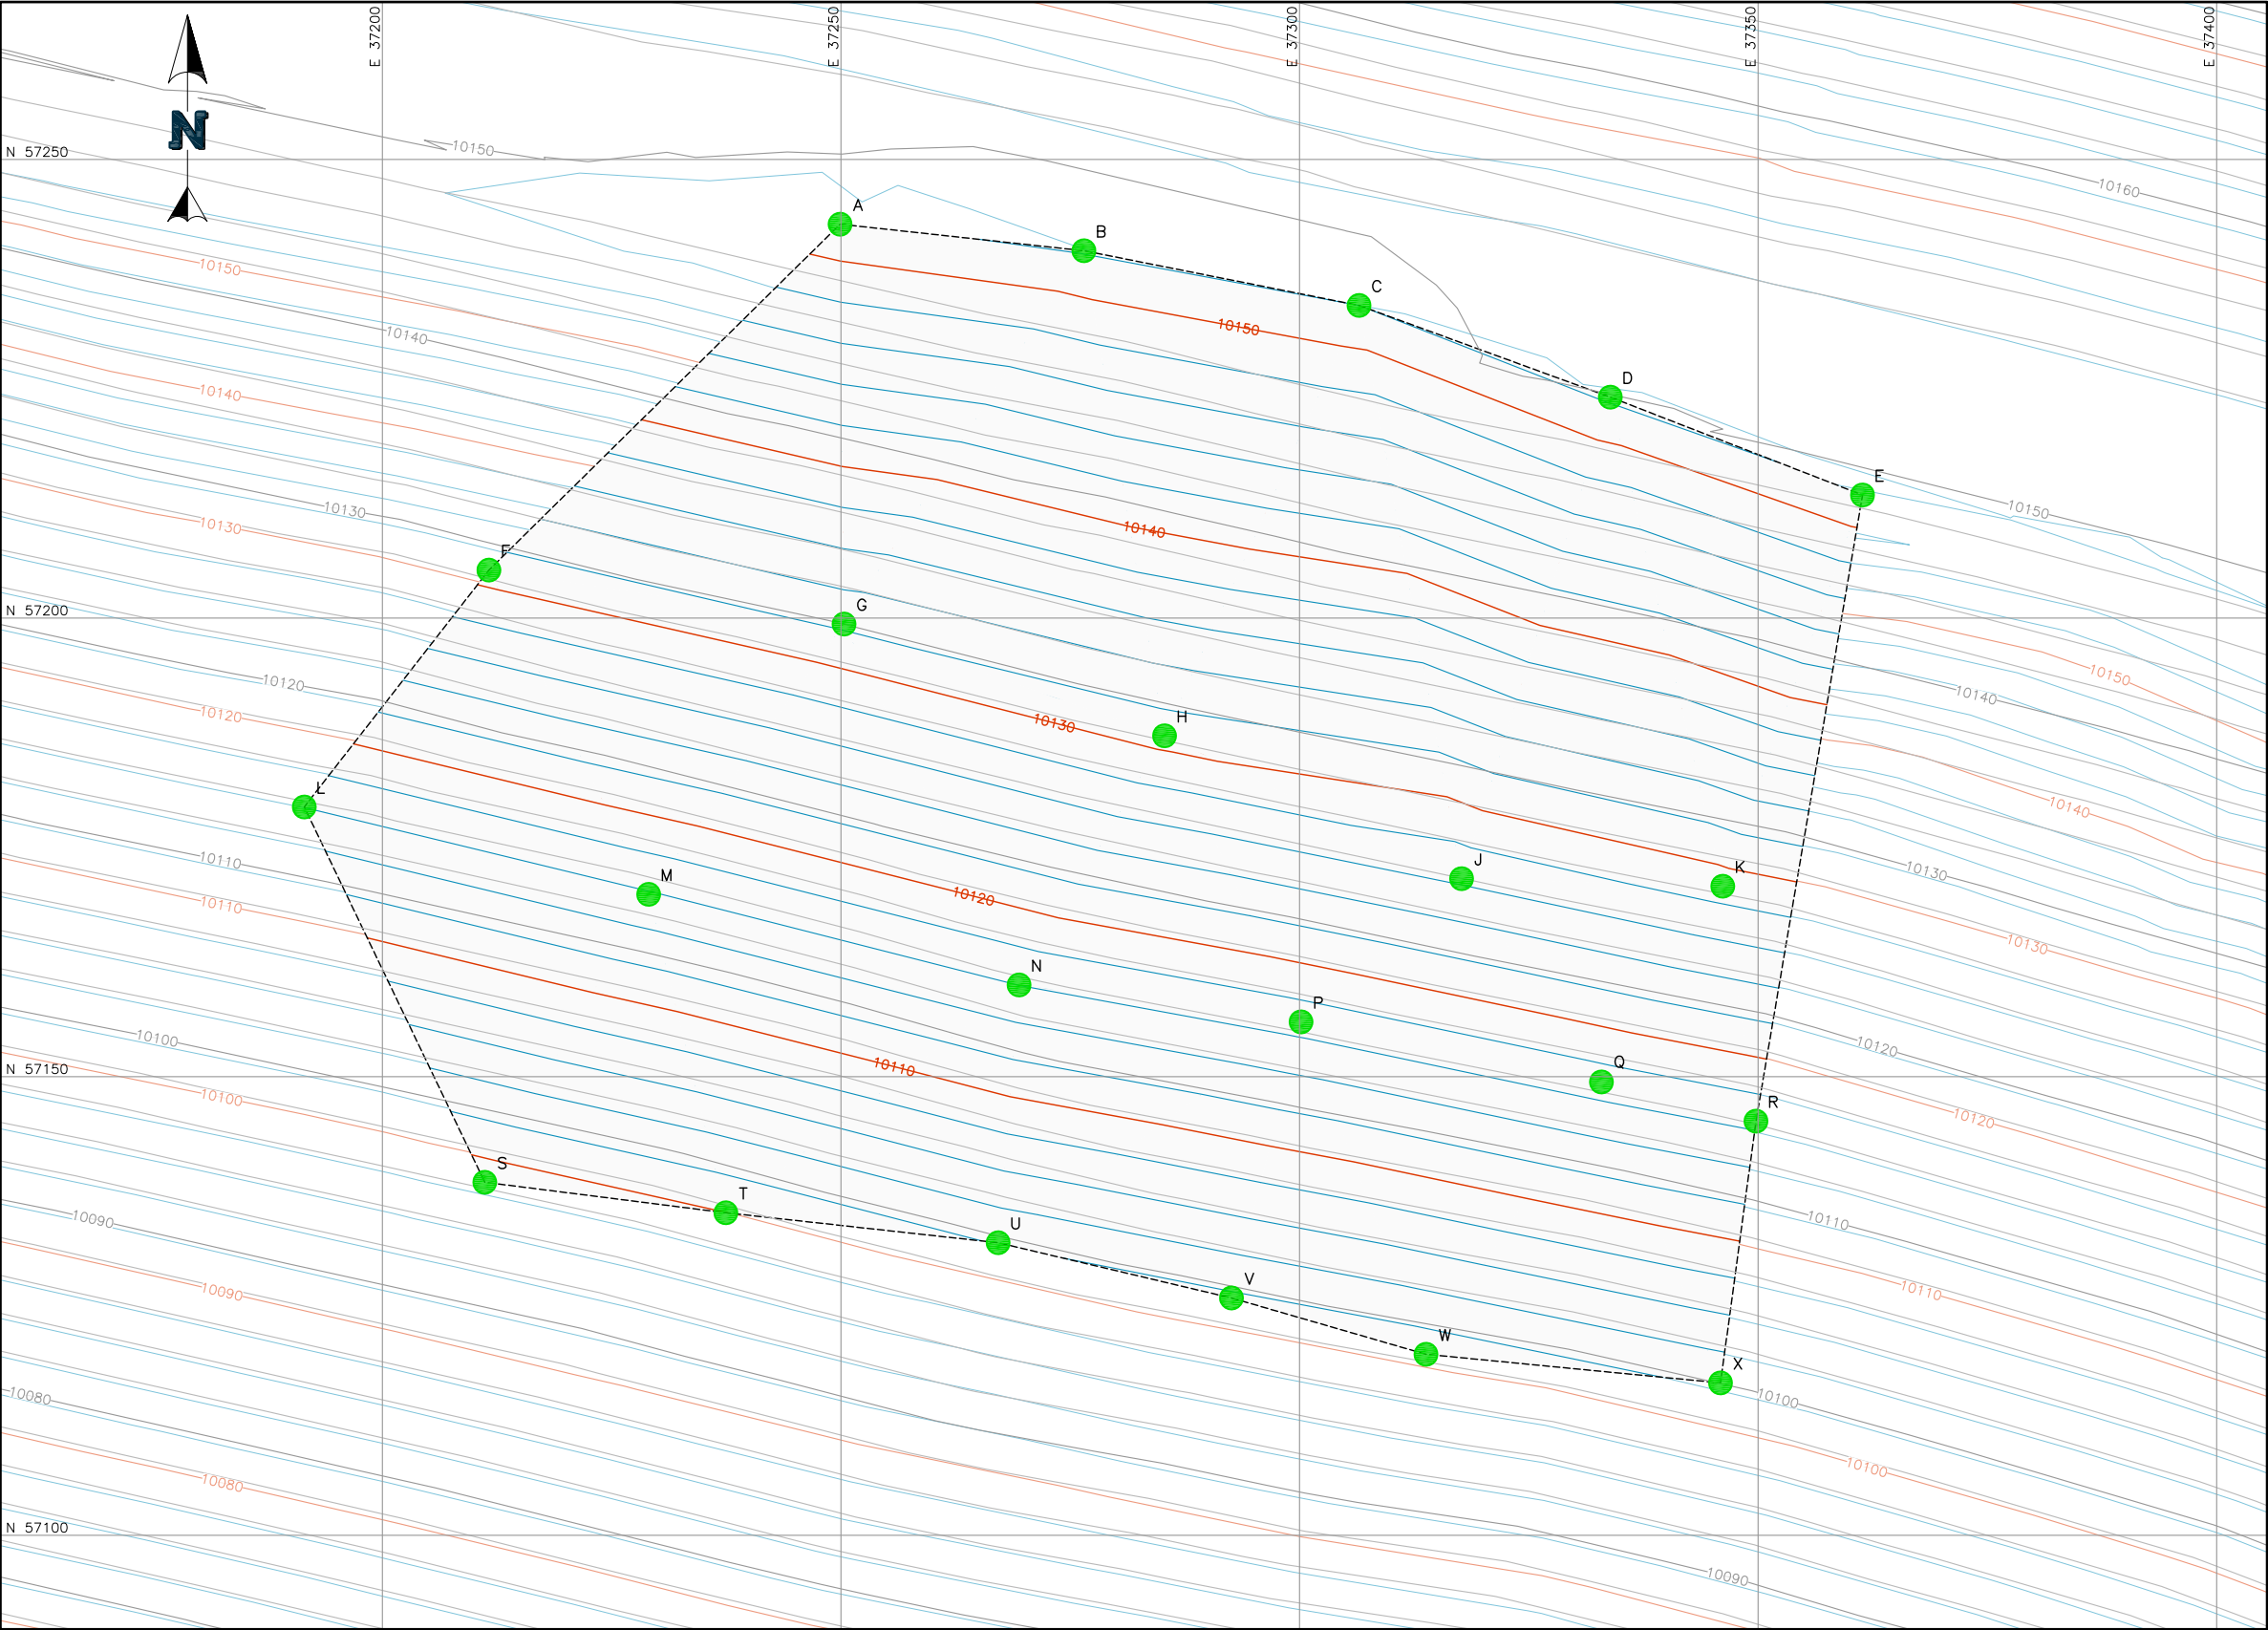
**DEPTH CHECKS**

POINT	DEPTH OF DCF (FEET)
A	2.21
B	2.73
C	2.25
D	2.38
E	3.21
F	2.44
G	2.32
H	2.54
J	2.35
K	2.55
L	2.33

POINT	DEPTH OF DCF (FEET)
M	2.76
N	2.46
P	2.29
Q	2.44
R	2.32
S	2.42
T	2.34
U	2.46
V	2.28
W	2.24
X	2.30
