**MINERALS PROGRAM INSPECTION REPORT**  
**PHONE: (303) 866-3567**

<b>MINE NAME:</b> Tucson South Resource	<b>MINE/PROSPECTING ID#:</b> M-2004-044	<b>MINERAL:</b> Sand and gravel	<b>COUNTY:</b> Adams
<b>INSPECTION TYPE:</b> Preoperation Inspection	<b>INSPECTOR(S):</b> Patrick Lennberg	<b>INSP. DATE:</b> December 8, 2021	<b>INSP. TIME:</b> 11:30
<b>OPERATOR:</b> Aggregate Industries - WCR, Inc.	<b>OPERATOR REPRESENTATIVE:</b> Gary Linden and Roger Wingate	<b>TYPE OF OPERATION:</b> 112c - Construction Regular Operation	
<b>REASON FOR INSPECTION:</b> Preoperation Inspection	<b>BOND CALCULATION TYPE:</b> None	<b>BOND AMOUNT:</b> \$3,505,000.00	
<b>DATE OF COMPLAINT:</b> NA	<b>POST INSP. CONTACTS:</b> None	<b>JOINT INSP. AGENCY:</b> None	
<b>WEATHER:</b> Cloudy	<b>INSPECTOR'S SIGNATURE:</b>

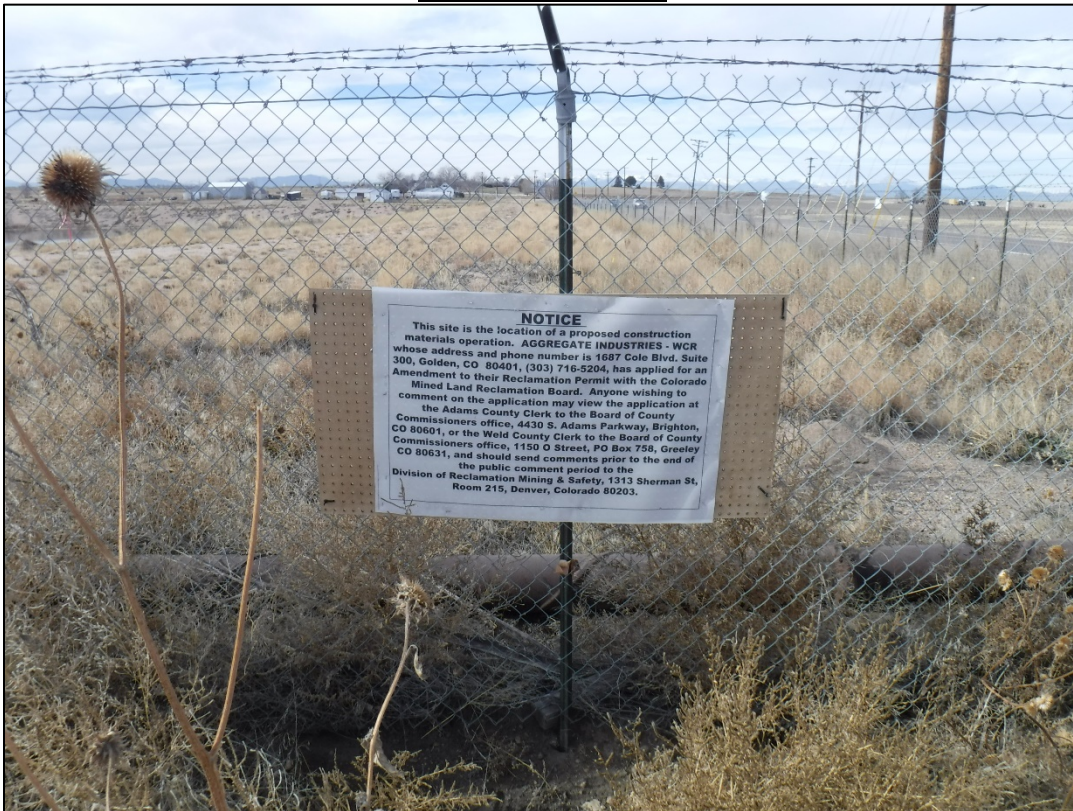
Amendment notice signs were viewed to be visible by the public near the intersections of Hwy 7 and Tucson Street, 168<sup>th</sup> Ave and Tucson St, along WCR 23 ½, and at the primary mine entrance.

**Photo 1:** Notice sign at 168<sup>th</sup> Ave and Tucson St.

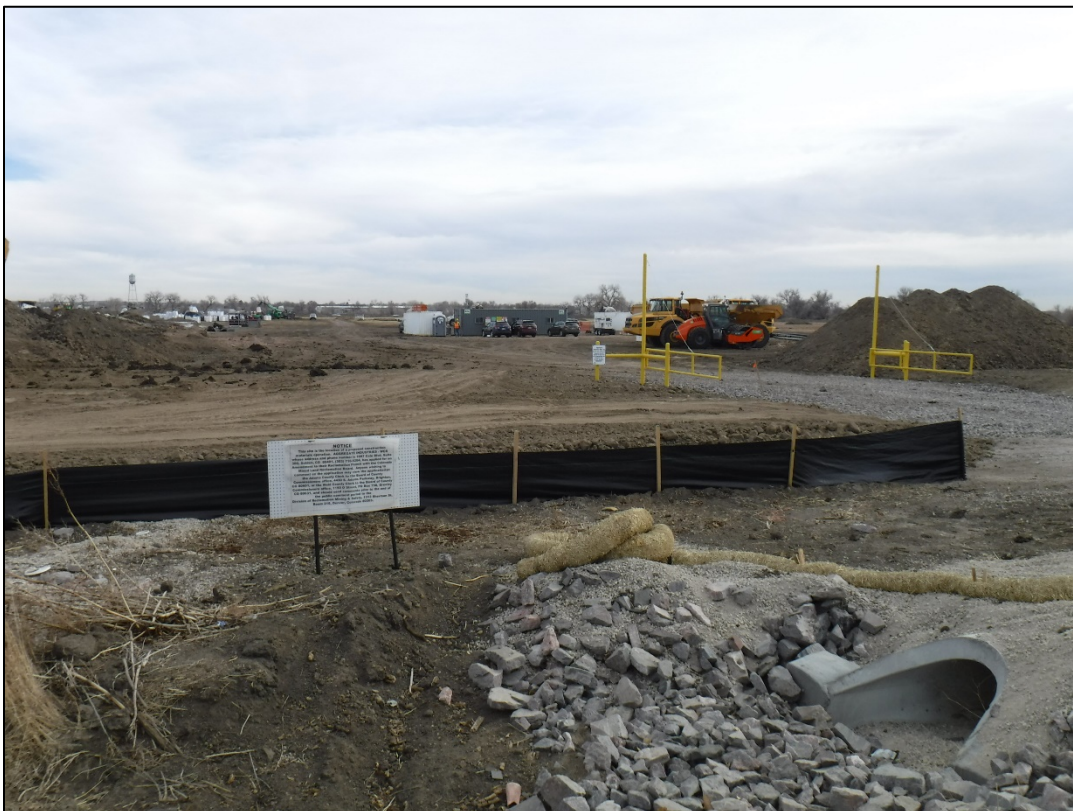
**Photo 2:** Notice at the primary mine entrance

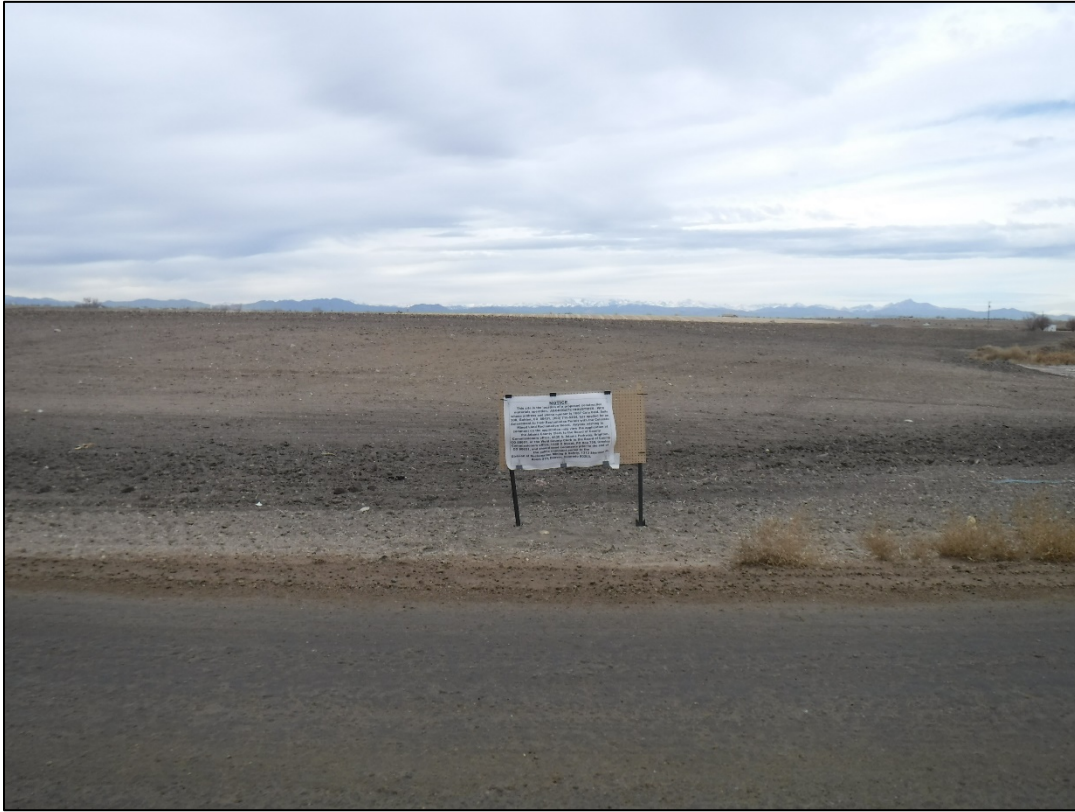
**Photo 3:** Notice at the along WCR 23 ½

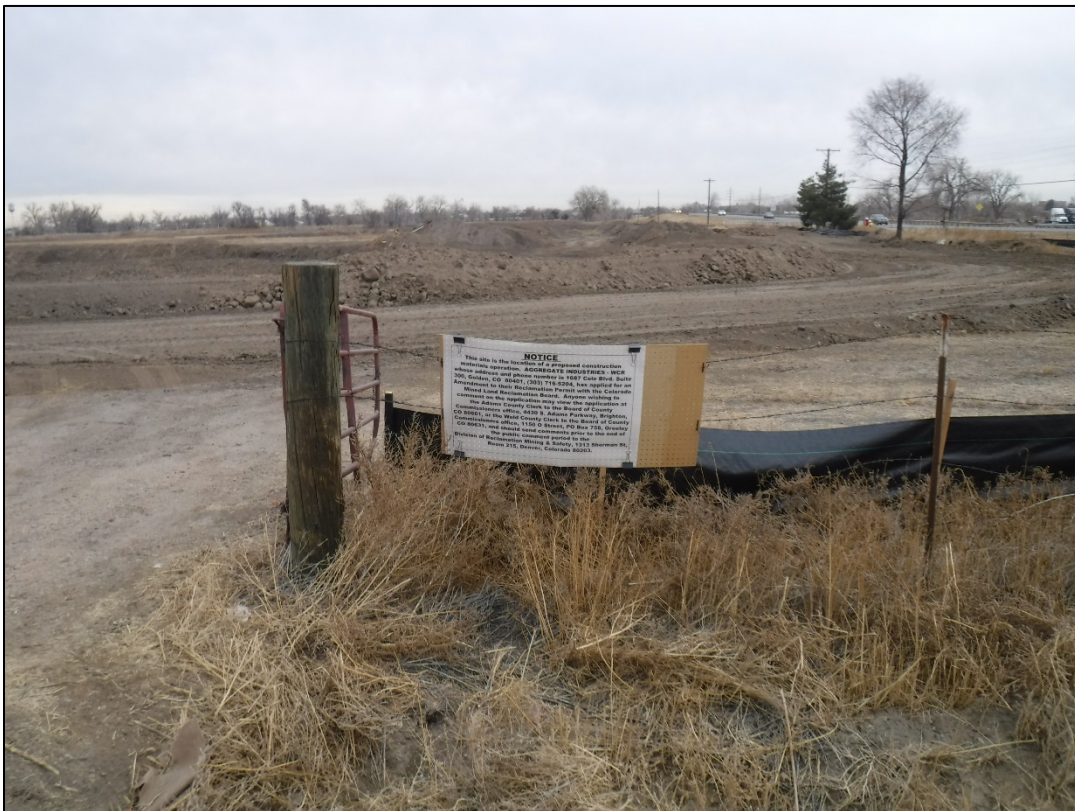
**Photo 4:** Notice near the intersection of Hwy 7 and Tucson St.

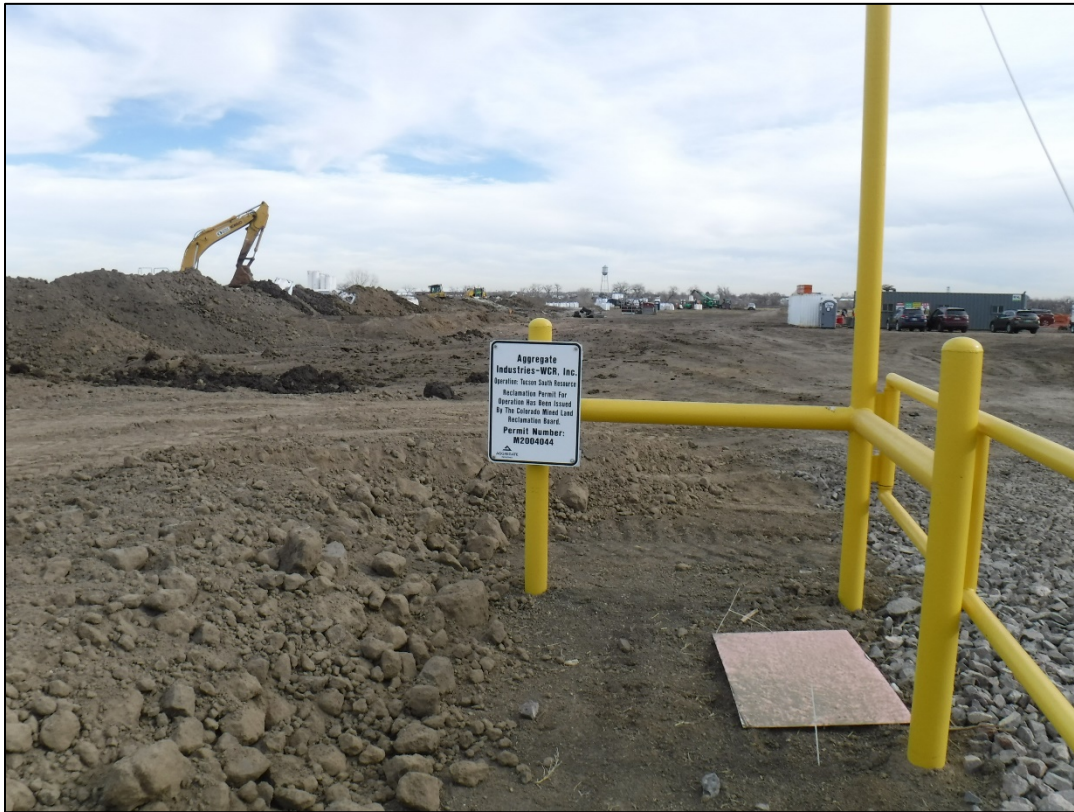
**Photo 5:** Mine sign at entrance

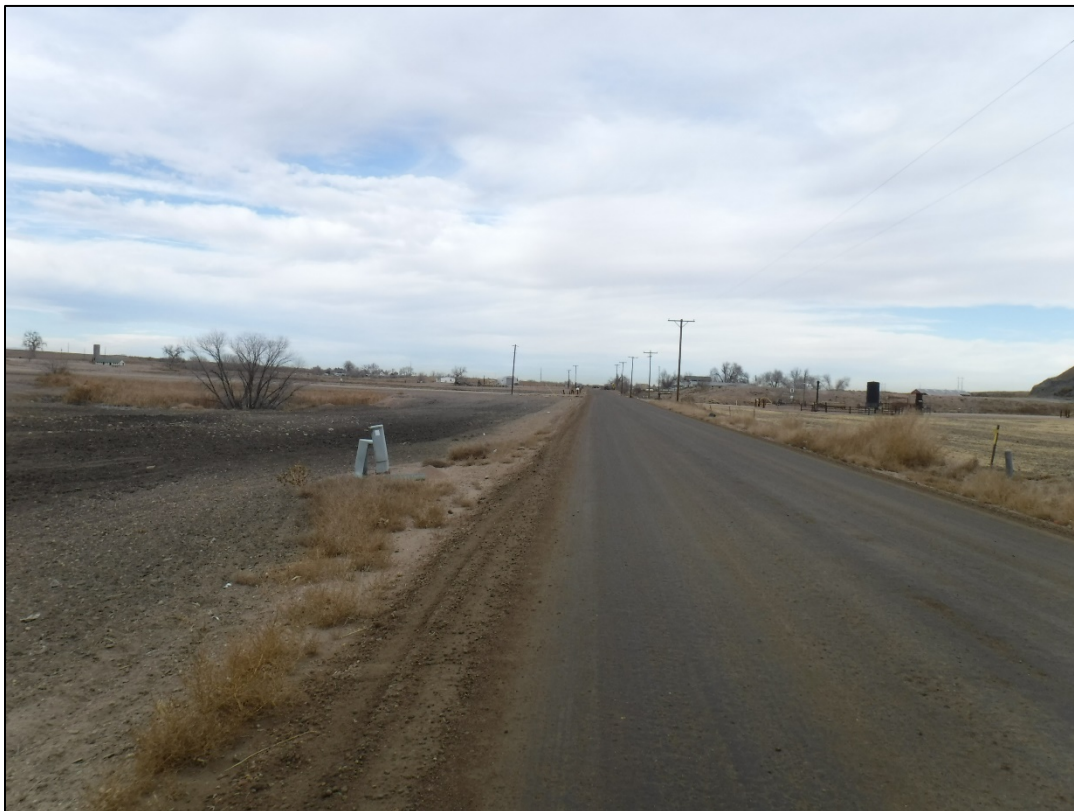
**Photo 6:** Looking north along WCR 23 ½, conveyor corridor is on the left

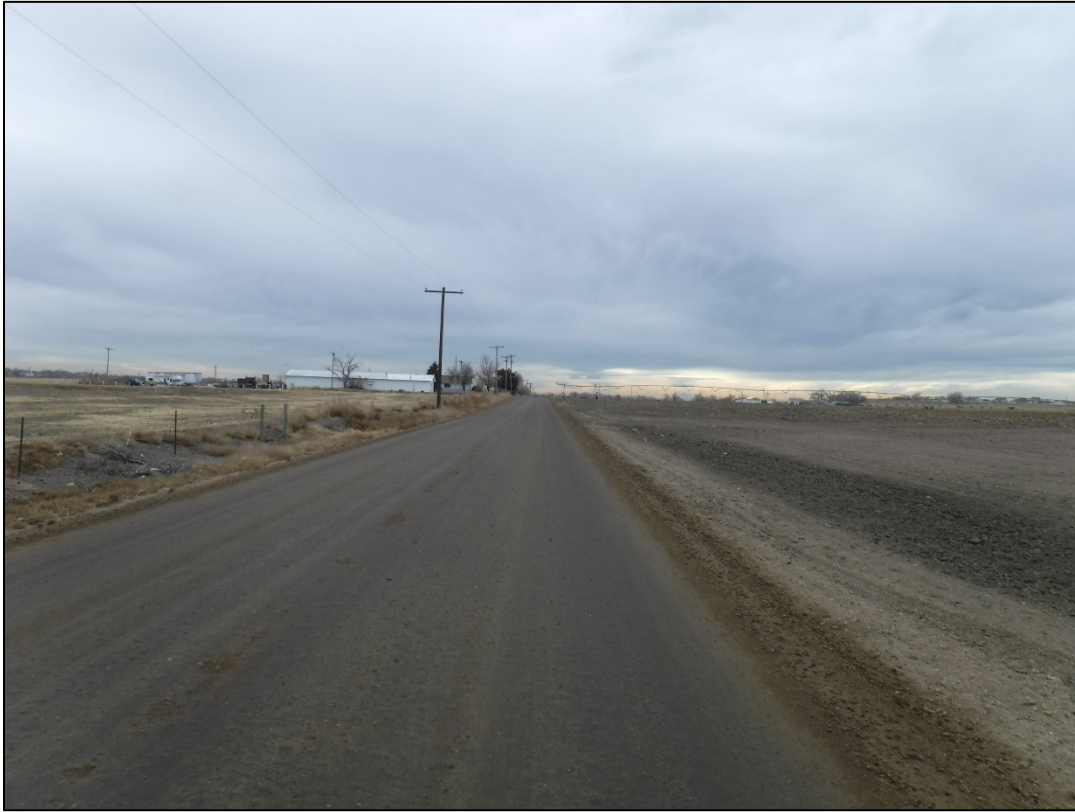
**Photo 7:** Looking south along WCR 23 ½, conveyor corridor is on the right

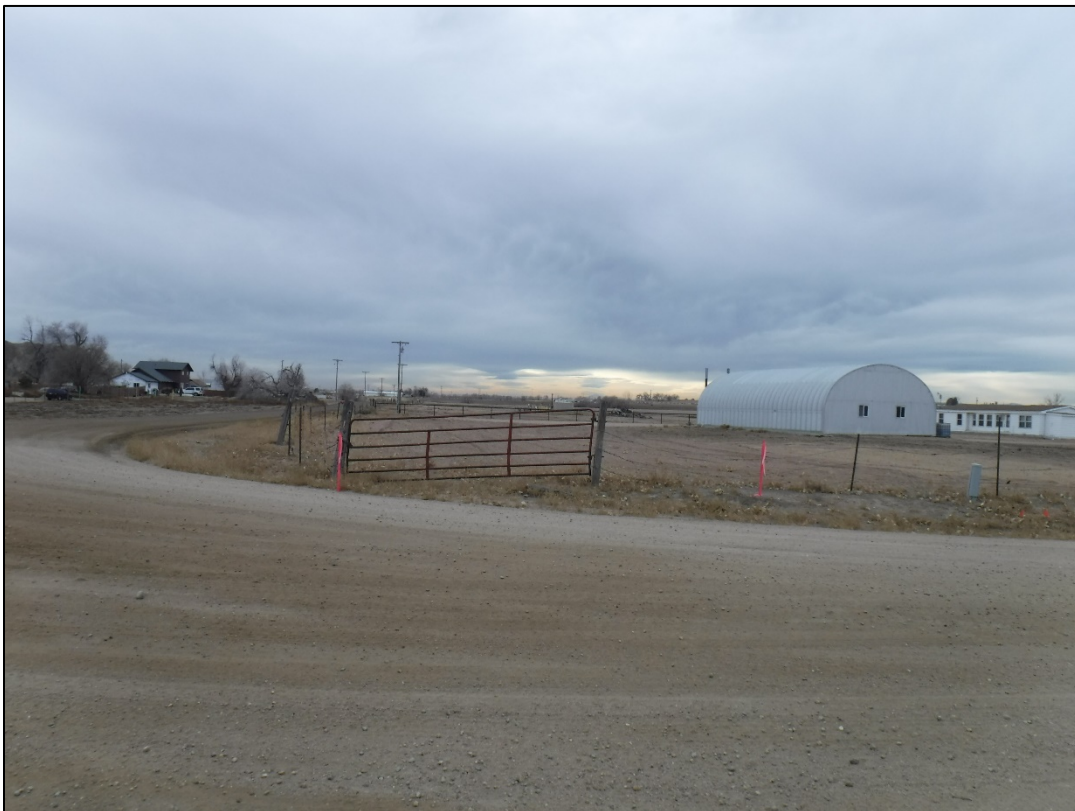
**Photo 8:** Looking south at the intersection of WCR 23 ½ and 23 ¾, conveyor corridor approximate limits are marked by laths

During the inspection of the proposed corridor along WCR 23 ½ the Division recommended the operator find a more permanent method of marking the permit boundary instead of the wooden lath currently used. Laths in a few locations were missing either through field cultivation or missing for other reasons. The Division also viewed the Struck driveway that will be relocated to the north side of the Struck property to allow for the conveyor. A comment received by the Division from CPW noted they prefer the conveyor corridor not be fenced.

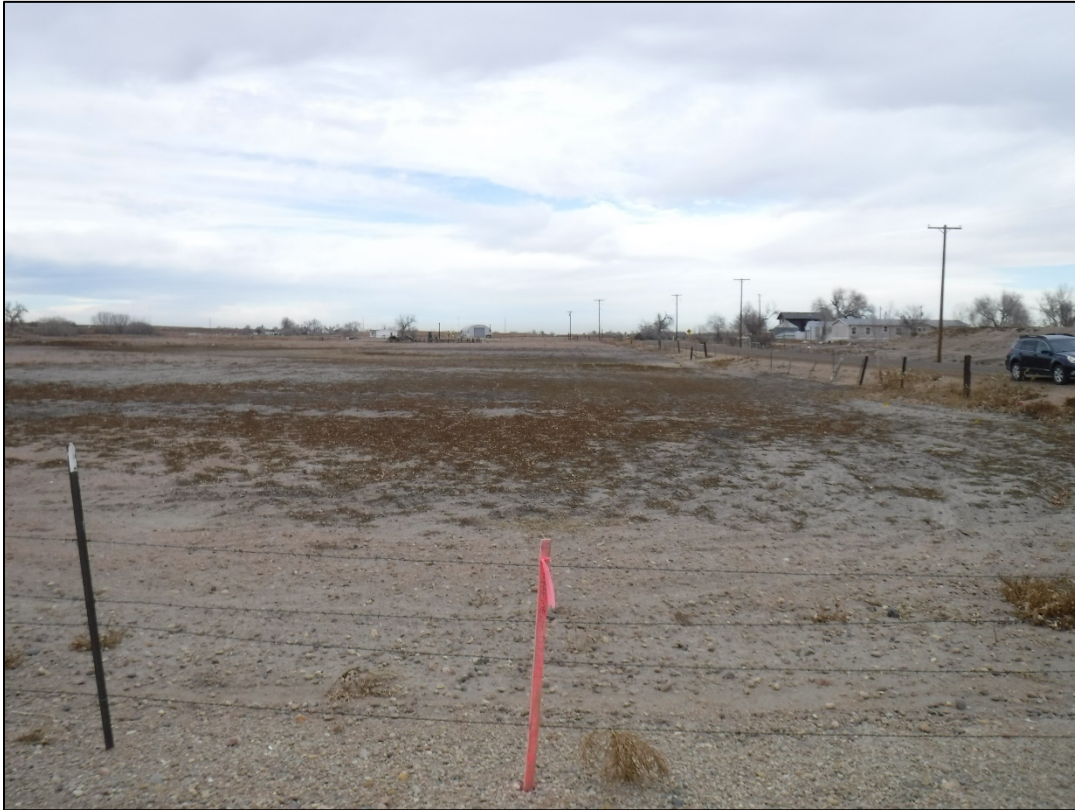
**Photo 9:** Looking north along conveyor corridor centerline, limits are marked by laths

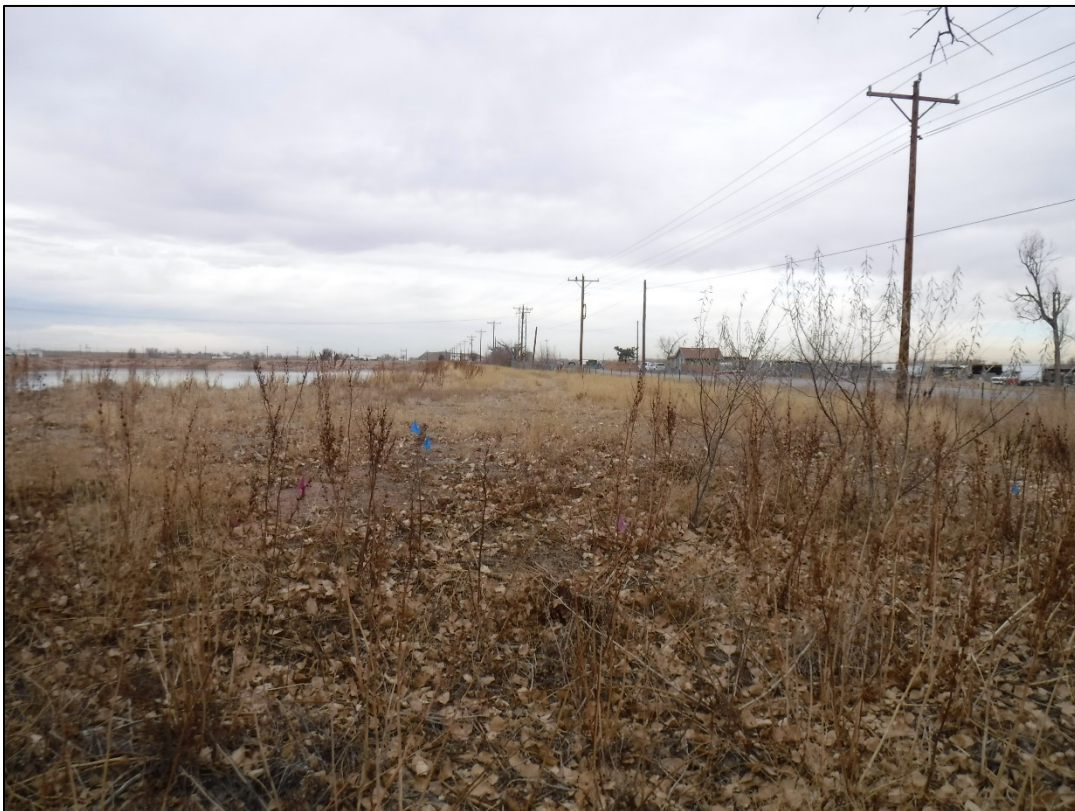
**Photo 10:** Looking north along conveyor corridor centerline into the Challenger Res. area

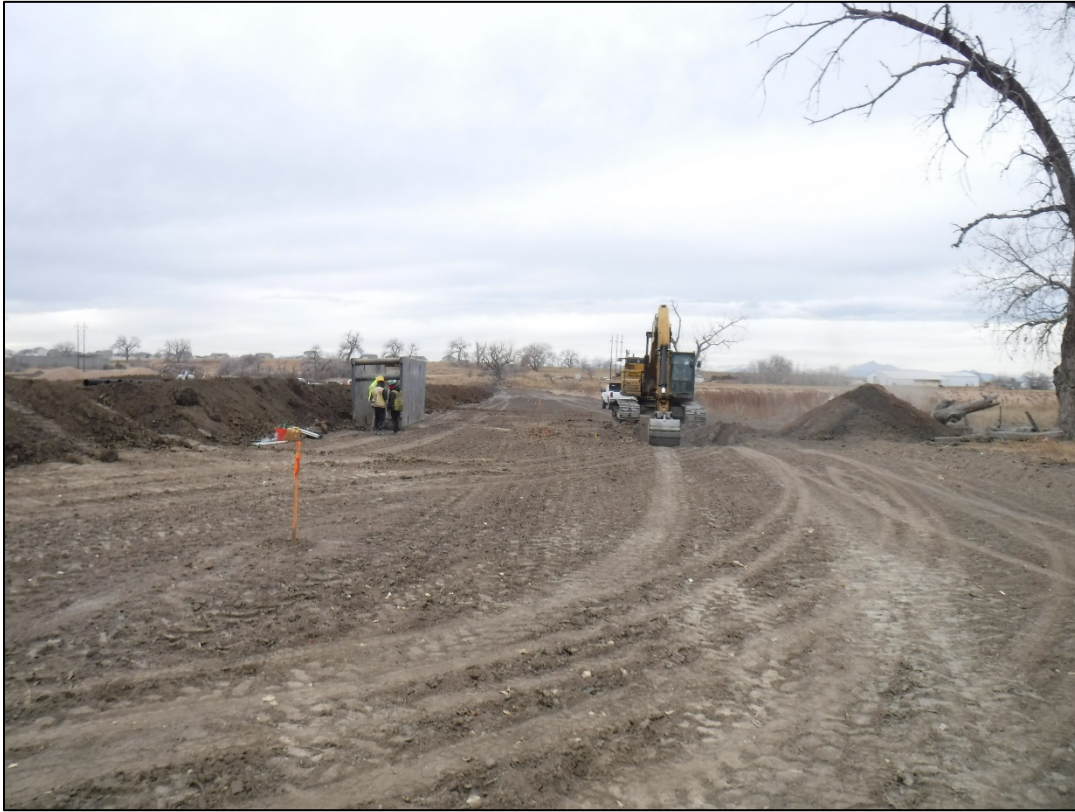
**Photo 11:** The beginning of the northern underdrain construction

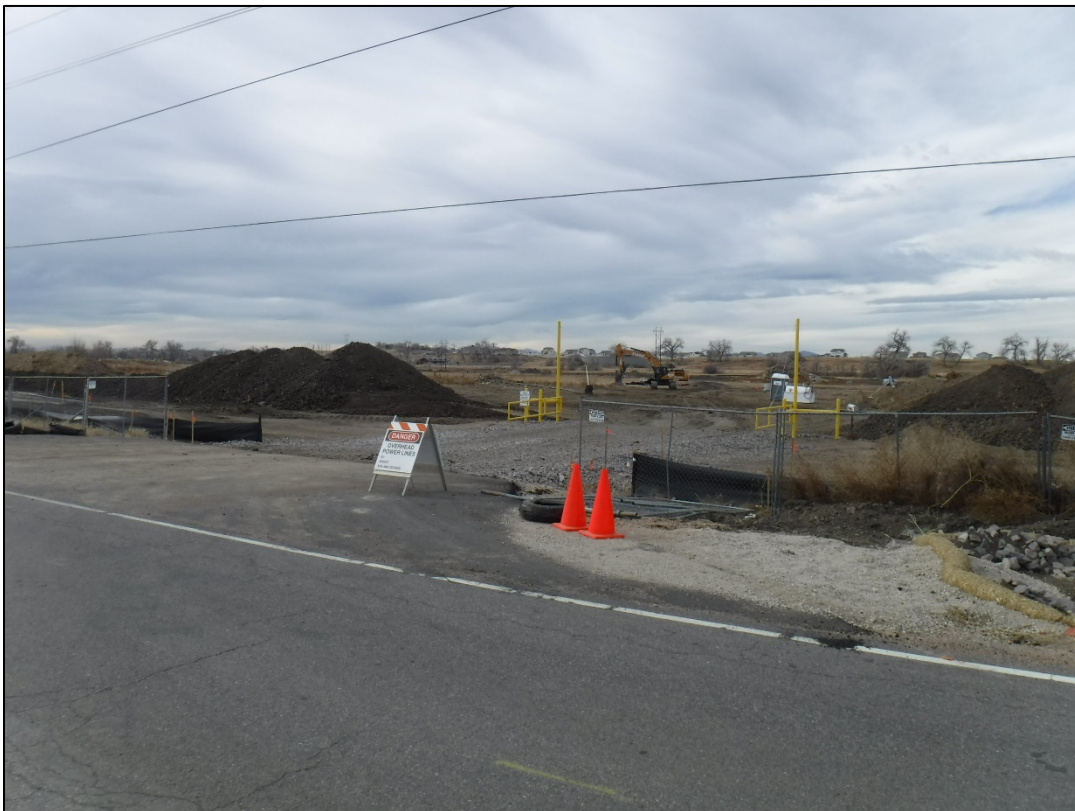
**Photo 12:** Mine entrance on the west side of Tucson St.
