MINERALS PROGRAM INSPECTION REPORT
PHONE: (303) 866-3567

MINE NAME: Cresson Project	MINE/PROSPECTING ID#: M-1980-244	MINERAL: Gold	COUNTY: Teller
INSPECTION TYPE: Monitoring	INSPECTOR(S): Brock Bowles	INSP. DATE: November 17, 2021	INSP. TIME: 09:00
OPERATOR: Cripple Creek & Victor Gold Mining Co.	OPERATOR REPRESENTATIVE: Jeana Ratcliff	TYPE OF OPERATION: 112d-3 - Designated Mining Operation	
REASON FOR INSPECTION: Normal I&E Program	BOND CALCULATION TYPE:	BOND AMOUNT: \$209,491,188.00	
DATE OF COMPLAINT: NA	POST INSP. CONTACTS: None	JOINT INSP. AGENCY: None	
WEATHER: Clear	INSPECTOR'S SIGNATURE:

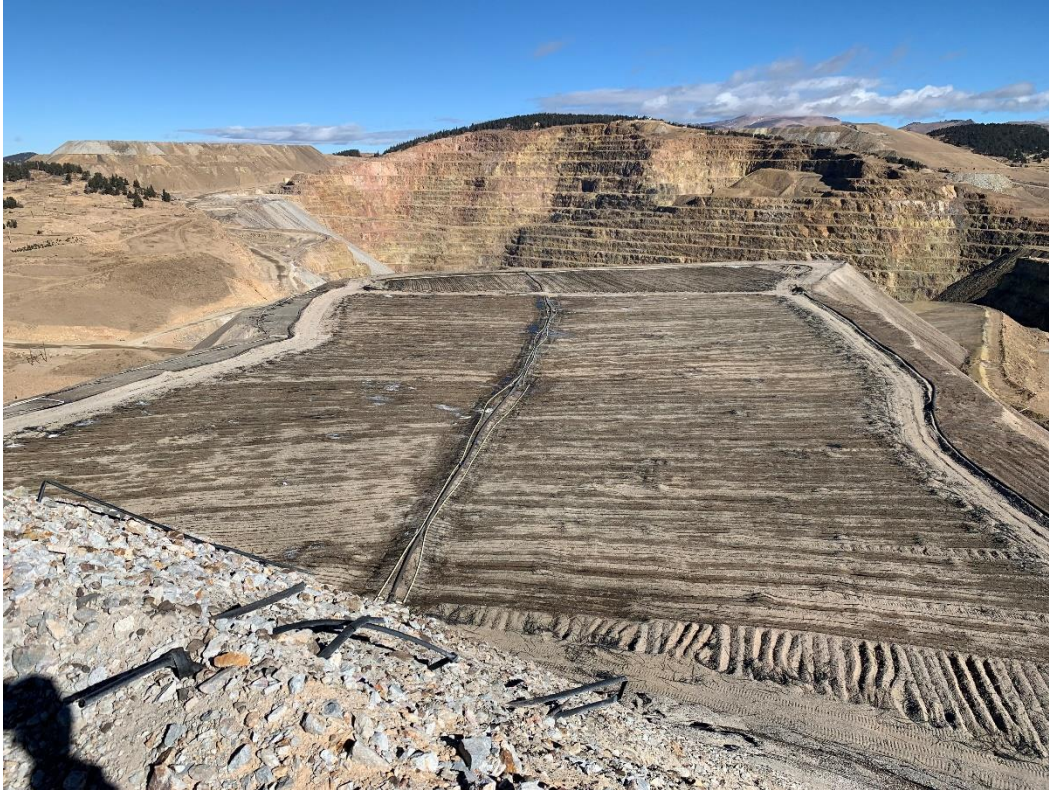
Photo 1 – VLF 1, 10,300 level, facing north

The VLF1 10,400 level had water being applied through the drip system. No leaks were noted. The 10,300 level also had water being applied (photo 1). A leak was noted on the north end of the drip system and it was repaired within the 10 minutes we were in the area. The 10,200 level also had water being applied (photo 2). No leaks were noted on this level. No ponding greater than 9 square feet was noted on any of the levels on VLF1.

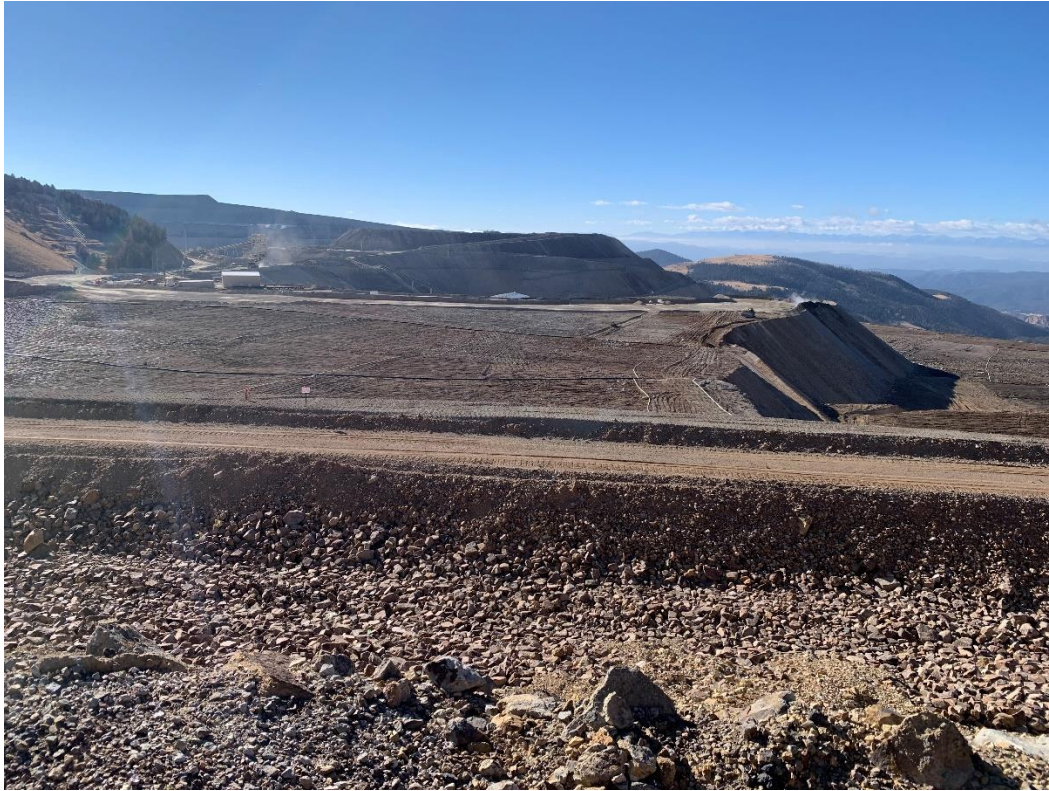
The VLF2 10,100 level had solution being applied on the north side of the lift. Ore was being stacked on the south side (photo 3). Solution was being applied to the 10,000 level (photo 4). No leaks were noted on either level and no ponding greater than 9 square feet was noted.

Photo 3 - VLF2 – 10,100 level, facing south, ore stacking on far side

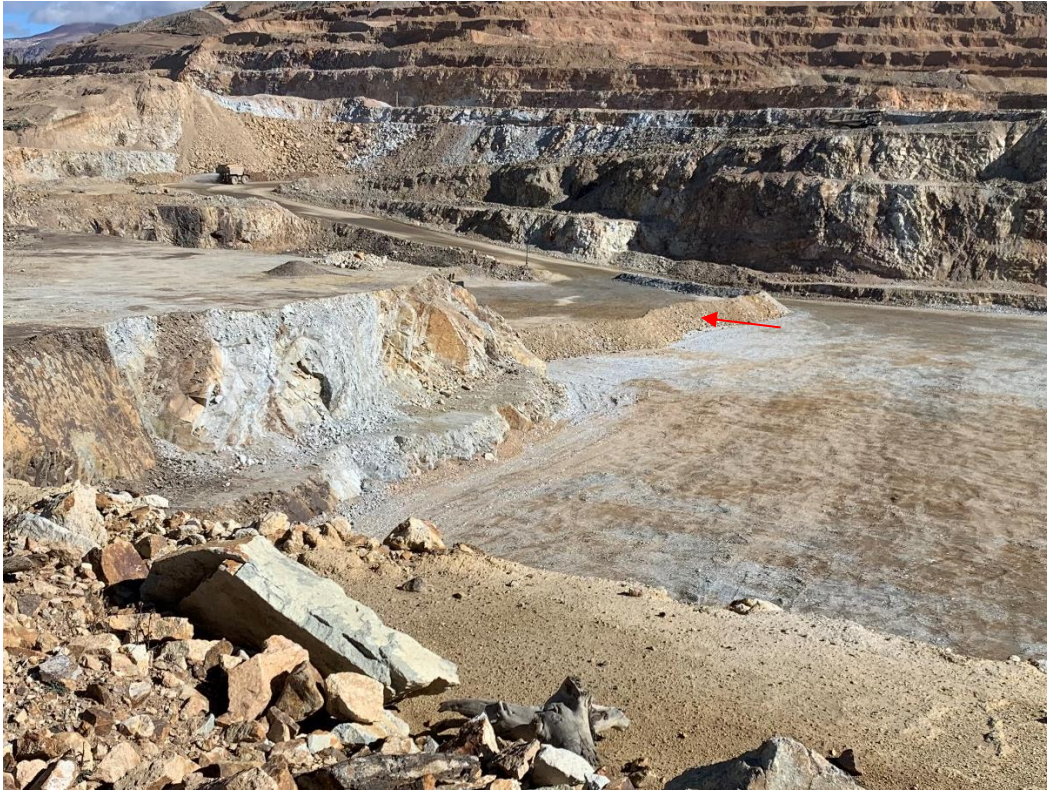
Photo 5 – Schist Island, 5' lift

Material was being stacked in 5 foot lifts from north to south. When the lift is complete a loaded haul truck will pass 3 times over the entire lift to ensure the compaction standard. A sheepsfoot compactor is used for the areas close to the perimeter wall where the haul truck cannot get. A water truck watered the access road and the top of the lift (photo 5). A couple of haul trucks dumped material. No rocks larger than 24 inches were noted.

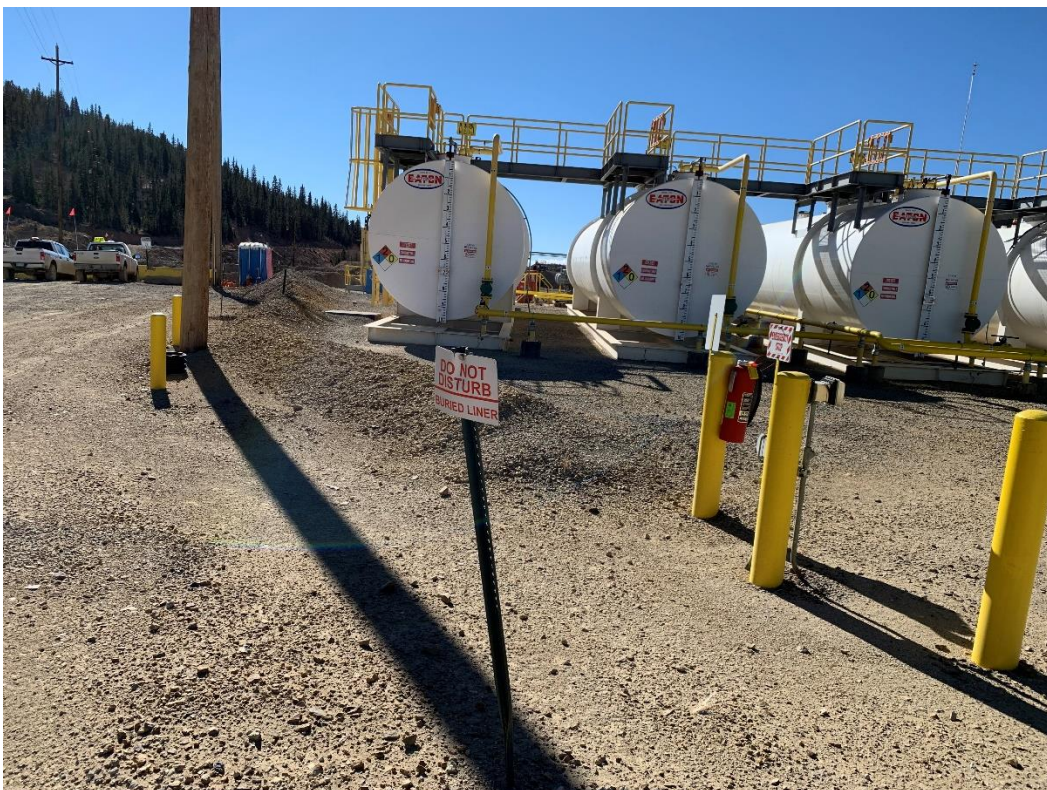
Photo 6 – Midway Fuel Island area

The fuel island area was free and clear of debris. No spills were noted. Several spill kits and fire extinguishers were in the area. The edge of liner was marked with signs (photos 6).

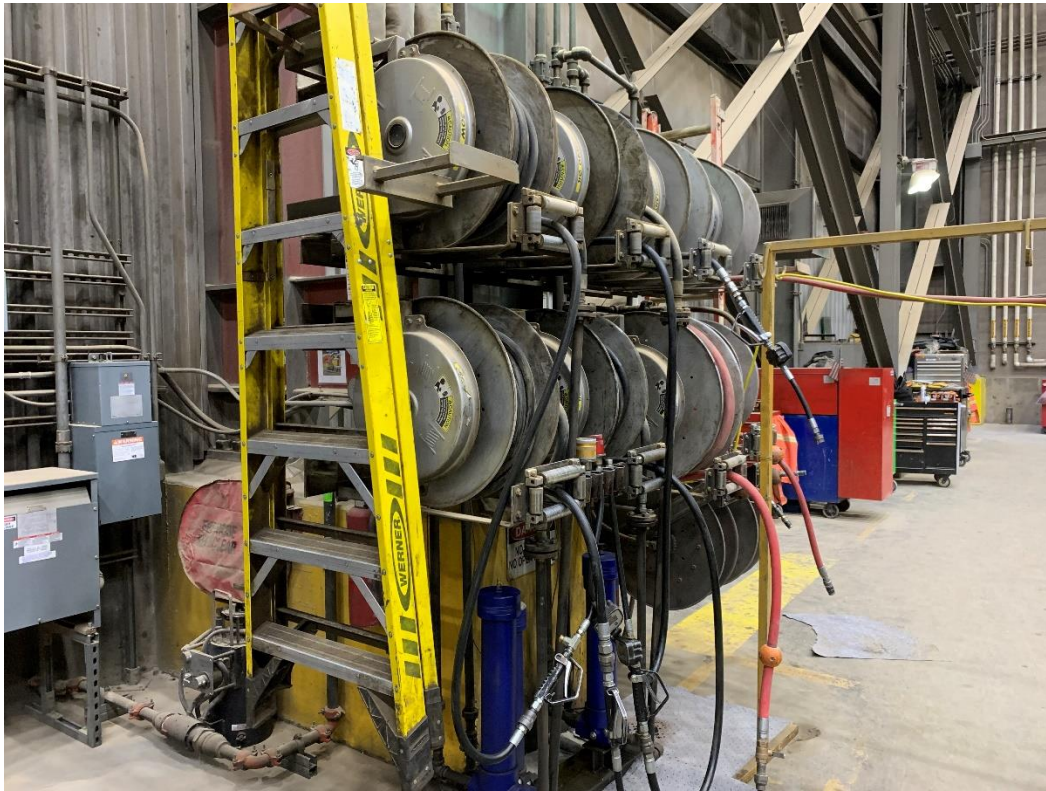
Photo 7 – Truck shop oil dispensing station

The truck shop was well organized. No oil spills were noted. The oil dispenser station was clean and well maintained (photo 7). The carts used for oil changes were clean and no spills were seen (photo 8).

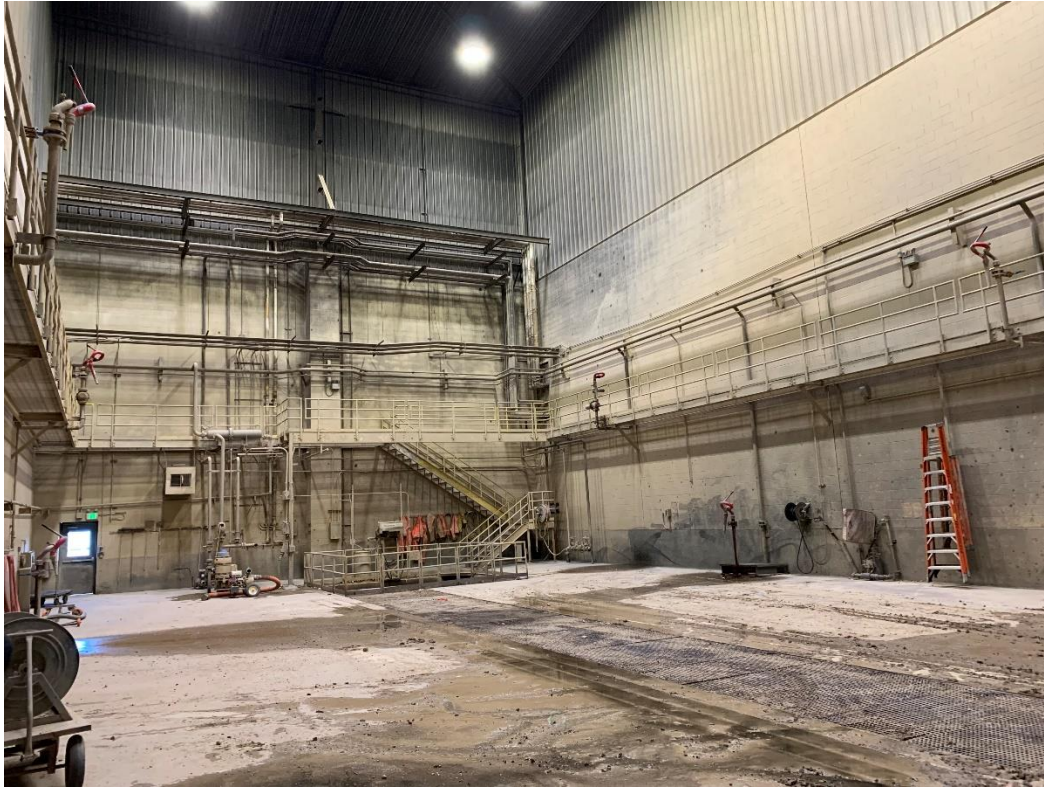
Photo 9 – Truck wash bay

The truck wash bay is a large indoor facility. Water jets are staged on the floor and along a catwalk about 20 feet above the floor (photo 9). The floor is sloped to middle of the room to a grate covered trench. Water flows into the trench and then directed to the north side of the room. A three stage sump is used to separate the water and dirt (photo 10). The water is recycled and pumped back to the water jets. The center trench is cleaned periodically. The material is remove by a skid-steer to a sump pit just outside the wash bay to the southeast (photo 11). Once the material dries it is then transported to the main pit area.

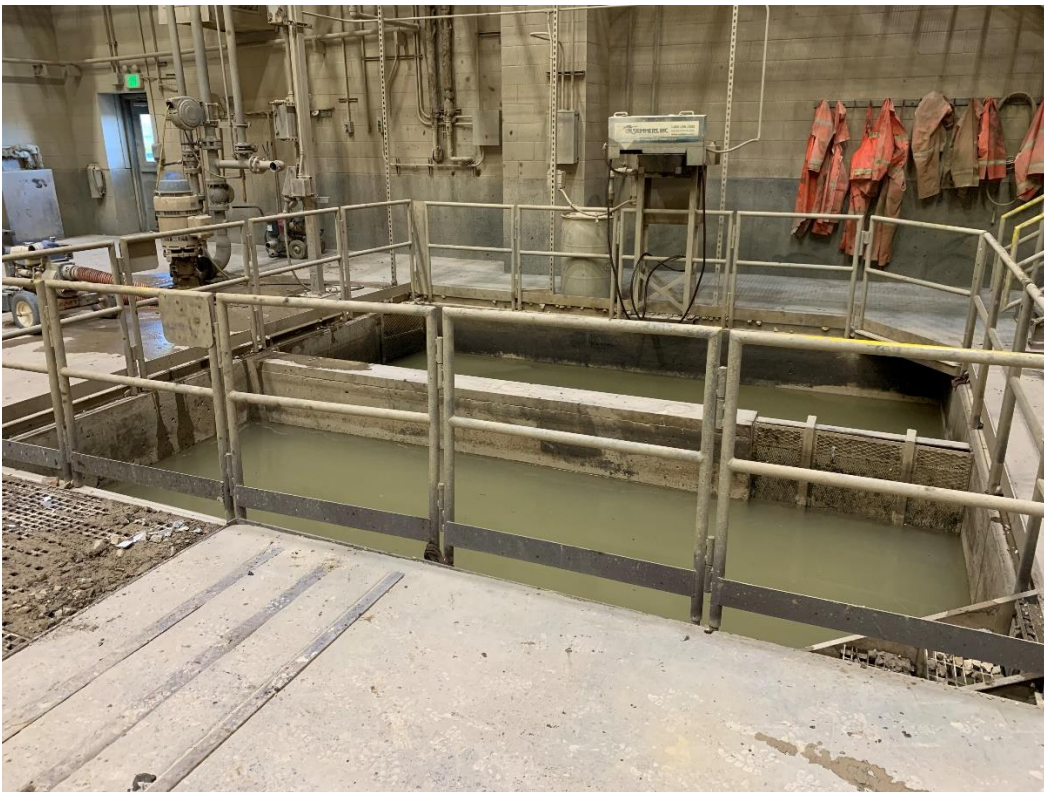
Photo 10 – 3 stage sump to separate dirt from recycled wash water.

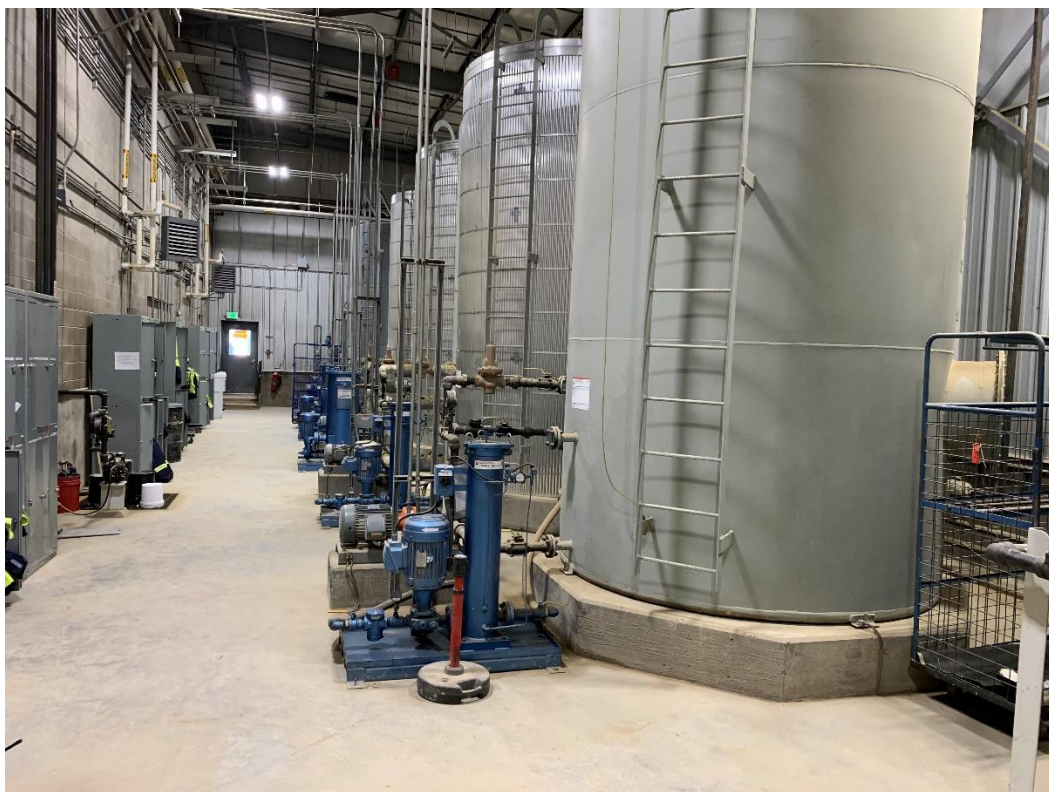
Photo 12 – Bulk lubricant storage area

The lubricant and oil bulk storage area is the eastern end of the truck shop. The room contains 5 large storage silos (photo 12). The room was clean and there were no oil spill stains noted. Spill kits and fire extinguishers

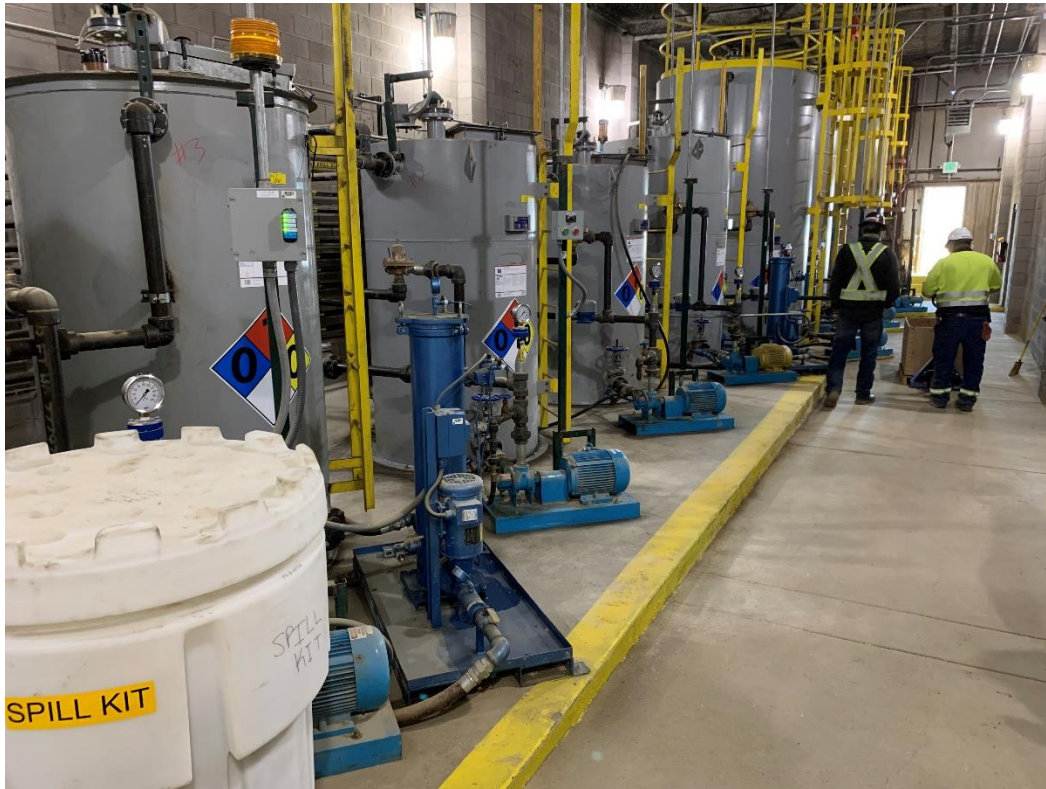
Photo 13 – Warehouse bulk lubricant storage area

were located in the room. A second bulk lubricant storage area is located in the warehouse (photo 13). This area was clean and there were no oil spill stains noted. Spill kits and fire extinguishers were located in the room. The area outside the warehouse where the oil is pumped into the servicing vehicles had a containment structure under the nozzles. The area was clean and a spill kit and fire extinguisher were nearby (photo 14).

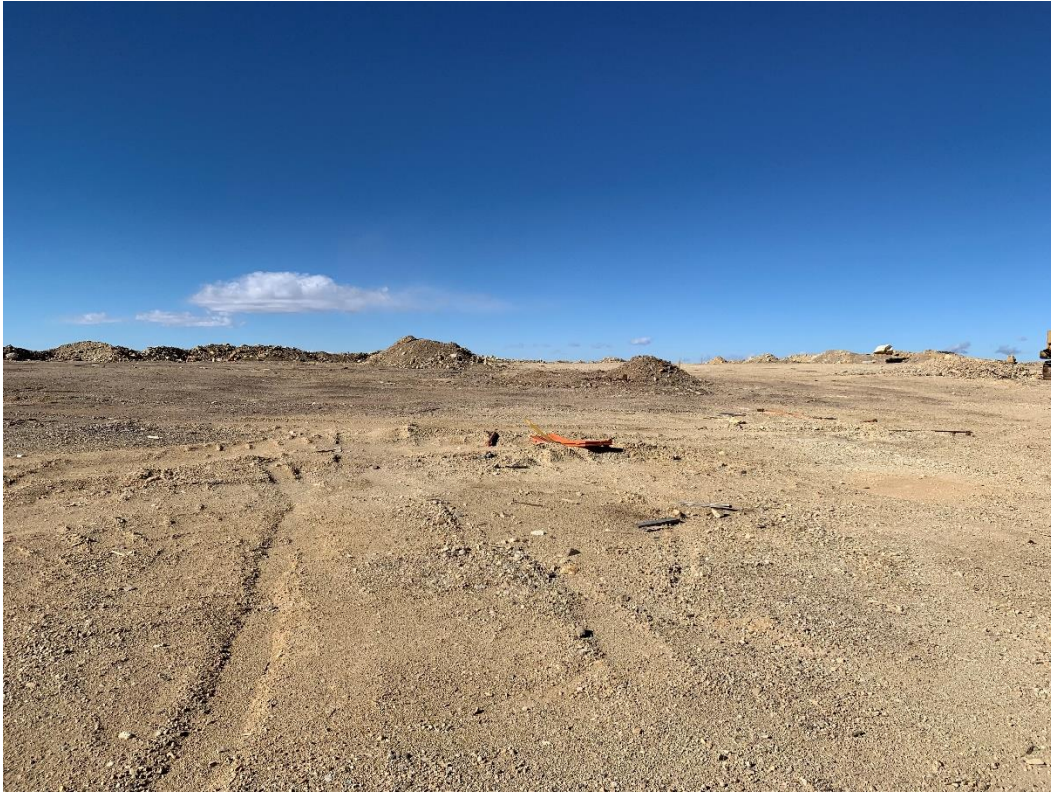
Photo 15 – Ironclad boneyard storage area

The boneyard area to the west of the Ironclad truck shop was being cleared. The extra storage items were being moved to prepare the area for mining (photo 15). The area was mostly clear of machinery, only a couple of items still needed to be removed. No oil spills or contaminated soil was noted.
