**COLORADO**  
Division of Reclamation,  
Mining and Safety  
Department of Natural Resources

**RE: Cooley Reservoir & Fulton Wildlife Area, Permit No. M-1999-034, Acreage Reduction Denial, Revision No. AR-1**

**MINERALS PROGRAM INSPECTION REPORT**  
**PHONE: (303) 866-3567**

<b>MINE NAME:</b> Cooley Reservoir & Fulton Wildlife Area	<b>MINE/PROSPECTING ID#:</b> M-1999-034	<b>MINERAL:</b> Sand and gravel	<b>COUNTY:</b> Adams
<b>INSPECTION TYPE:</b> Surety-Related Inspection	<b>INSPECTOR(S):</b> Patrick Lennberg	<b>INSP. DATE:</b> December 13, 2021	<b>INSP. TIME:</b> 09:00
<b>OPERATOR:</b> Aggregate Industries - WCR, Inc.	<b>OPERATOR REPRESENTATIVE:</b> Andre Laroche	<b>TYPE OF OPERATION:</b> 112c - Construction Regular Operation	
<b>REASON FOR INSPECTION:</b> Surety Related	<b>BOND CALCULATION TYPE:</b> None	<b>BOND AMOUNT:</b> \$1,510,800.00	
<b>DATE OF COMPLAINT:</b> NA	<b>POST INSP. CONTACTS:</b> None	<b>JOINT INSP. AGENCY:</b> None	
<b>WEATHER:</b> Clear	<b>INSPECTOR'S SIGNATURE:</b>

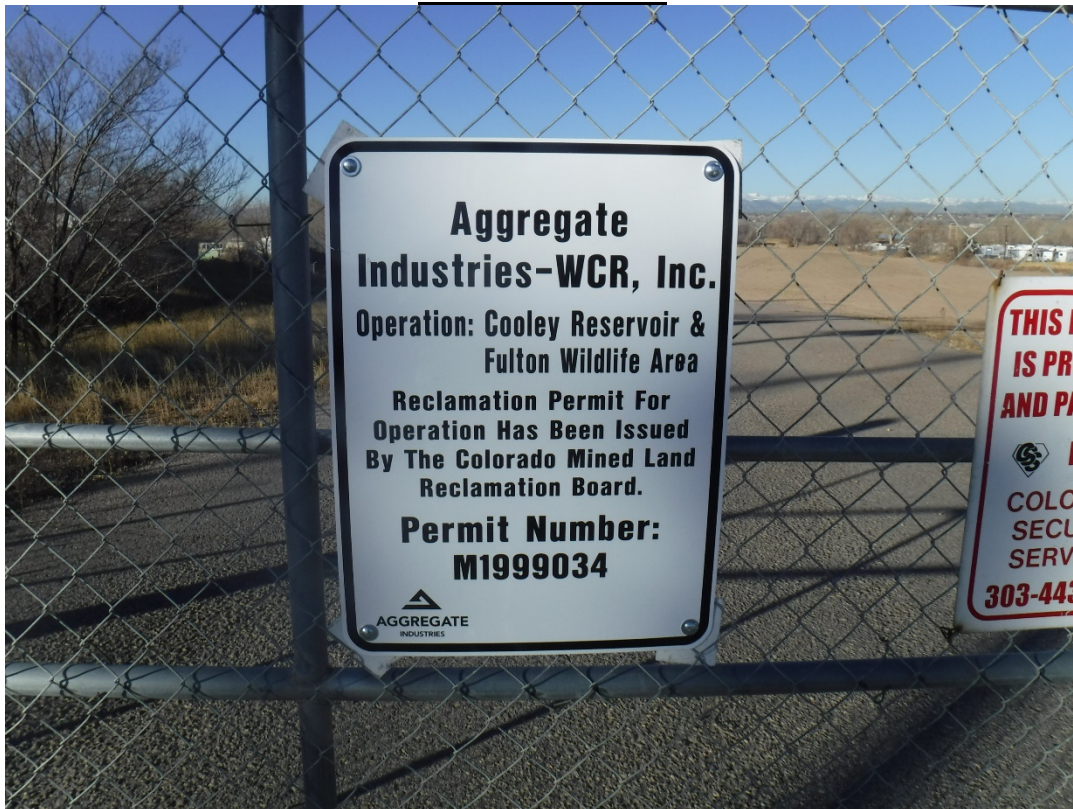
**Photo 1:** Mine sign posted at entrance

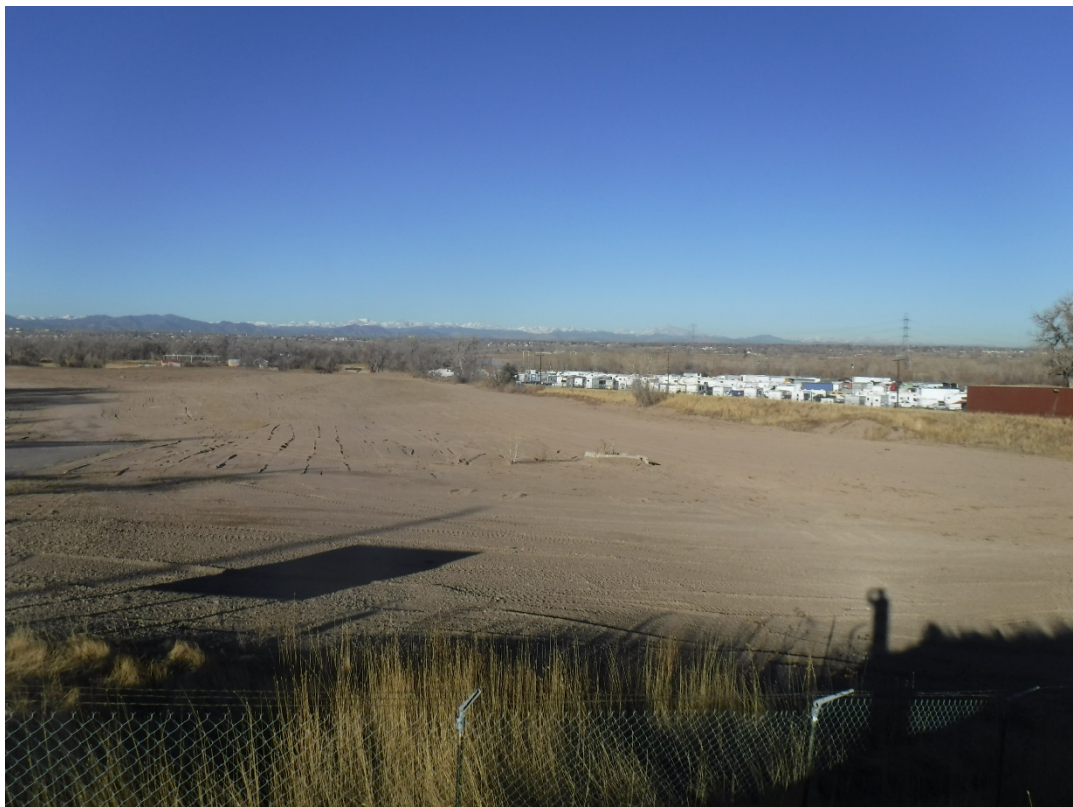
The majority of the site has been graded flat and all structures associated with the processing area have been removed and ponding areas have been filled in. However, the site has not had any topsoil replaced on it nor has any vegetation been planted as required by the approved reclamation plan. The operator earlier this year performed grading at the site and removed several large stand of Russian olive trees from along the Bull Seep area to the west. A large berm along the southern boundary of the site has had the majority of the north facing side slopes graded but it appears there are portions along the east end that may be steeper than required 3:1. Also, the southern side of the berm is steeper than a 3:1 slope. It also appears the material contained in the berm may be stockpiled topsoil. During the permit file review the Division could not document the relocating of the power poles or the requirement they be returned to their original location.

**Photo 2:** Overview of site looking west from mine entrance

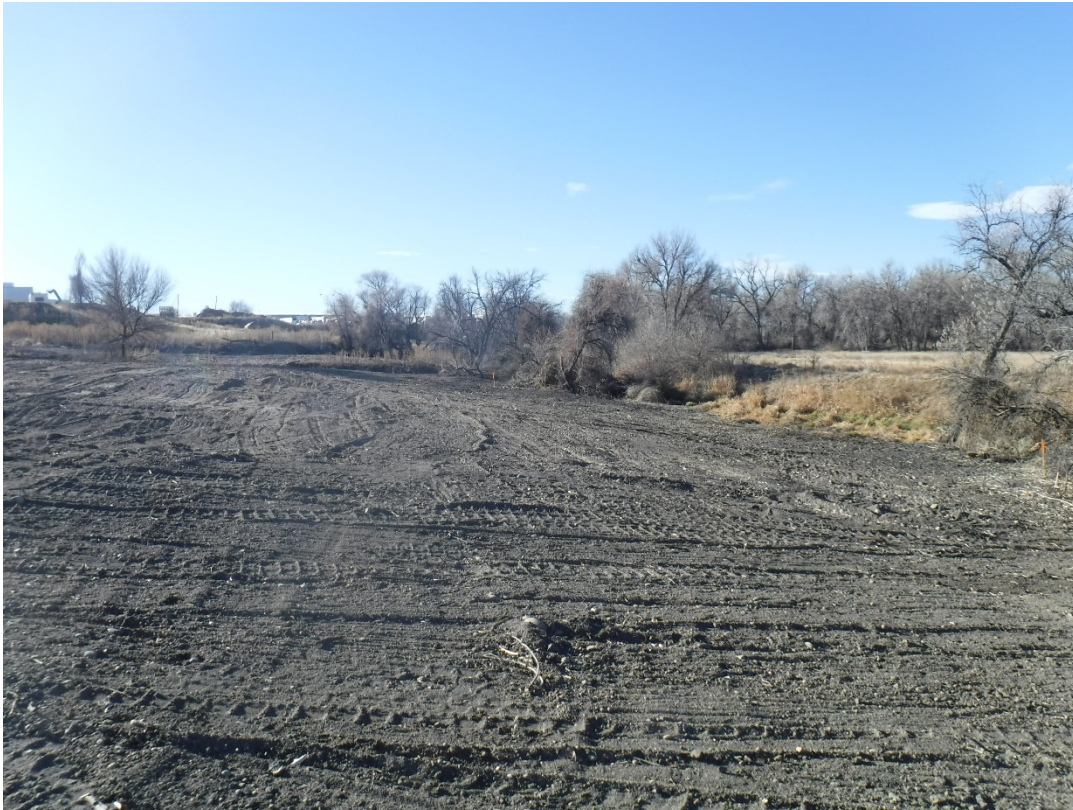
The Division sent notice of the release request to the Adams County Planning Department and Commissioners, West Adams Soil Conservation District, Division of Water Resources (DWR), and Albert Frei and Sons (AFS) the landowner. The Division received a comment letter from AFS. The letter brought up four items; relocated powerlines along 100<sup>th</sup> Ave need to be returned to their original locations, the berm along the southern portion of the property needs to be graded into the site, all perimeter slopes need to be at a 3(H):1(V) slope, and sediment discharge to the Bull Seep needs to be evaluated.

**Photo 3:** Looking south along Bull Seep towards the southwest corner of site

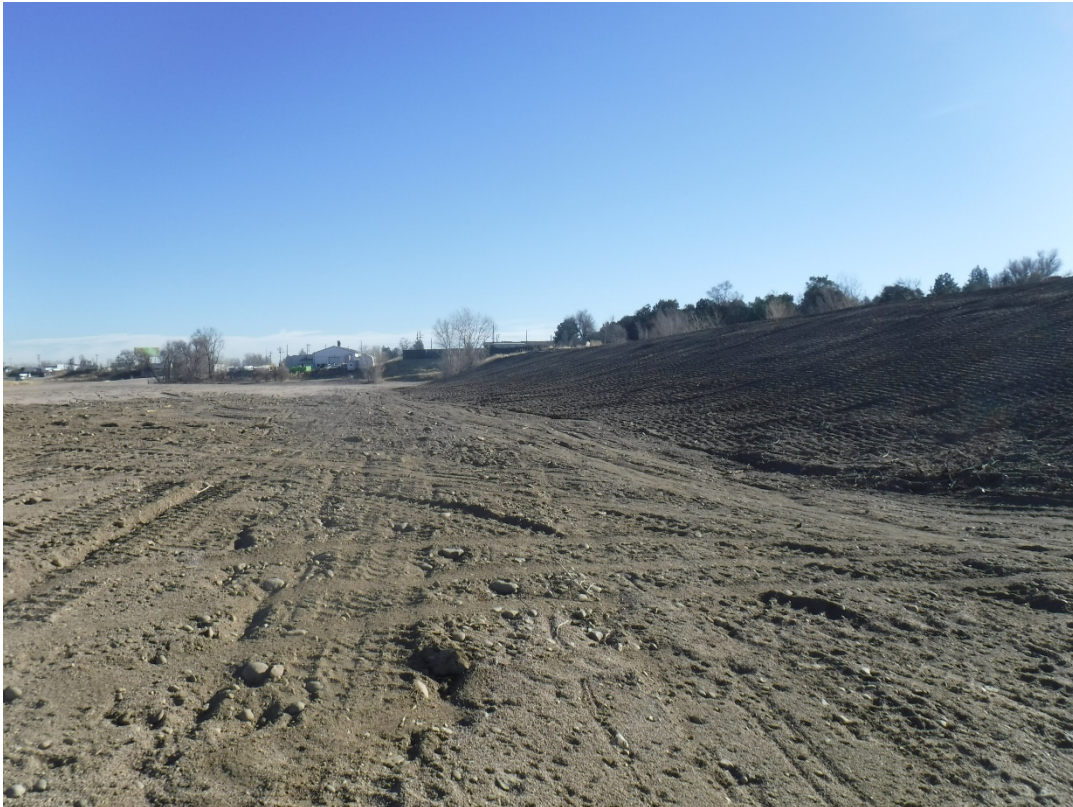
**Photo 4:** Looking east along the southern berm

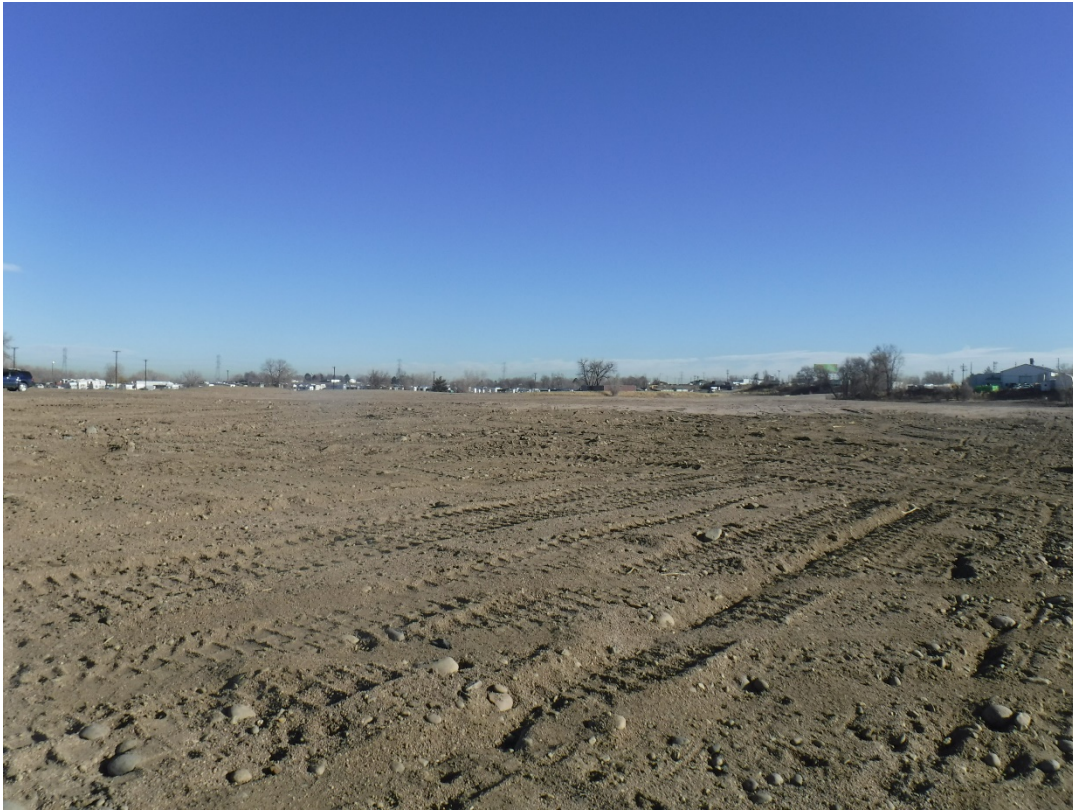
**Photo 5:** Looking northeast across the site

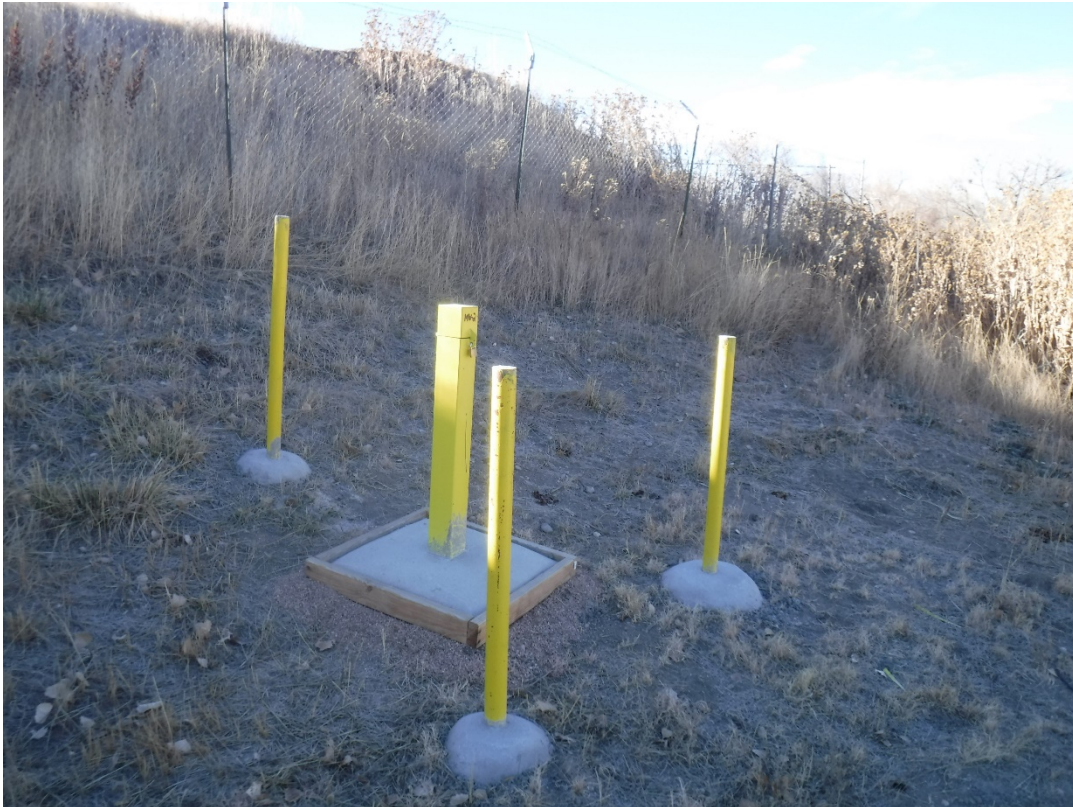
Also, several monitoring wells have been installed by AFS at the site. The Division assumes these wells have been installed to collect information on groundwater elevations ahead of applying for a permit to mine the site in the future.

**Photo 6:** MW-2 located near the west end of the southern berm

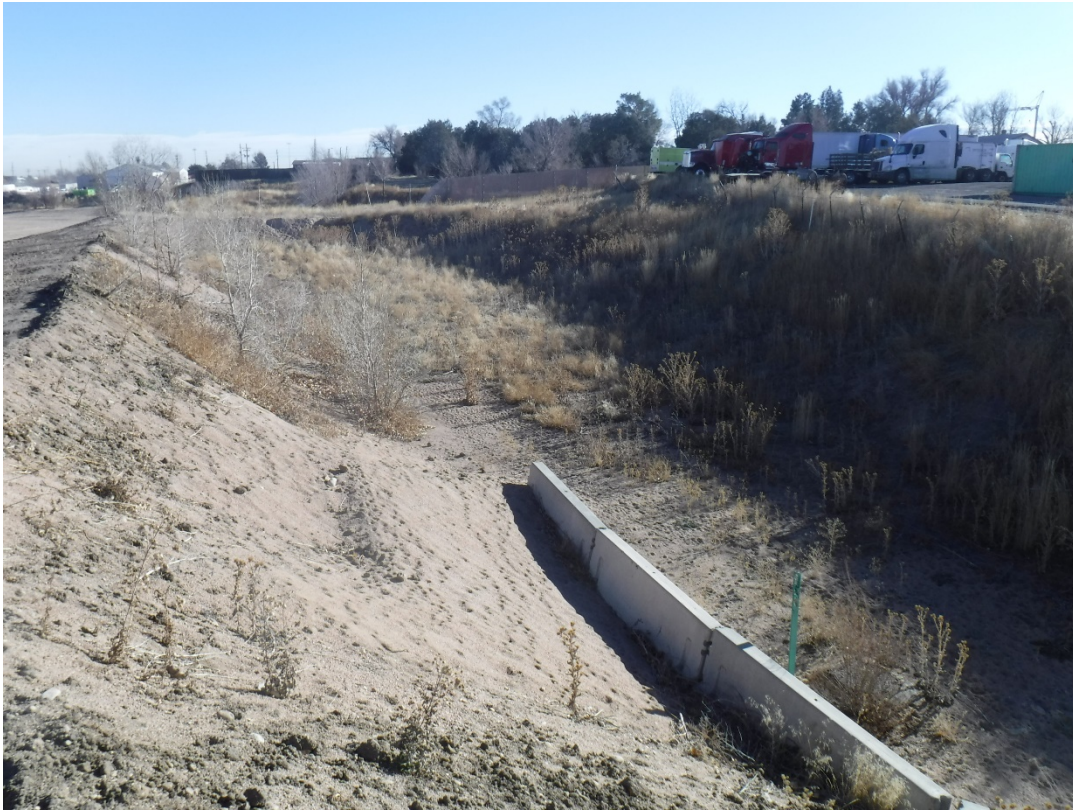
AR-1 is for 27 acres that includes the former processing area. According to the approved reclamation plan, the processing area is required to be covered with six to twelve inches of topsoil and revegetated with the non-irrigated grass seed mixture and all slopes will be returned to 3(H):1(V) or shallower.

**Photo 7:** South side of the southern berm not graded to 3:1

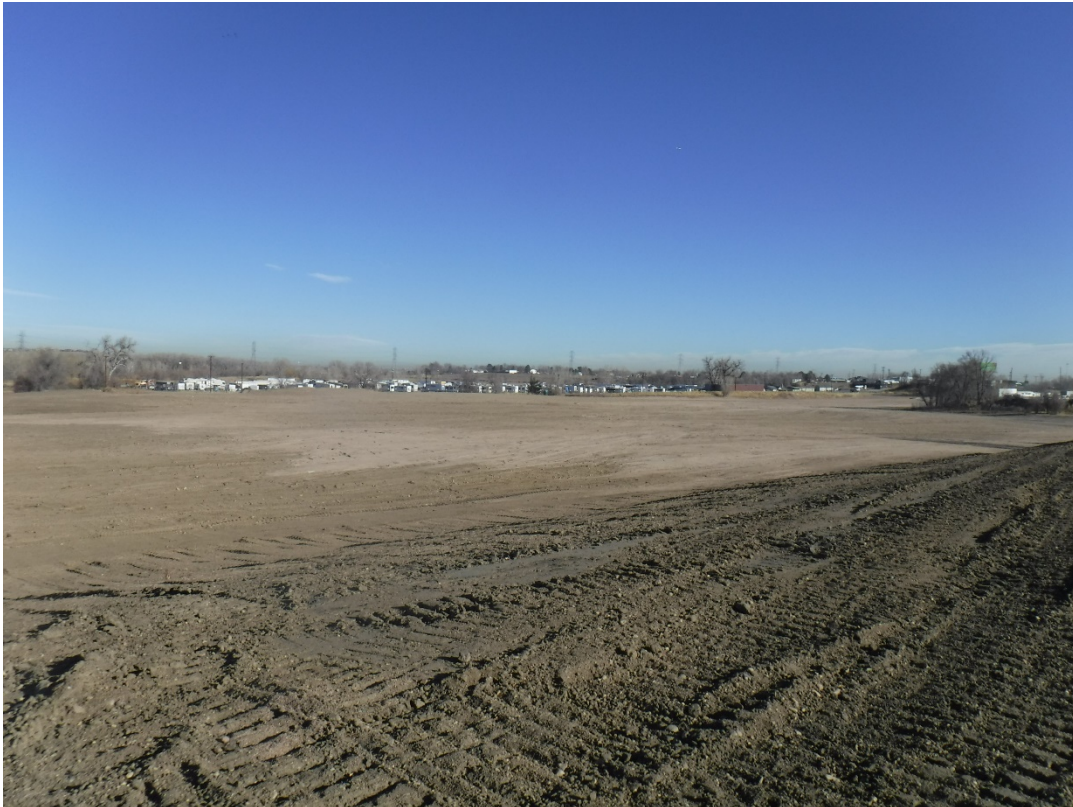
**Photo 8:** Looking northeast across the site from the southern berm

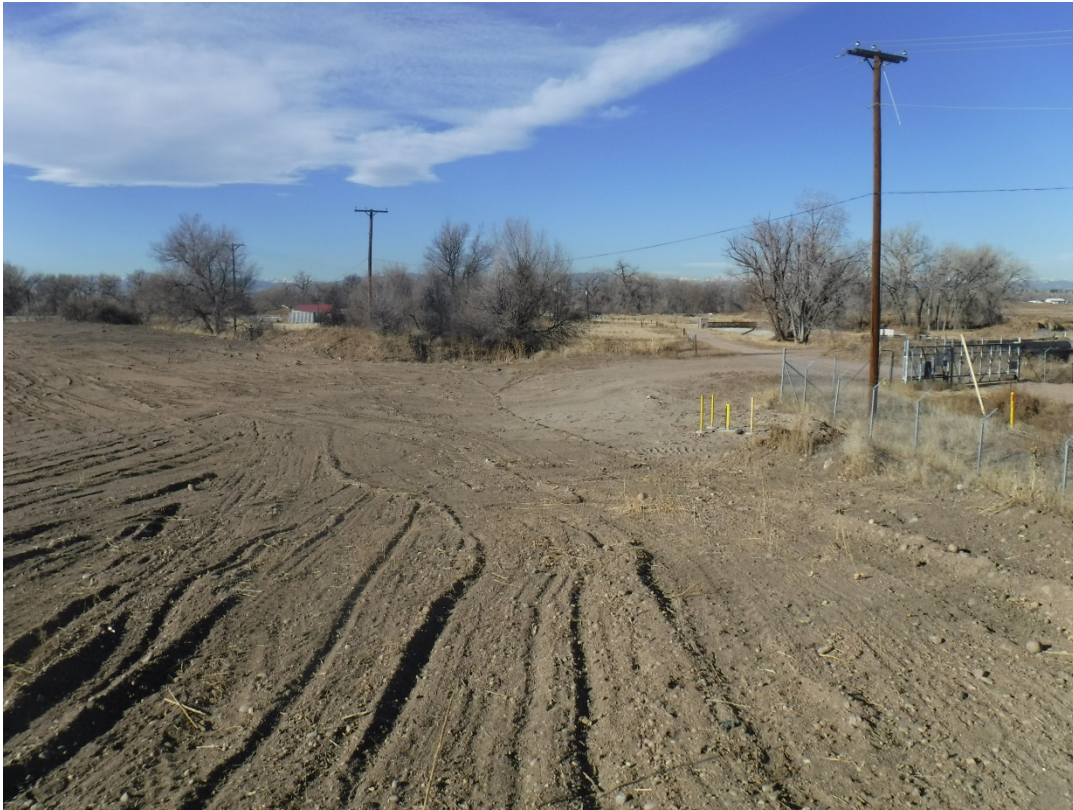
**Photo 9:** Northwest corner of site with power poles and monitoring well

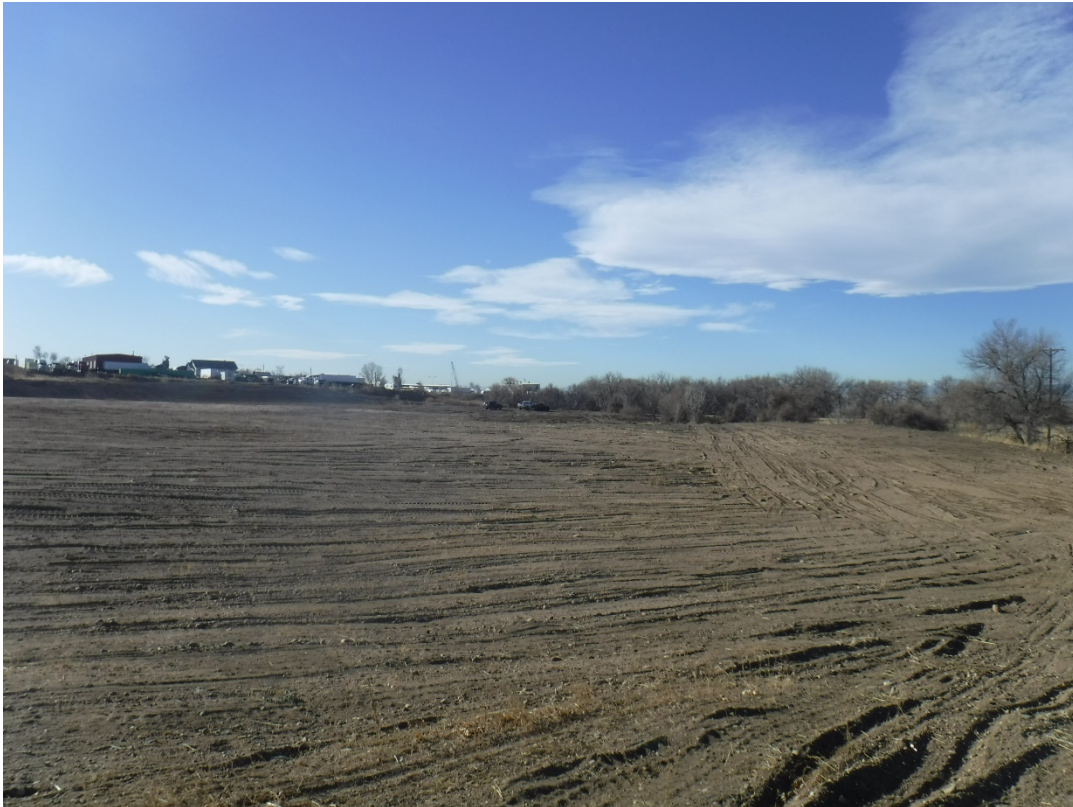
**Photo 10:** Looking south across the site from the northwest corner.
