**COLORADO**  
Division of Reclamation,  
Mining and Safety  
Department of Natural Resources

<b>Permit Number:</b> C-1981-035 <b>Mine Name:</b> King Coal Mine <b>Operator:</b> GCC Energy, LLC <b>Operator Address:</b> Mr Jordan McCourt 6473 County Road 120 Hesperus, CO 81326	<b>County:</b> La Plata <b>Operation Type:</b> Underground <b>Permit Status:</b> Active <b>Ownership:</b> Private
	<b>Operator Representative Present:</b>  Wade Wymore
<b>Operator Representative Signature: (Field Issuance Only)</b>

<b>Inspection Start Date:</b> December 7, 2021 <b>Inspection Start Time:</b> 09:30 <b>Inspection End Date:</b> December 7, 2021 <b>Inspection End Time:</b> 11:00		<b>Inspection Type:</b> Coal Partial Inspection <b>Inspection Reason:</b> Normal I&E Program <b>Weather:</b> Snowing	
<b>Joint Inspection Agency:</b>  None		<b>Joint Inspection Contacts:</b>  	
<b>Post Inspection Agency:</b>  None		<b>Post Inspection Contacts:</b>  	
<b>Inspector(s):</b>  Janet Binns	<b>Inspector's Signature:</b>  12/13/2021		
	<b>Signature Date:</b>

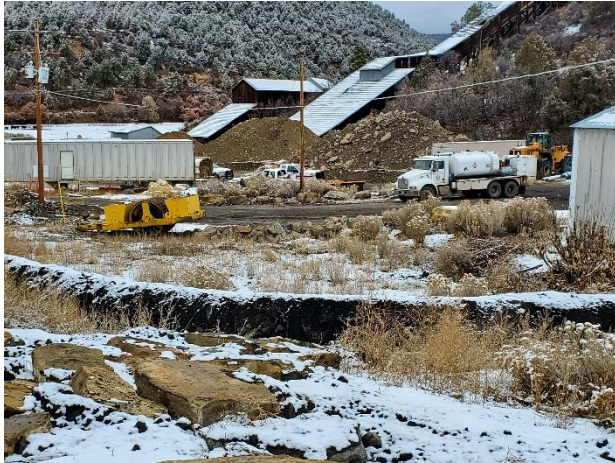
At King I, the operator has cleaned sediment out of the ditch west of the shop building and increased the height of the berm to assure runoff coming off the haul road/lower refuse area is contained within the ditch and flows to the West pond. This repair is adequate.

Photo 1: KI-reinforced berm west of warehouse

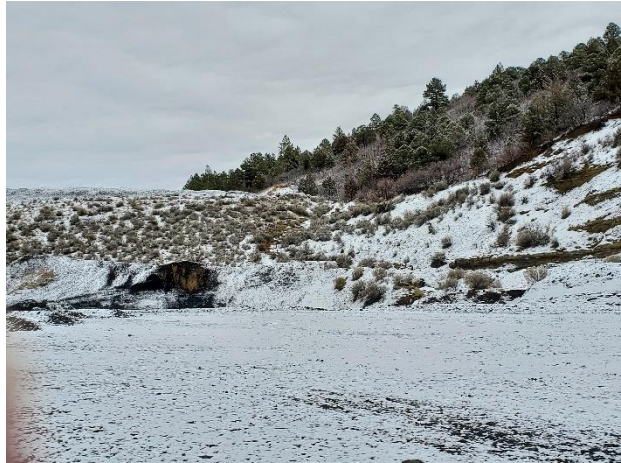
Waste material was placed in windrows on the east side of the lower RDA, ready to be spread and compacted. GCC is working on adding material to the west side of the lower RDA to keep the slope of the pile within the design specifications and control the runoff off the pile. This management of the lower RDA is progressing. The operator has armored the gully on the west side of the lower RDA with large rocks. Re-establishment of the berm remains to be completed to avoid runoff from short circuiting the rocked drainage-way.

Photo 2: Lower RDA looking eastward

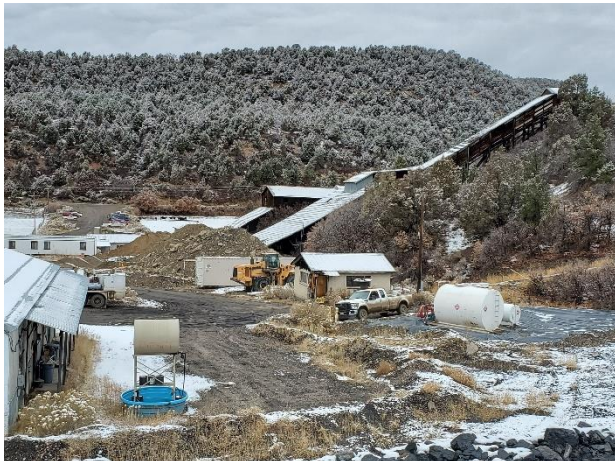
Photo 3: KI facilities, fuel tanks with secondary containment

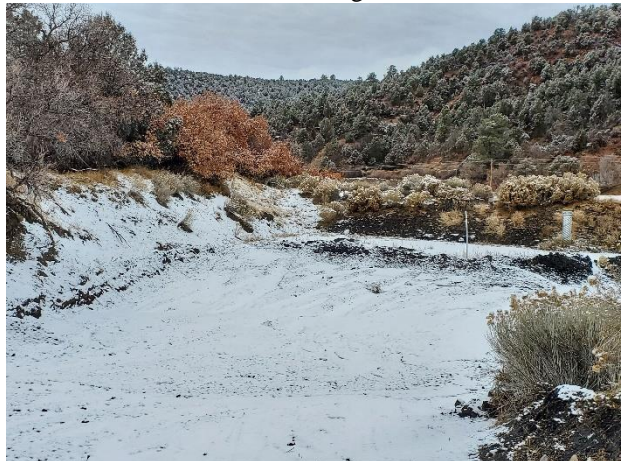
GCC had been in the process of cleaning sediment from the West pond at King I when precipitation events made conditions too soft. The operator has left the breach in the embankment open for access to clean additional sediment should conditions allow. This access to the pond is blocked with orange traffic cones for safety and is at the inlet end of the pond and should not limit water storage in the West Pond. The material that GCC was able to clean from the pond allows for adequate storage for the pond at this time.

Photo 4: KI-West pond, sediment removal

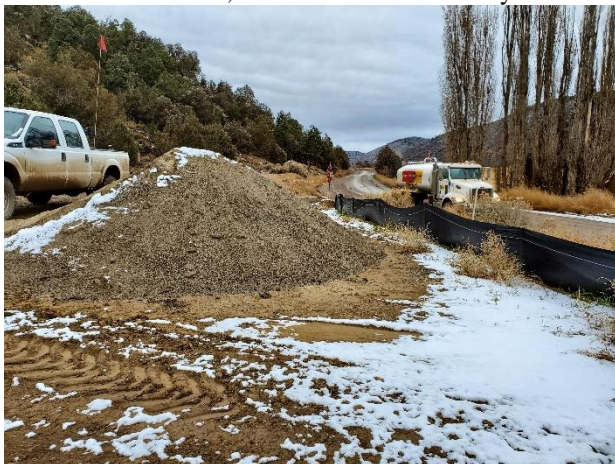
Sediment control at the Old Barn access road are is well managed and maintained. Adequate storage was observed on the uphill side of the hay bales at the silt fencing north of County Road 120. Road material is stored at the old Barn area within the sediment control system. There was no evidence that runoff from the road had bypassed the sediment control system. It appears that runoff from the road and work area has been adequately contained and managed.

Photo 5: material stored upslope of sediment fence at Old Barn area. Looking northeast

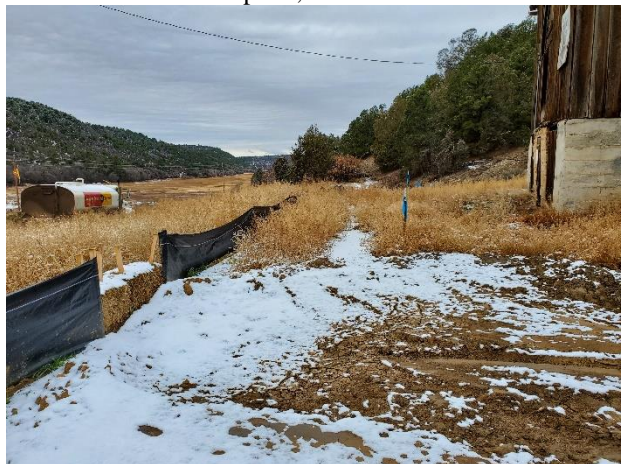
Photo 6: Old Barn area, LPCR 120 on L side of photo  
Silt fence and hay bale sediment control in good repair. Looking southwestNumber of Partial Inspection this Fiscal Year: 3Number of Complete Inspections this Fiscal Year: 2

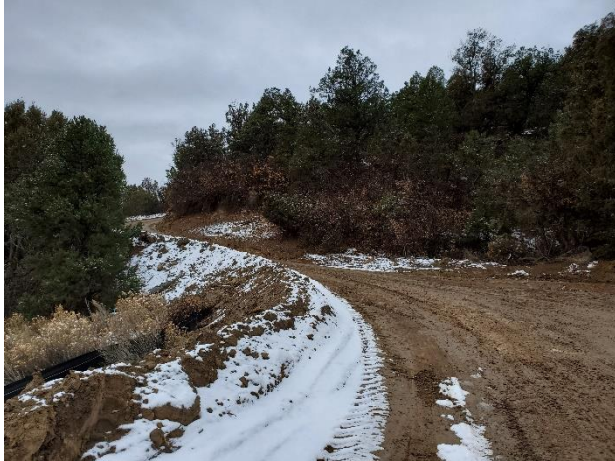
The Access road to the low cover crossing at the Old Barn area is regularly graded, especially after precipitation events. The runoff from the low cover crossing (LCC) access road is reporting to the designed sediment traps. Activity in this area is staying within the sediment control system. The contractor maintains the traffic signaling and the radio contact for this single lane roadway. No problems or maintenance items were identified in this area.

Photo 7: Low cover crossing access road

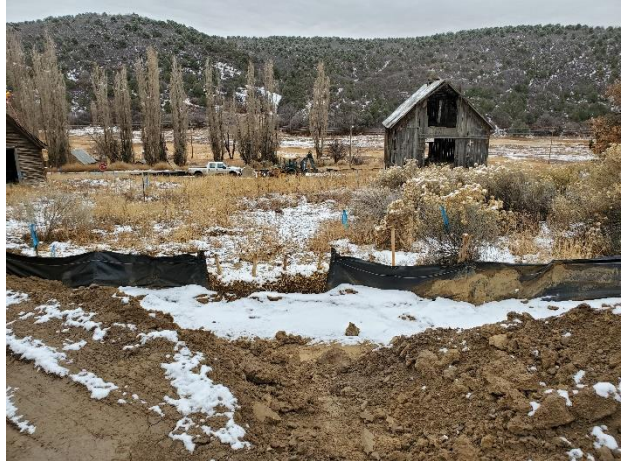
Photo 8: Sediment trap at bottom of LCC access road  
As road opens up to Old Barn work area

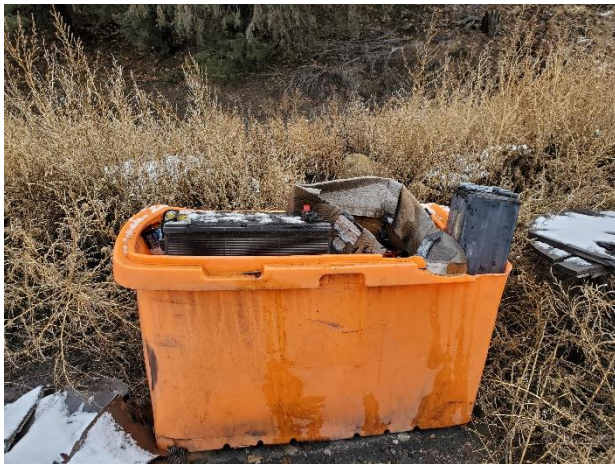
Photo 9: KII facilities, old batteries stored in secondary containment

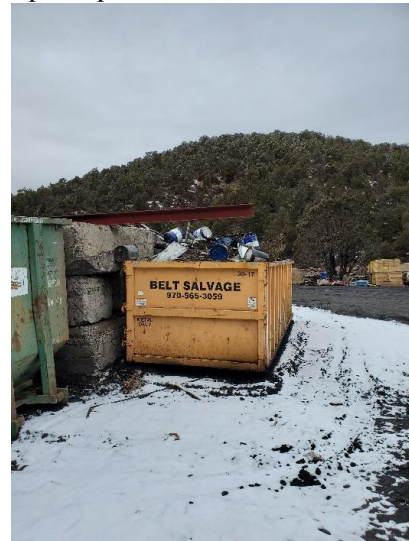
Battery storage, Fuel storage, and other trash at the facilities areas are stored appropriately. Small barrels in a roll-off on the north end of Pond 1 is reaching its storage capacity. The operator needs to assure that material

isn't falling out of the roll-off container. (photo 10: yellow roll-off)

Photo 10: Roll-off with small barrels at KII

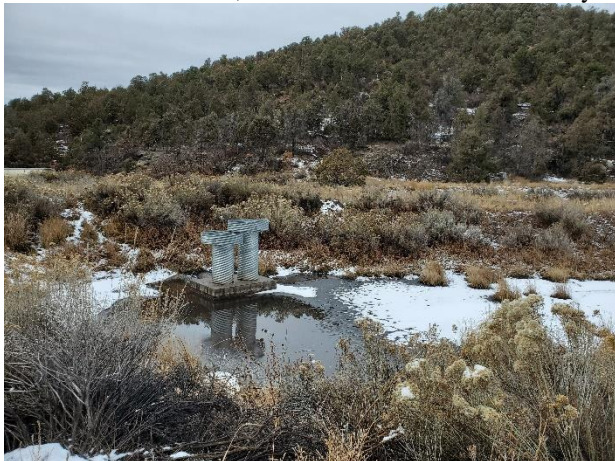
Pond 1 at King II facilities was in good condition and was holding a shallow pool of water at the riser structure. The water level was near the bottom of the concrete support for the riser pipe. Adequate storage remains in this pond. The pond embankments were well vegetated.

Photo 11: KII Pond 1 water pool at riser

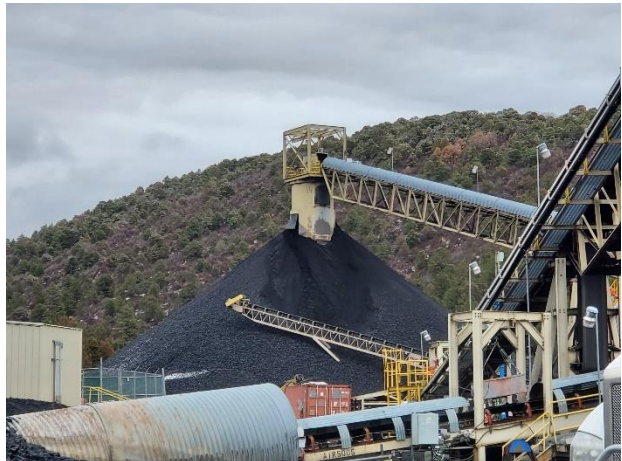
Photo 12: KII Clean coal stockpile
