Daniels Sand Pit 2, Permit No. M-1973-007-SG: Monthly Monitoring Report

December 9, 2021
Project No.: 19125

Regarding: Daniels Sand Pit 2, Permit No. M-1973-007-SG
Slope Stability Monthly Monitoring Report

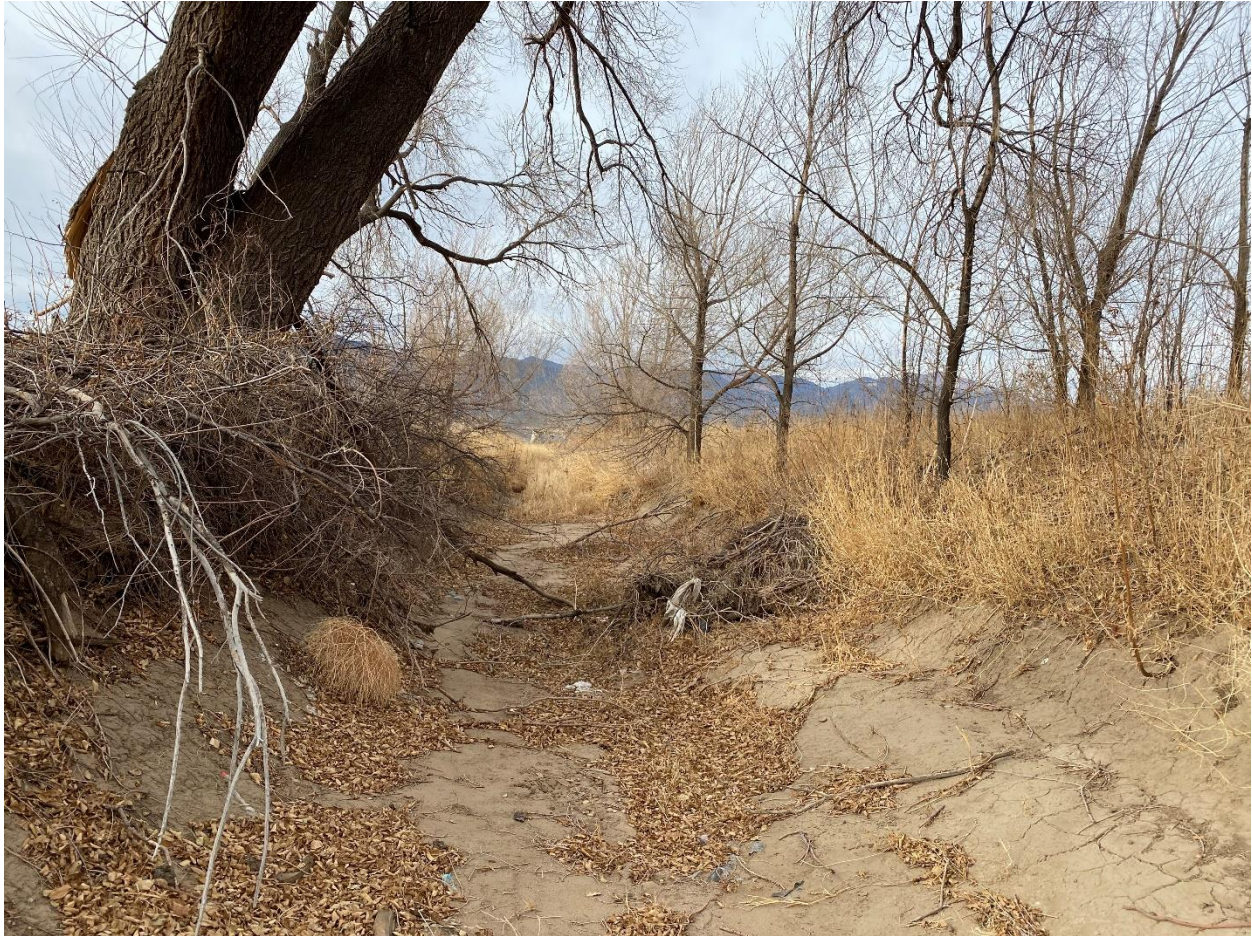
- Weather: 55°, partially cloudy, wind 10-15 mph
- Visual observation of the Fountain Mutual Ditch:
 - No tension cracks
 - No toe erosion
 - No moisture changes, ditch is dry
 - No sloughed slope surfaces
 - The condition of the ditch is stable

Photo 1. Fountain Mutual Ditch looking west

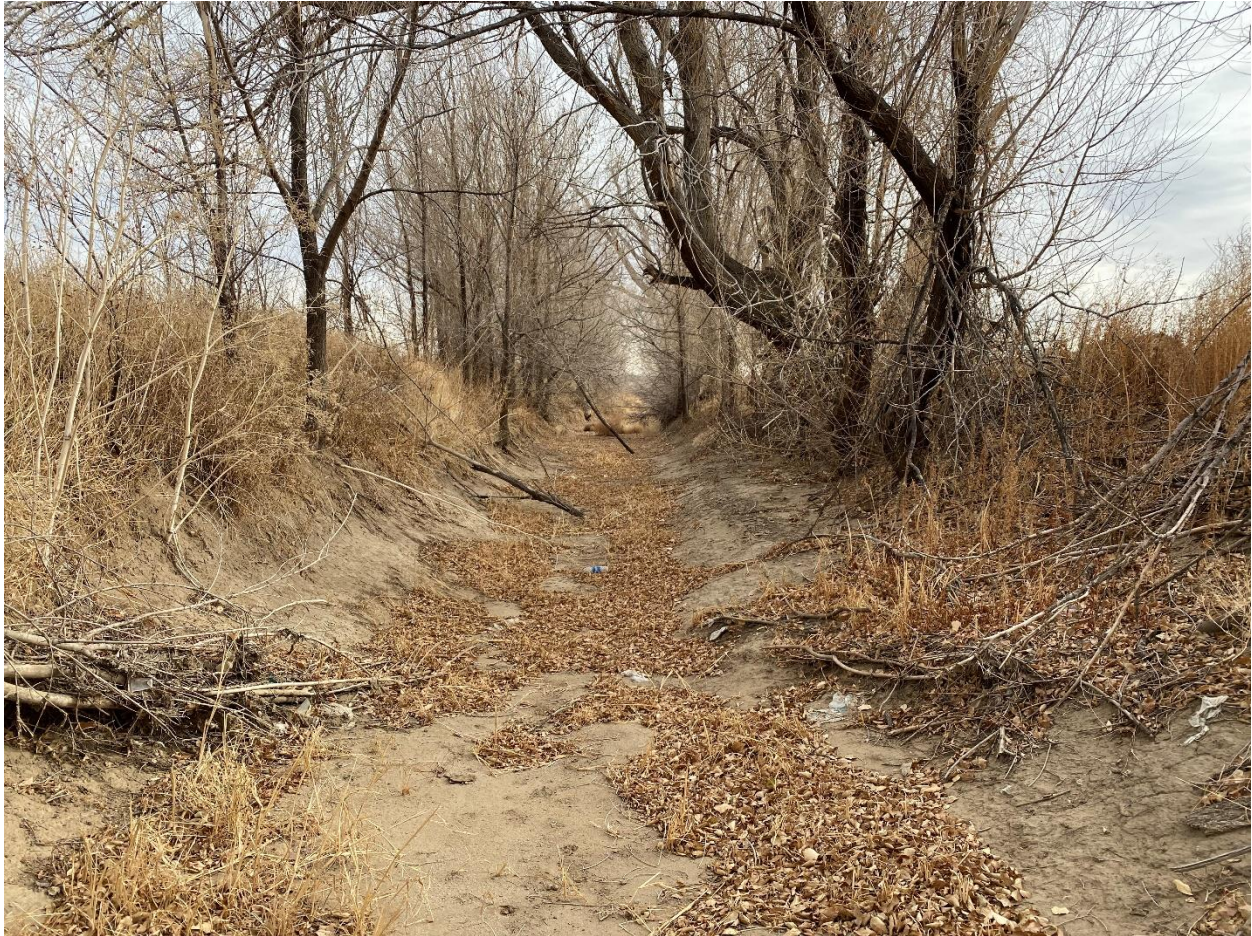
Photo 2. Fountain Mutual Ditch looking east

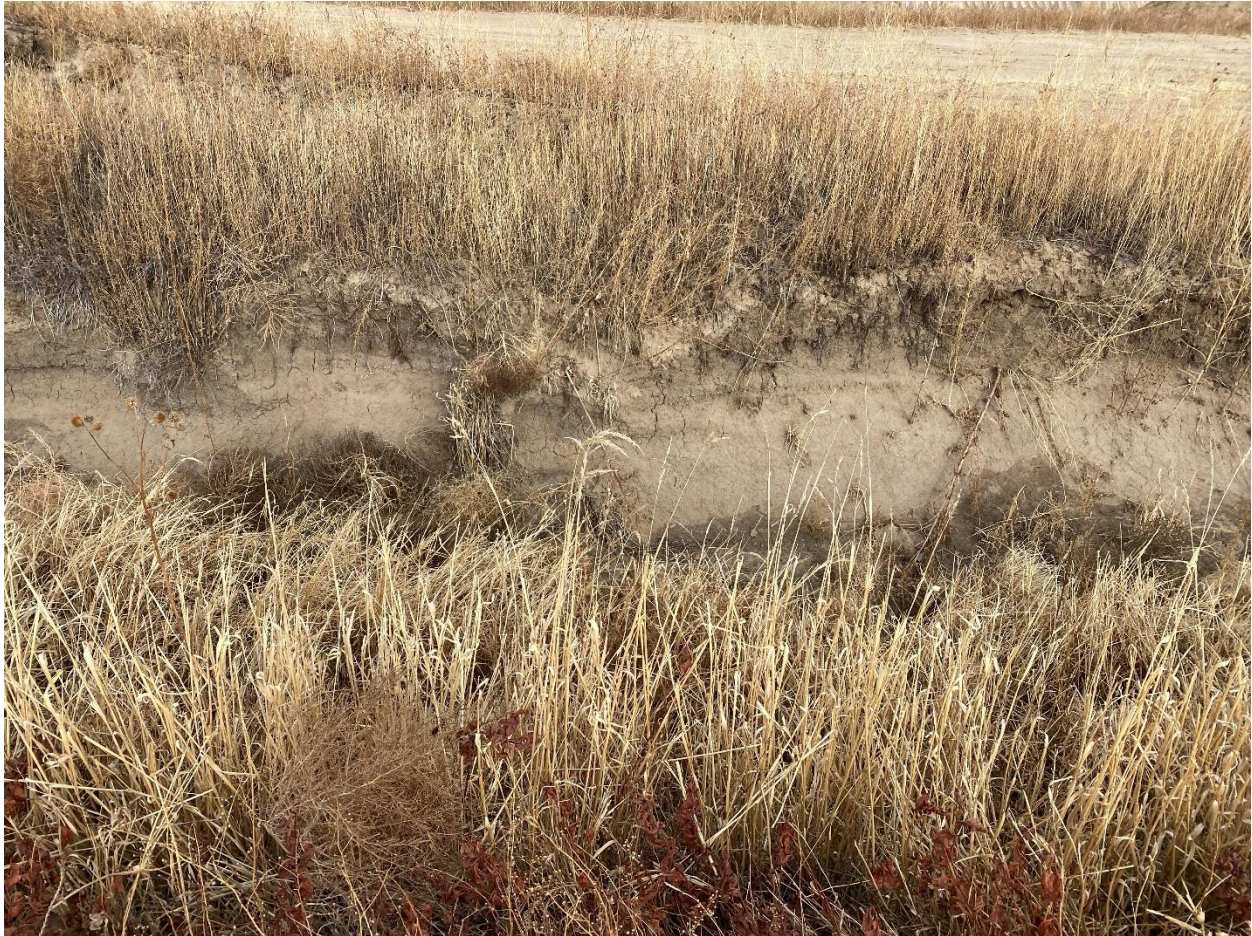
Photo 3. Fountain Mutual Ditch looking north

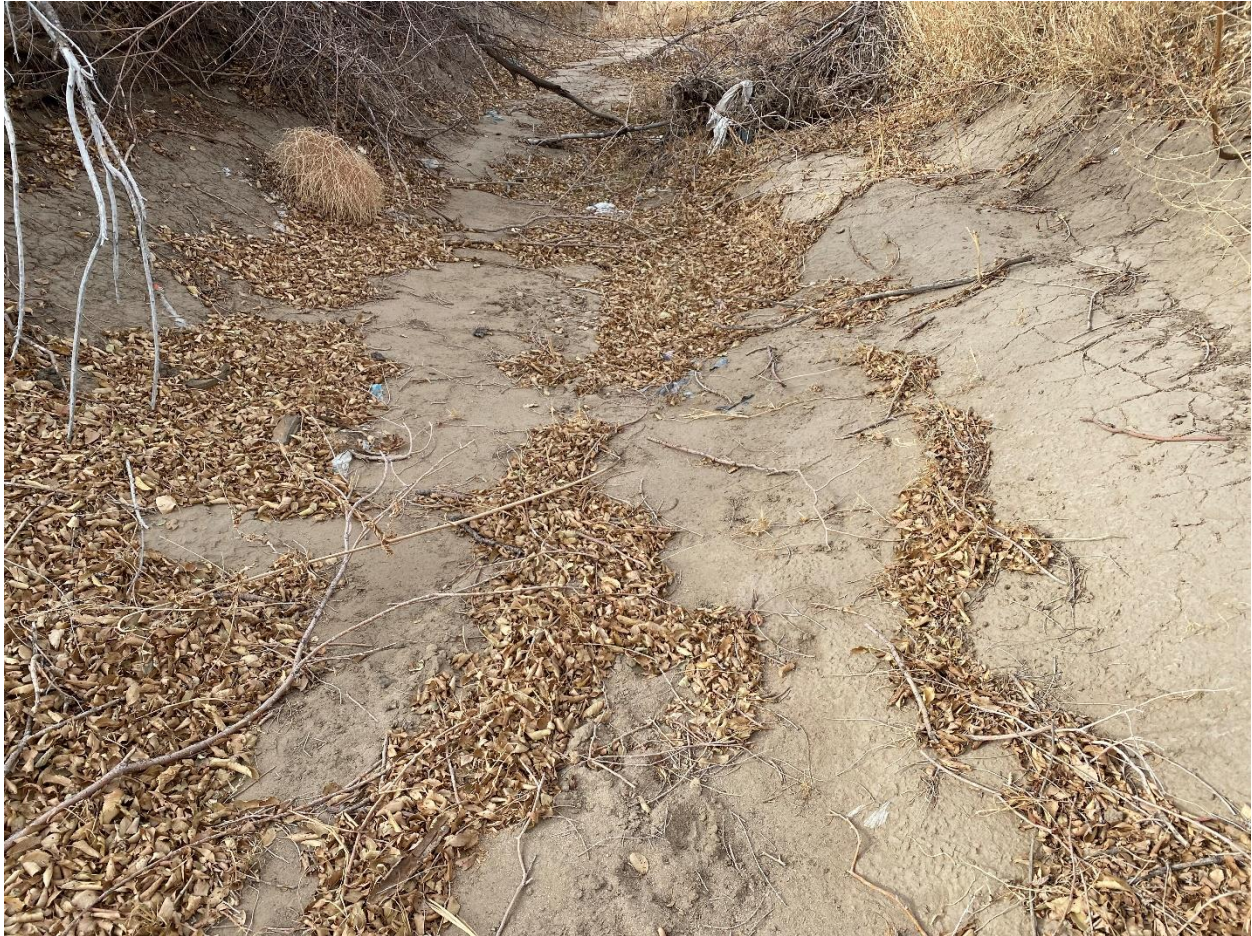
Photo 4. Fountain Mutual Ditch invert

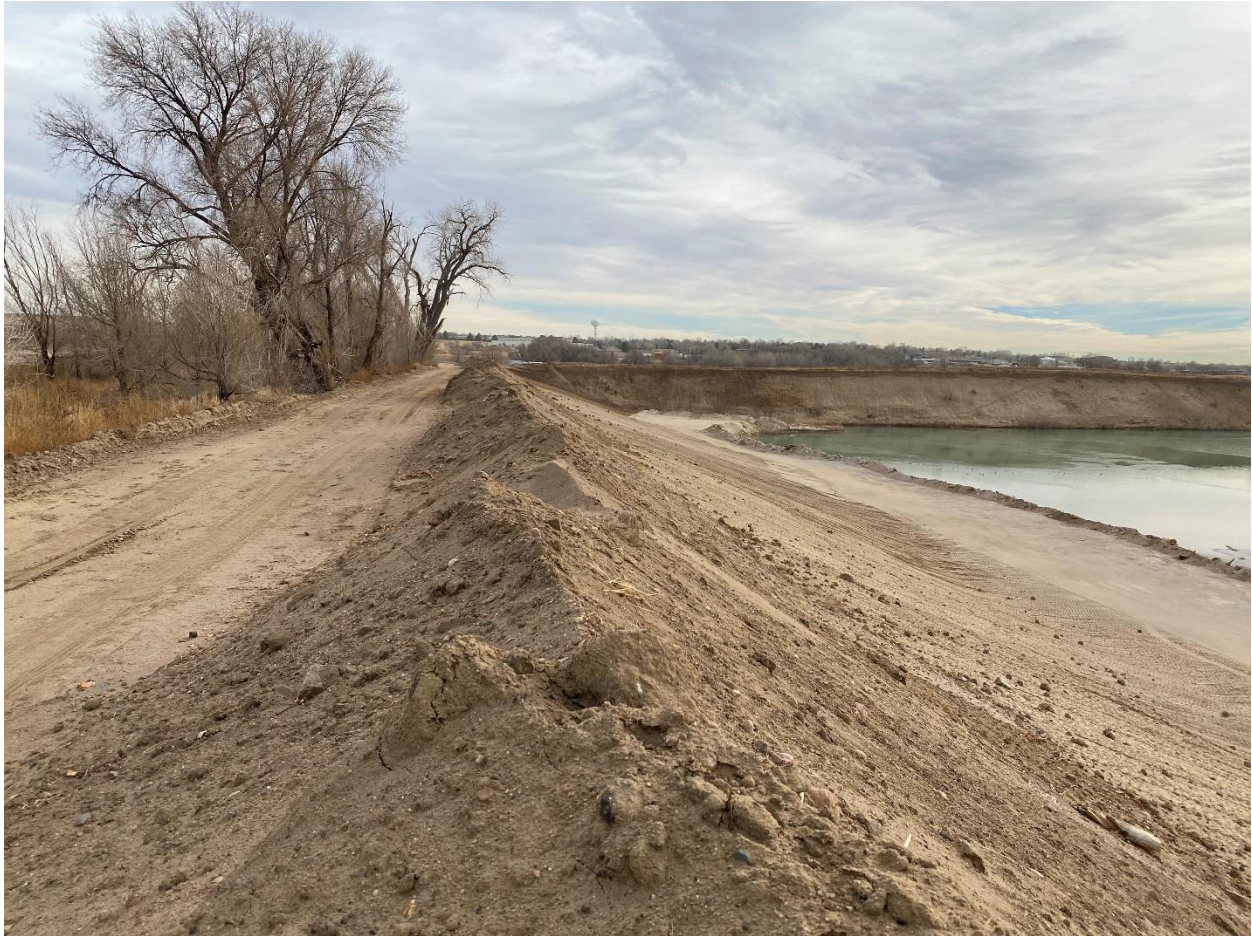
- Construction sequence
 - At this time, the buttress slope varies from 3H:1V to 4H:1V
 - Preparation for final lift
 - Stockpiled sand located at crest of embankment for the whole length

Photo 5. Stockpiled sand for final lift, access road and ditch (looking east)

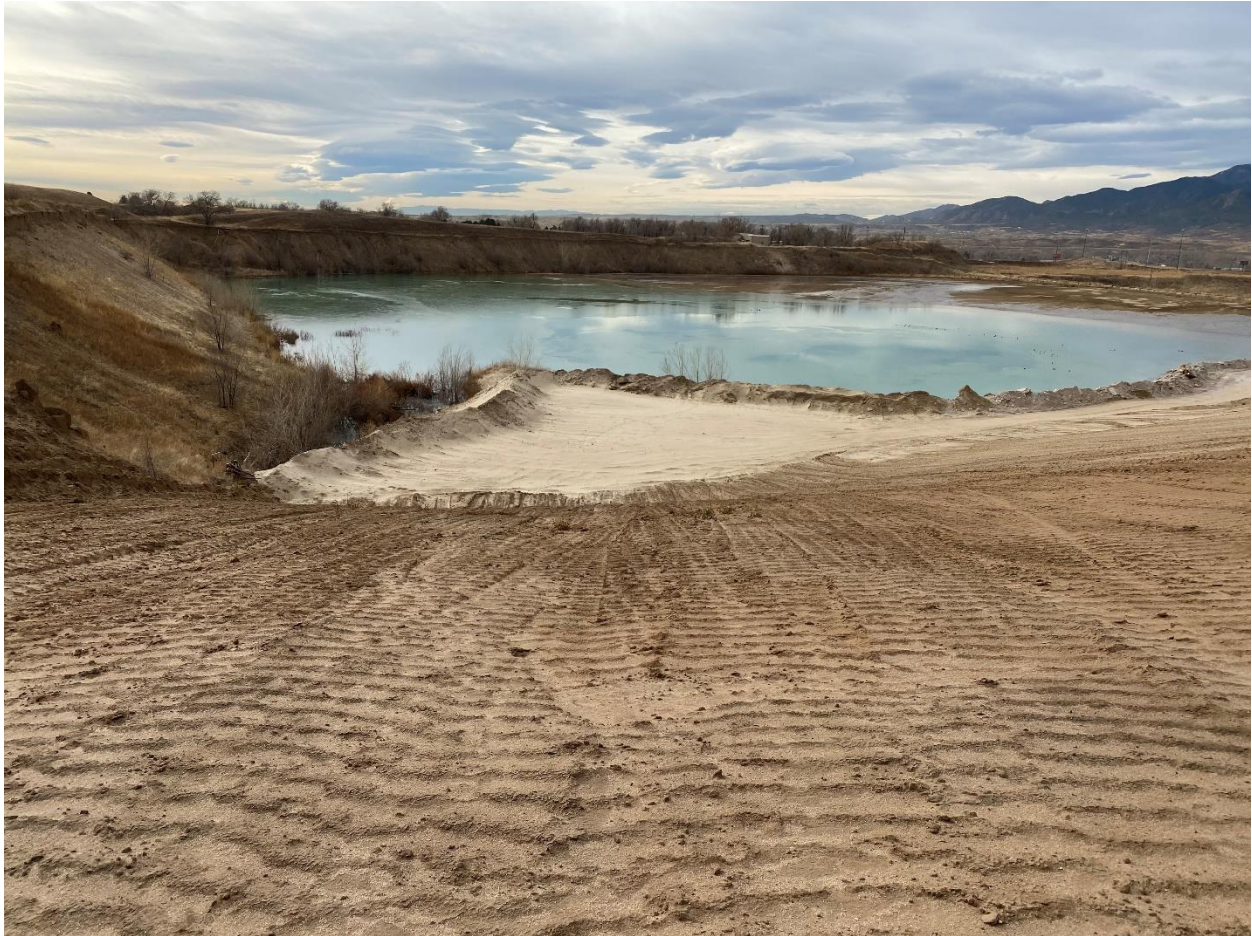
Photo 6. Buttress slope
