MINERALS PROGRAM INSPECTION REPORT
PHONE: (303) 866-3567

MINE NAME: Hayes Pit	MINE/PROSPECTING ID#: M-1998-065	MINERAL: Gravel and clay (gen)	COUNTY: Washington
INSPECTION TYPE: Preoperation Inspection	INSPECTOR(S): Brock Bowles	INSP. DATE: November 24, 2021	INSP. TIME: 10:00
OPERATOR: Washington County	OPERATOR REPRESENTATIVE: Robert Frick	TYPE OF OPERATION: 112c - Construction Regular Operation	
REASON FOR INSPECTION: Preoperation Inspection	BOND CALCULATION TYPE: None	BOND AMOUNT: \$0.00	
DATE OF COMPLAINT: NA	POST INSP. CONTACTS: None	JOINT INSP. AGENCY: None	
WEATHER: Cloudy	INSPECTOR'S SIGNATURE:

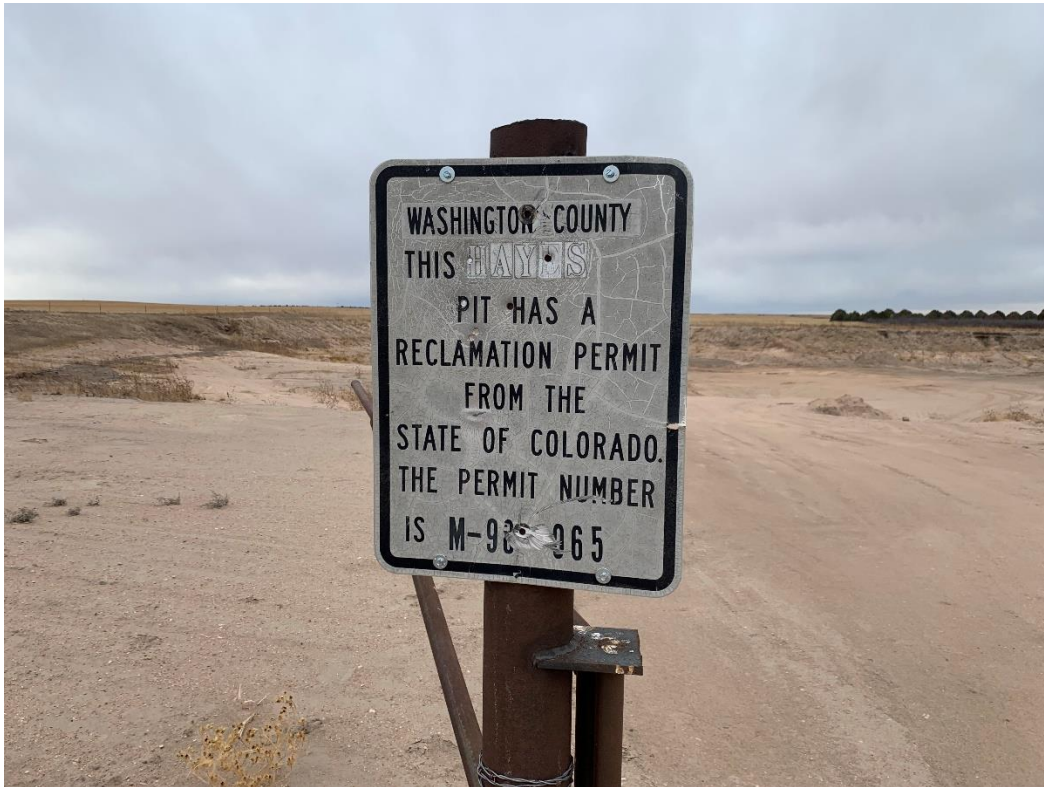
The mine entrance sign was in place facing CR QQ (photo 1). The public notice about the conversion application was posted on the entrance gate (photo 2). The current boundary was marked on all four sides by a fence.

Photo 1 – Mine entrance sign facing CR QQ

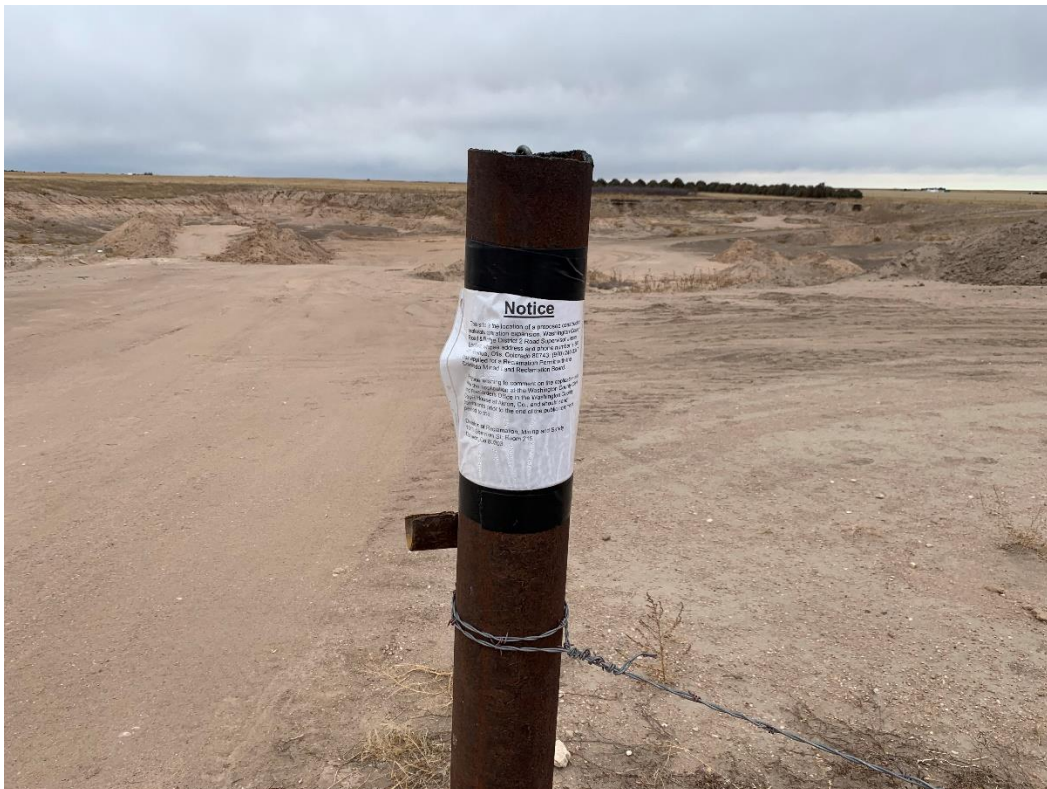
Photo 2 – Conversion notice on entrance gate

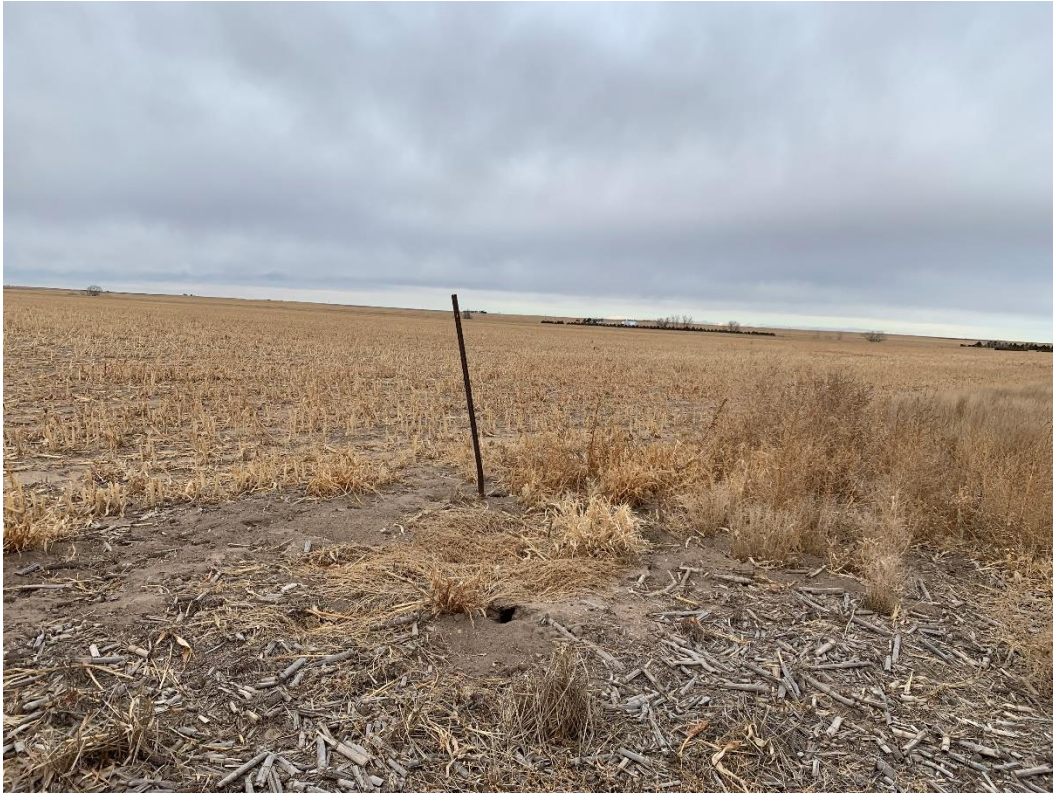
The proposed permit boundary was marked with a t-post on the northwest corner (photo 3), the southwest corner had post (photo 4) and the southeast corner is the intersection of CR QQ and CR 42. During the site inspection a buried gas pipeline marker was identified at the intersection of CR QQ and CR 42 (photo 5). The pipeline runs on the north side of CR 42, which is the proposed southern boundary. Washington County will submit a new map showing a mining set back to stay at least 200 feet away from the pipeline. The interior of the proposed permit area is a dryland crop field and the field currently has wheat stubble (photo 6).

Photo 3 – Proposed northwest permit corner marker

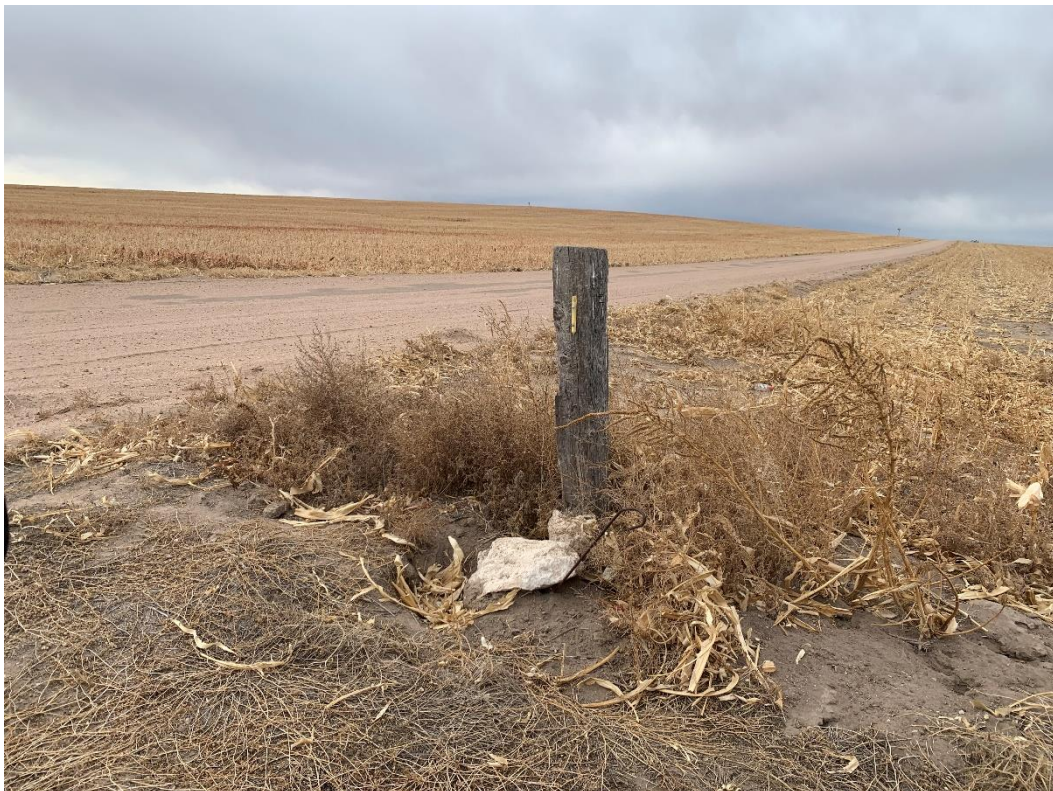
Photo 4 – Proposed southwest permit corner post

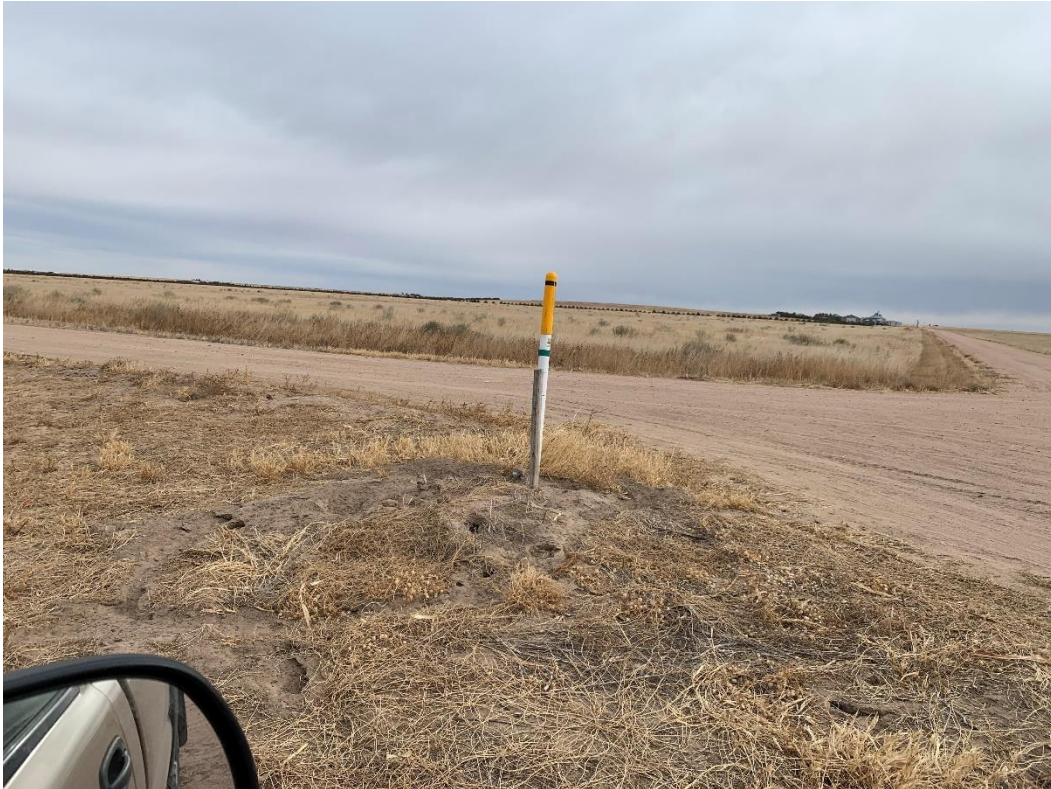
Photo 5 – Proposed southeast permit corner at intersection of CRs QQ and 42, gas pipeline marker

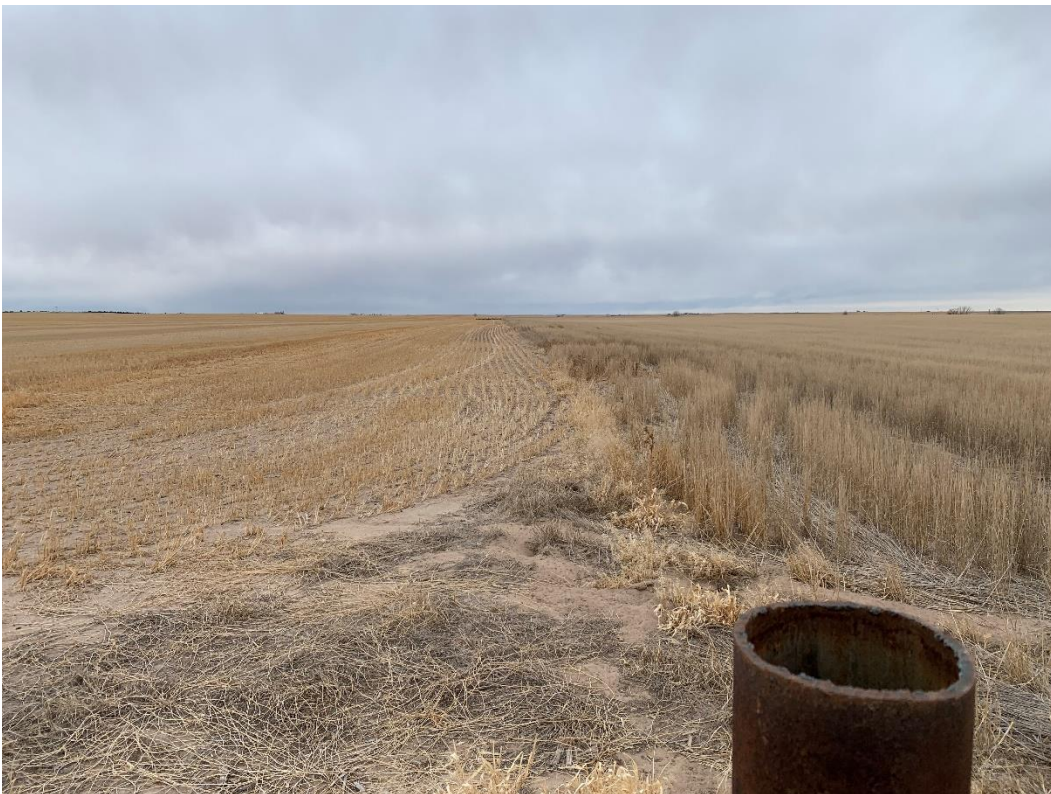
Photo 6 – Northern boundary facing west. Proposed permit area on the left.

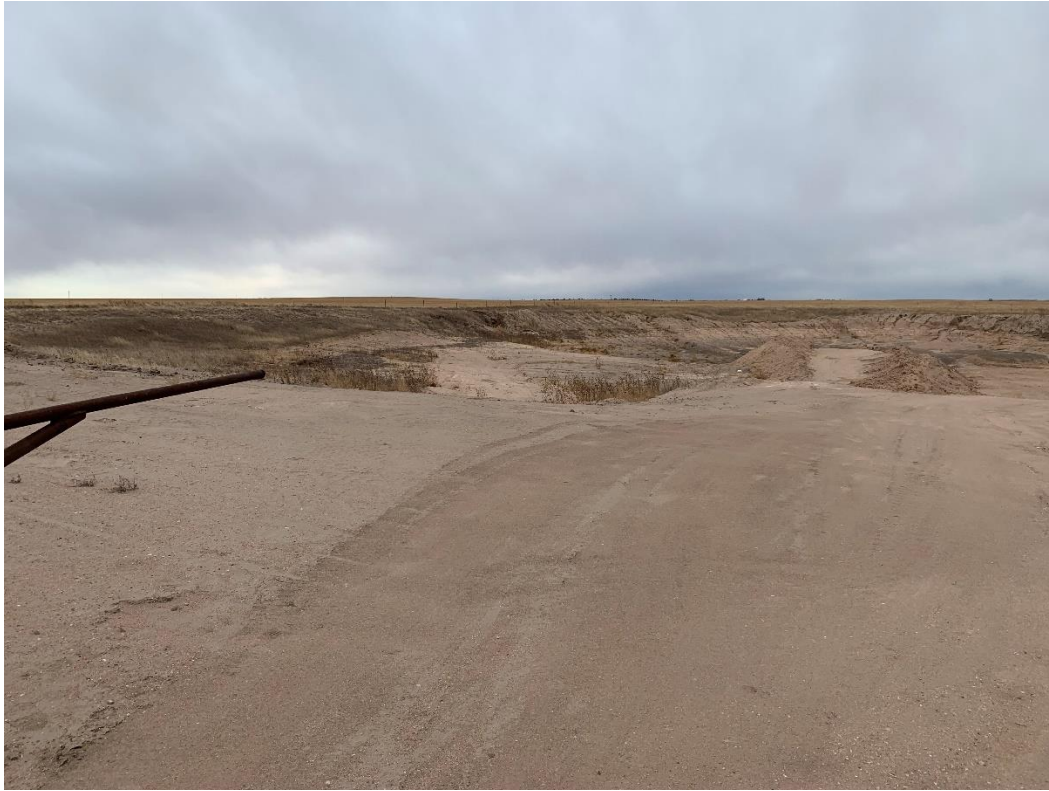
No mining equipment was on-site during the inspection. The current pit slopes were approximately 3:1 and the pit was about 20 feet deep (photo 7). The topsoil piles were located along the eastern permit boundary (photo 8). An L-shaped tree belt is located along the northern fence line on the western side of the current permit boundary. The tree belt will not be disturbed as part of the new mining plan.

Photo 7 – Southern end of the current pit area

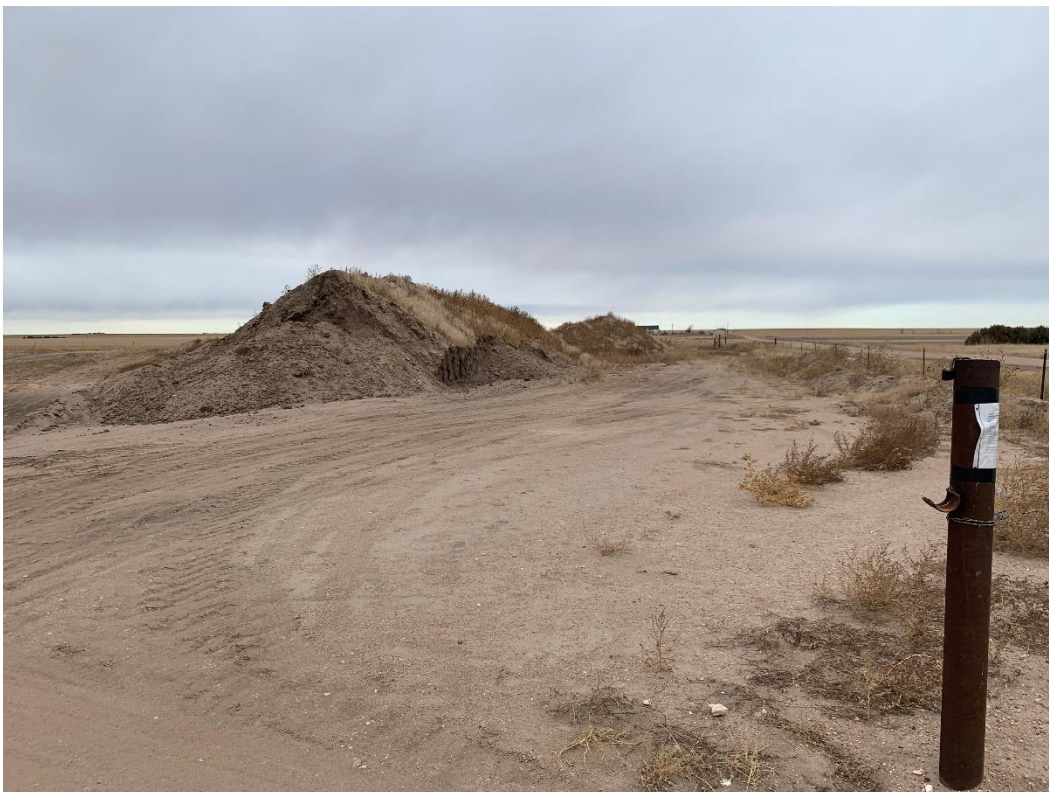
Photo 8 – Topsoil piles located on eastern boundary of the current permit area
