## Keenesburg report

**PERMIT INFORMATION**

<b>Permit Number:</b> C-1981-028 <b>Mine Name:</b> Keenesburg Strip Mine <b>Operator:</b> Coors Energy Company <b>Operator Address:</b> Mr. Ben Moline PO Box 4030 Golden, CO 80402	<b>County:</b> Weld <b>Operation Type:</b> Surface <b>Permit Status:</b> Permanent Cessation <b>Ownership:</b> Private
	<b>Operator Representative Present:</b>  None
<b>Operator Representative Signature: (Field Issuance Only)</b>

<b>Inspection Start Date:</b> December 16, 2021 <b>Inspection Start Time:</b> 11:50 <b>Inspection End Date:</b> December 16, 2021 <b>Inspection End Time:</b> 13:10	<b>Inspection Type:</b> Coal Partial Inspection <b>Inspection Reason:</b> Normal I&E Program <b>Weather:</b> Clear
<b>Joint Inspection Agency:</b>  None	<b>Joint Inspection Contacts:</b>  
<b>Post Inspection Agency:</b>  None	<b>Post Inspection Contacts:</b>  
<b>Inspector(s):</b>  Robert Zuber, P.E.	<b>Inspector's Signature:</b>  <i>Robert D. Zuber</i>  <b>Signature Date:</b>  12/17/2021

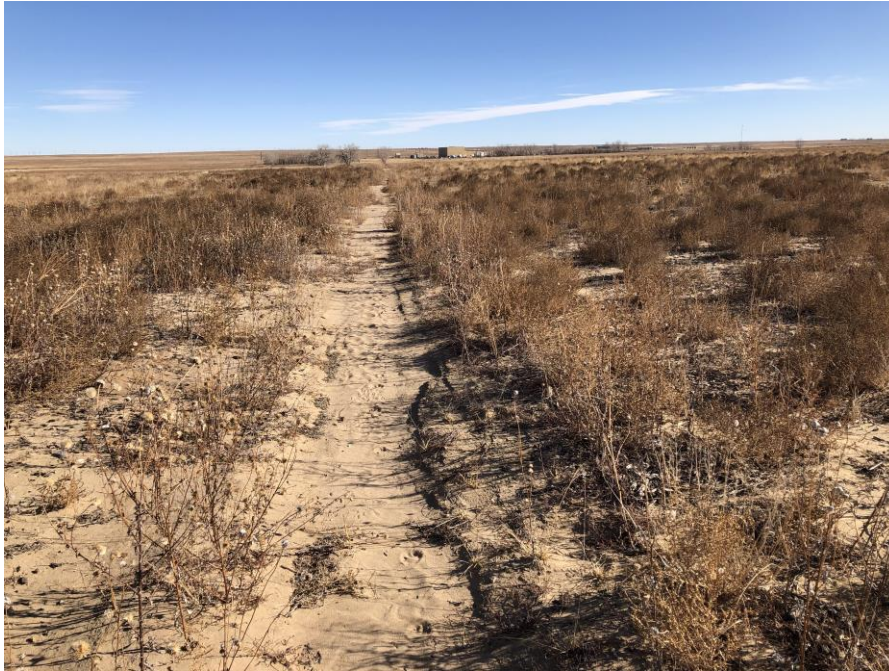
Minor erosion problems were seen at the Long Term Spoil Area (west side and south side). Also, large bare spots were seen on reclaimed roads, and smaller bare spots were seen at the reclaimed B Pit area. The reclamation in areas south of B Pit (e.g., Area 32) continue to exhibit good vegetation cover with desirable grass species.

**Erosion within Long Term Spoil Area (west side)**

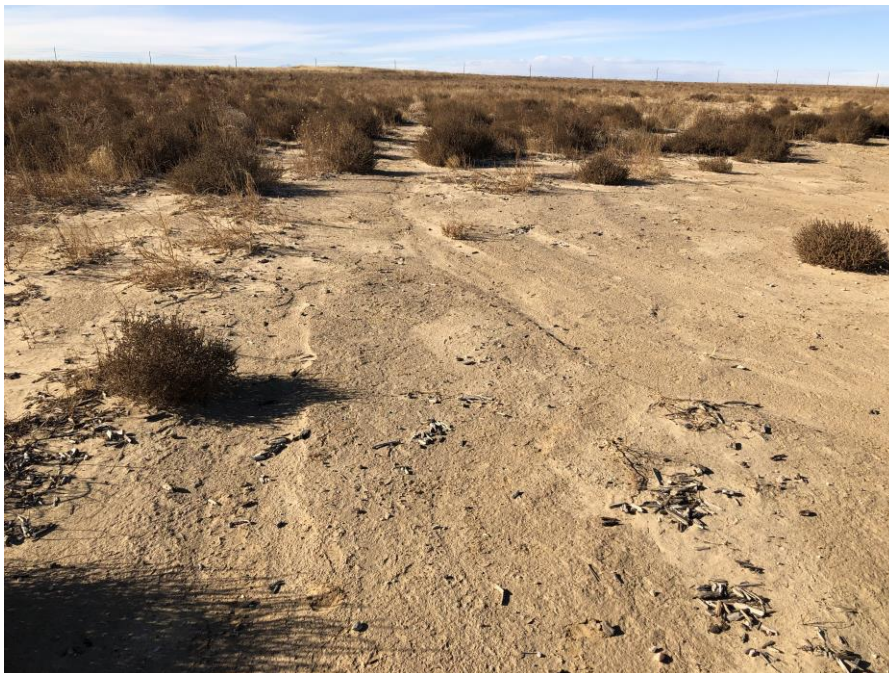
**Erosion within Long Term Spoil Area (south side)**

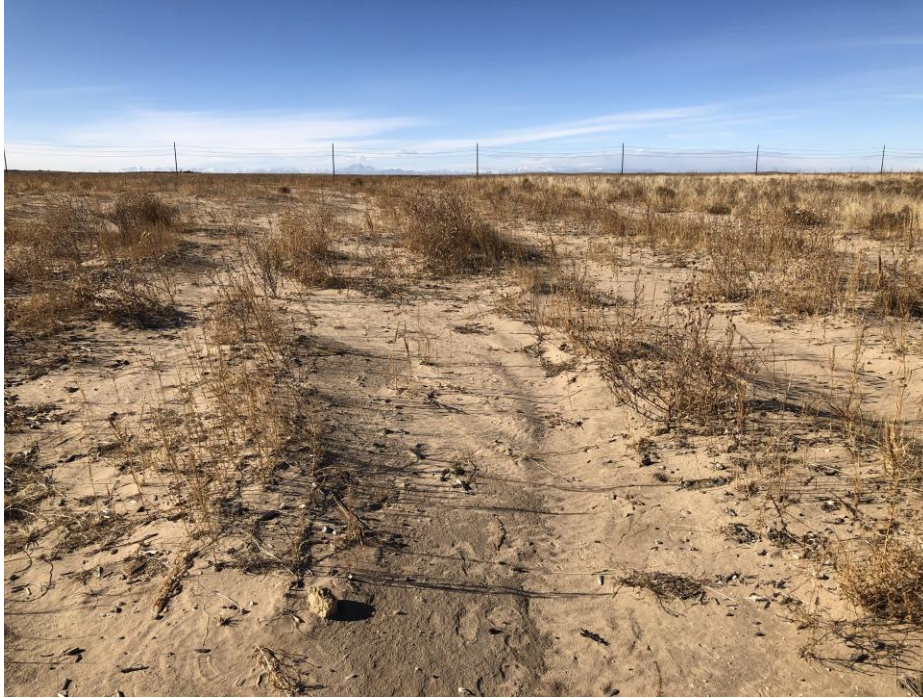
**Reclaimed B Pit (center of area)**

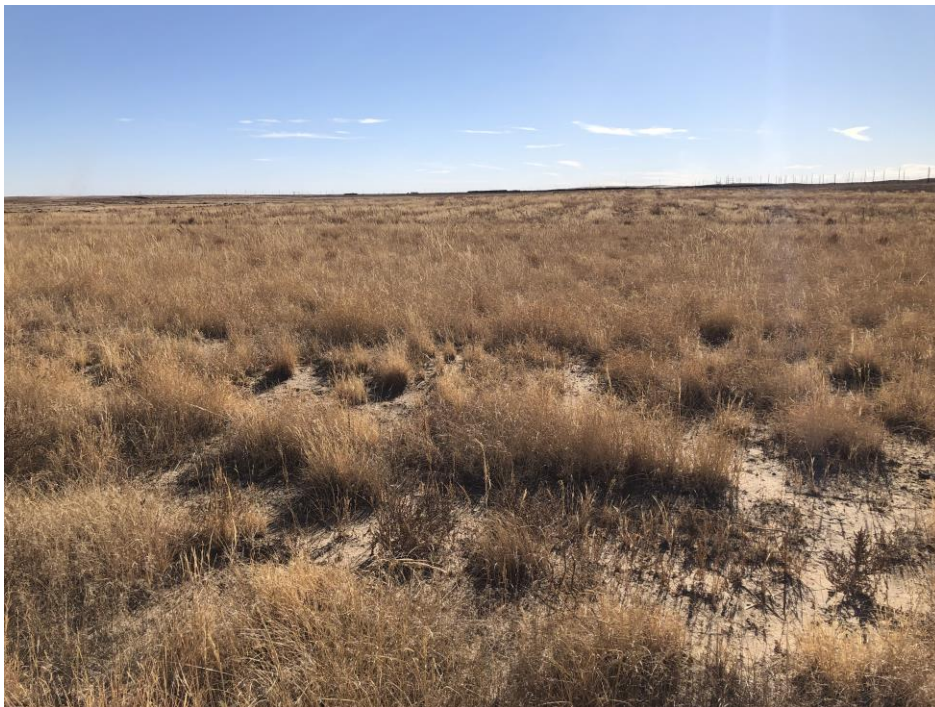
**Good reclamation south of B Pit area (Area 32 in foreground)**
