COLORADO
Division of Reclamation,
Mining and Safety
Department of Natural Resources

Permit Number: C-1981-018 Mine Name: Deserado Mine Operator: Blue Mountain Energy, Inc. Operator Address: Mr. Kurtis Blunt 3607 County Road 65 Rangely, CO, 81648	County: Moffat, Rio Blanco Operation Type: Underground Permit Status: Active Ownership: Private
	Operator Representative Present: Kurt Blunt
Operator Representative Signature: (Field Issuance Only)

Inspection Start Date: December 14, 2021 Inspection Start Time: 11:50 Inspection End Date: December 14, 2021 Inspection End Time: 13:30		Inspection Type: Coal Partial Inspection Inspection Reason: Normal I&E Program Weather: Cloudy	
Joint Inspection Agency: None		Joint Inspection Contacts: None	
Post Inspection Agency: None		Post Inspection Contacts: None	
Inspector(s): Clayton Wein	Inspector's Signature: <i>Clayton Wein</i>		Signature Date: 12/20/2021

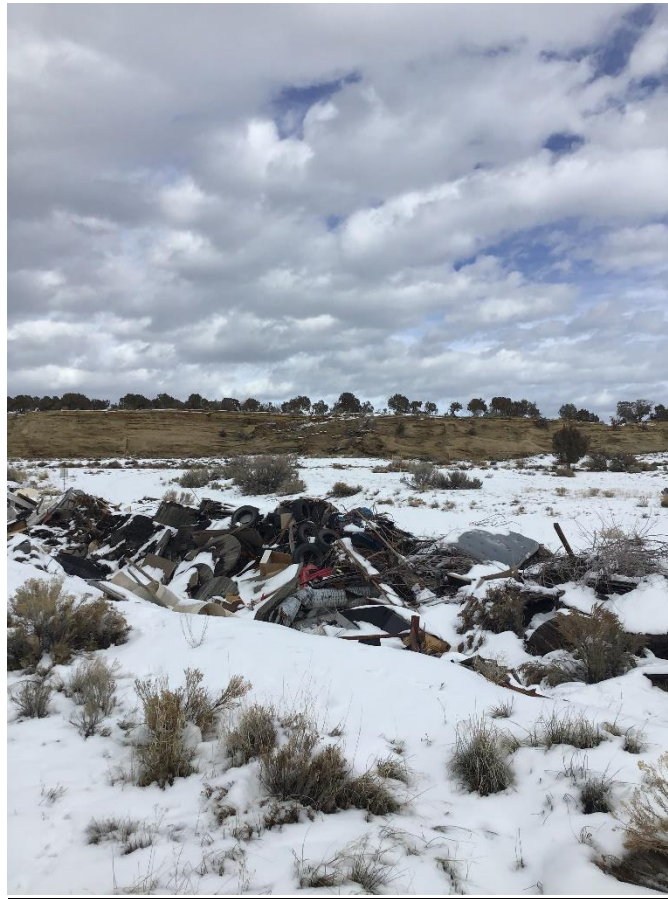
During the inspection, the Halandras Landfill was visited. The site was well kept and there were no off site impacts observed. The topsoil piles were observed to be stable. Since the Division's November 2021 inspection, excess trash on the edges of the landfill had been pushed into the pits (Photo 1). This was Maintenance Item No. 1 in the November 9, 2021 inspection report. The work conducted by BME satisfies the Division's maintenance item.

Photo 1: The waste material pushed into the pit at the Halandras Landfill.

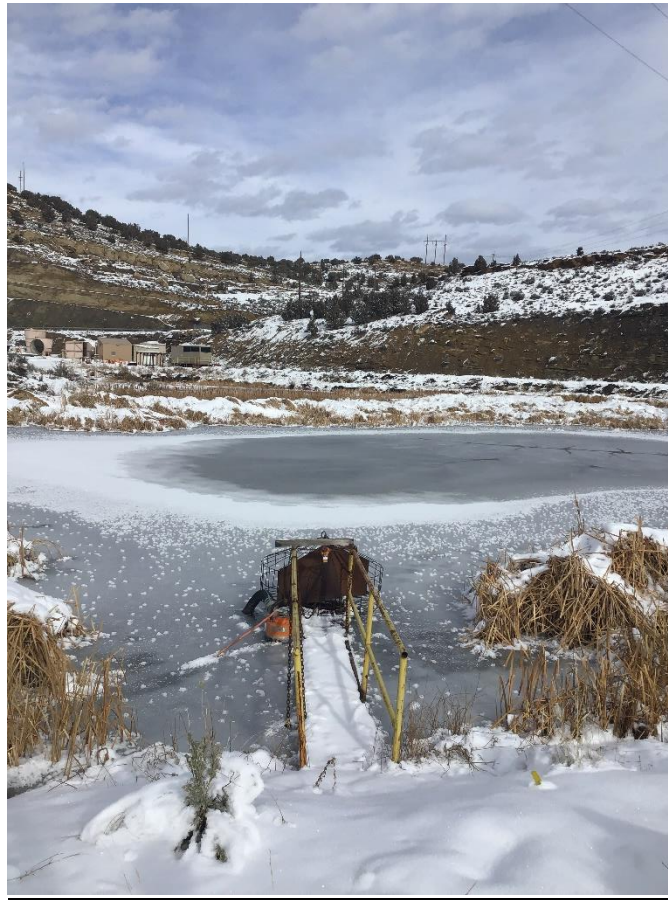
During the inspection of the Main Facilities Area, the DP-1 Pond and the PP-2 Pond were visited. The DP-1 Pond was frozen over and the embankment was covered with snow (Photo 2). There was discharge through the spillway at the time of the inspection. The embankment was stable with no erosional features noted. The PP-2 Pond was also frozen during the inspection. The embankment was stable and snow covered. There were no erosional concerns identified. No discharge was occurring.

Photo 2: The outlet of the DP-1 Pond.

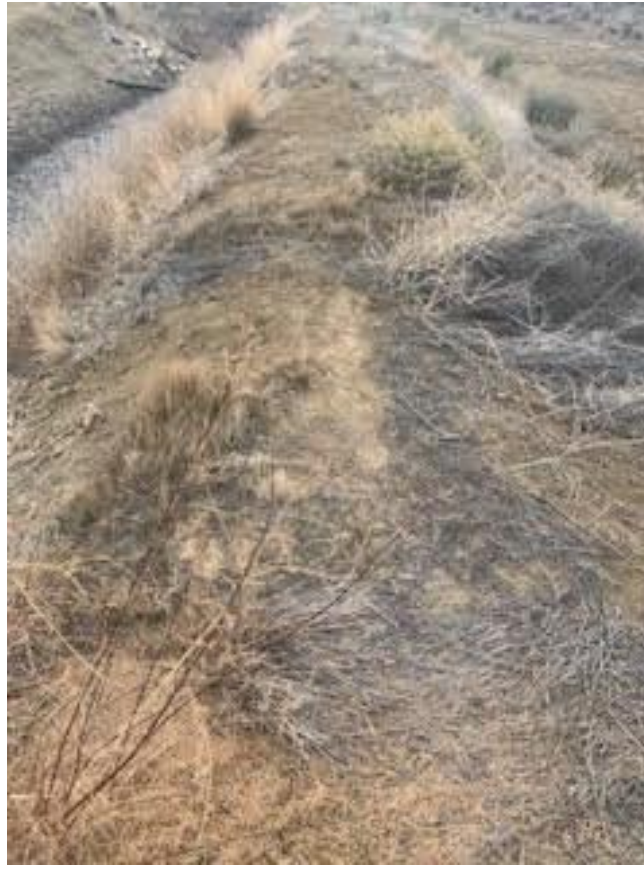
The upper cell of the B Seam Dewatering System No. 2 was covered with snow. There was no water impounded in the cell. The east embankment had erosional features identified on it during the Division's November 2021 inspection. Maintenance work was completed on the embankment prior to this inspection. The operator has provided photos to the division of the completed work (Photo 3). The work conducted Satisfies Maintenance Item No. 2 of the Division's November 2021 Inspection Report. There were no indications of instability or erosion on the embankment of the upper cell.

Photo 3: The repaired east embankment of the upper cell of the B Seam Dewatering System No. 2.

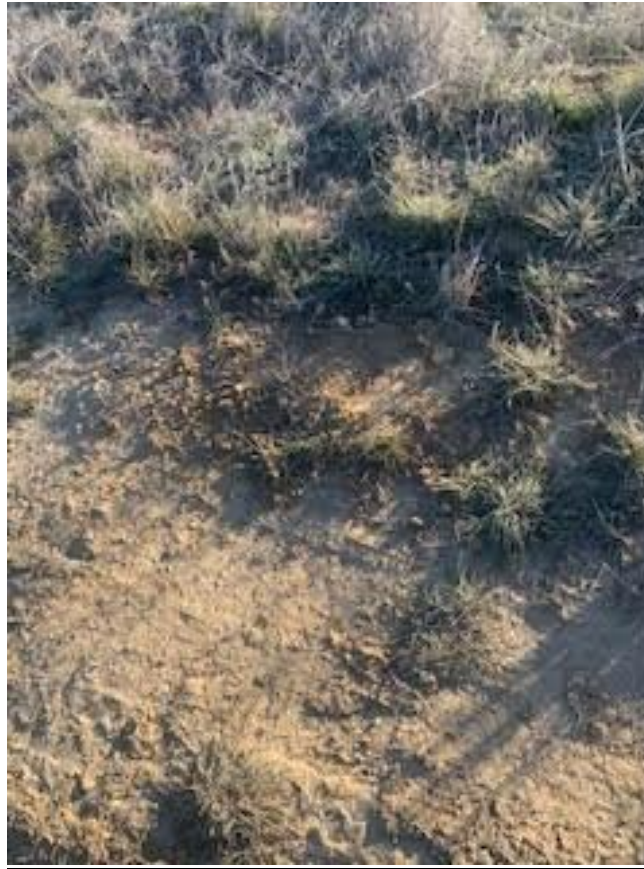
All cells of the B Seam Dewatering System No. 1 were holding water. The cells were observed to be frozen over and the embankments were covered with snow. There was outflow observed at the discharge point at the Last Chance Pond. The embankments were stable with no indications of erosion. Maintenance Item No. 3 of the Division's November 2021 Inspection Report identified a burrow on the top of the embankment of the Last Chance Pond. The operator completed maintenance at this site to fill in the burrow. Photos were provided to the Division of the completed work (Photo 4). Item No. 3 has been completed.

Photo 4: The repaired area on the embankment of the Last Chance Pond.

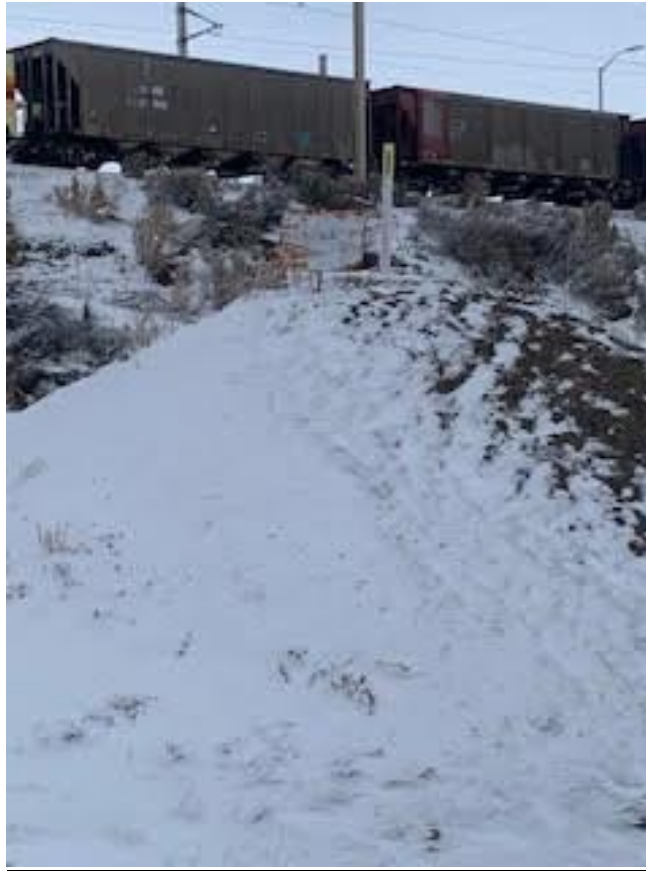
Maintenance Item No. 4 from the Division's November Inspection Report was to replace the PVC Marker on top of the topsoil pile for the RR-1 Pond. The pile was observed to be stable and covered with snow. The PVC Marker had been replaced and the topsoil marker sign had been re-posted (Photo 5). The PVC marker and the sign

were in an easily identifiable location. Maintenance Item No. 4 has been completed.

Photo 5: The topsoil pile next to the RR-1 pond with the replaced PVC marker.
