**MINERALS PROGRAM INSPECTION REPORT**  
**PHONE: (303) 866-3567**

| <b>MINE NAME:</b><br>Mica White | <b>MINE/PROSPECTING ID#:</b><br>M-1992-058 | <b>MINERAL:</b><br>Mica and silica (quar) | <b>COUNTY:</b><br>Fremont |
| <b>INSPECTION TYPE:</b><br>Multi Person Inspection | <b>INSPECTOR(S):</b><br>Timothy Cazier, P.E. | <b>INSP. DATE:</b><br>December 16, 2021 | <b>INSP. TIME:</b><br>10:00 |
| <b>OPERATOR:</b><br>Colorado Quarries Inc | <b>OPERATOR REPRESENTATIVE:</b><br>Aaron Tezak | <b>TYPE OF OPERATION:</b><br>112c - Construction Regular Operation | |

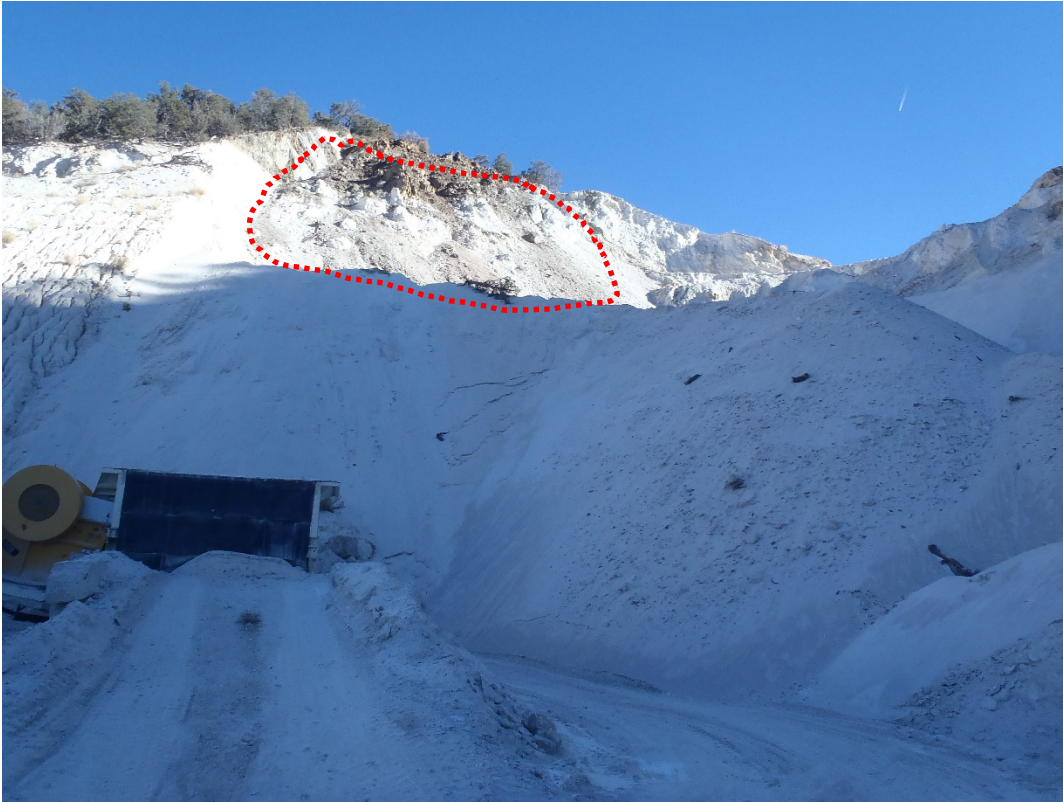
The inspection began with pointing out the two slope failures that occurred in the June/July 2021 time frame (see **Photos 1** and **2**). Mr. Tezak was uncertain as to the exact dates of the slope failures. The failures did not appear to have reached the pit floor, but Mr. Tezak also pointed out the fines pile that had been on the west end of the pit floor (as seen in my June 15, 2021 inspection) had been moved to the east end to be used as backfill for the previously active portion of the pit. Neither of these failures caused any injuries or resulted in offsite impacts.

Photo 1. First 2021 failure (south facing slope, looking NE from pit floor).

**CORRECTIVE ACTIONS:** The operator shall submit a Technical Revision, with the required \$216 revision fee, to update and clarify the current approved mine plan to prevent and mitigate potential slope failures associated with the observed summer failures and the existing tension crack by the corrective action date.

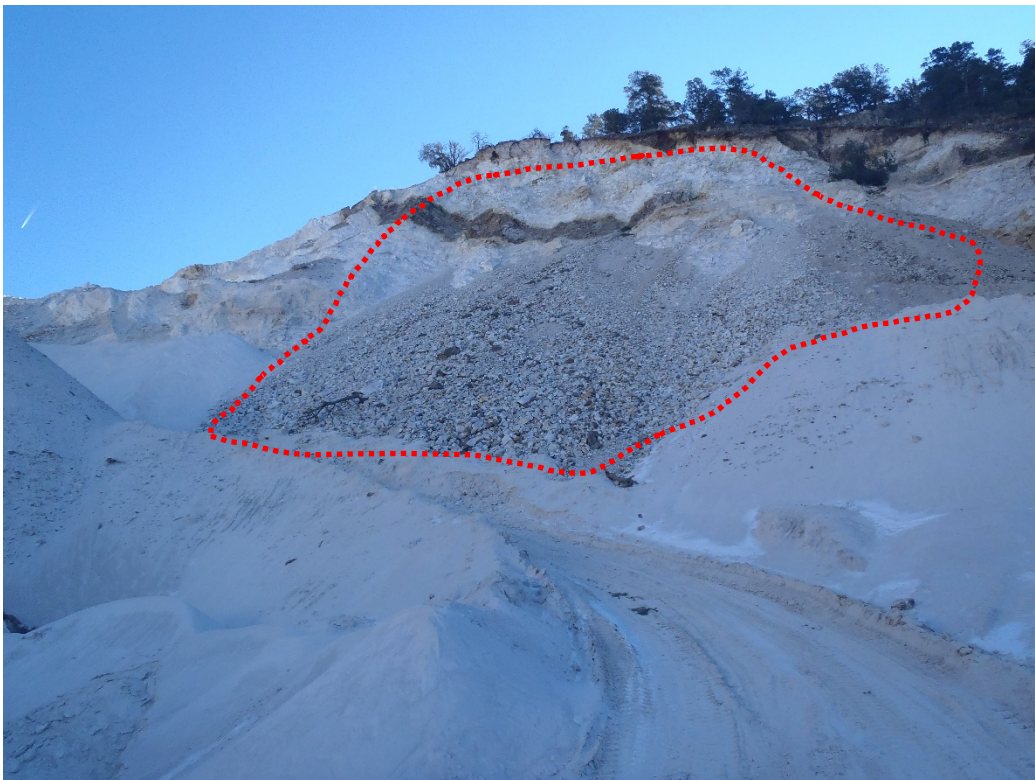
Photo 2. Second 2021 failure (north facing slope, looking east from pit floor)

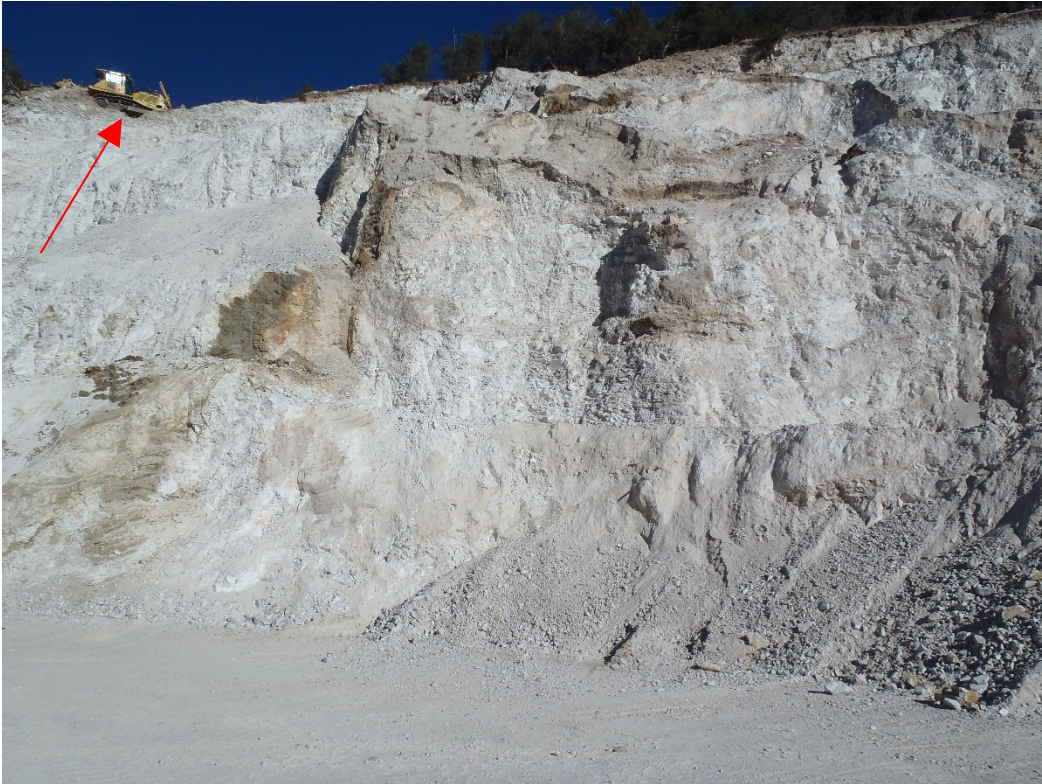
The tension crack (see **Figure 1**) above the area in the pit where the fines were moved from (see **Photo 3**) was also observed. The visible tension crack extends from where the midlevel access road intersects a small unnamed drainage (see **Photo 4**) about 200 feet across a steep access road (see **Photo 5**) to the southeast towards the formerly active pit (see **Photo 6**).

Photo 3. Area from which fines were moved (NW end of pit – note location of dozer).

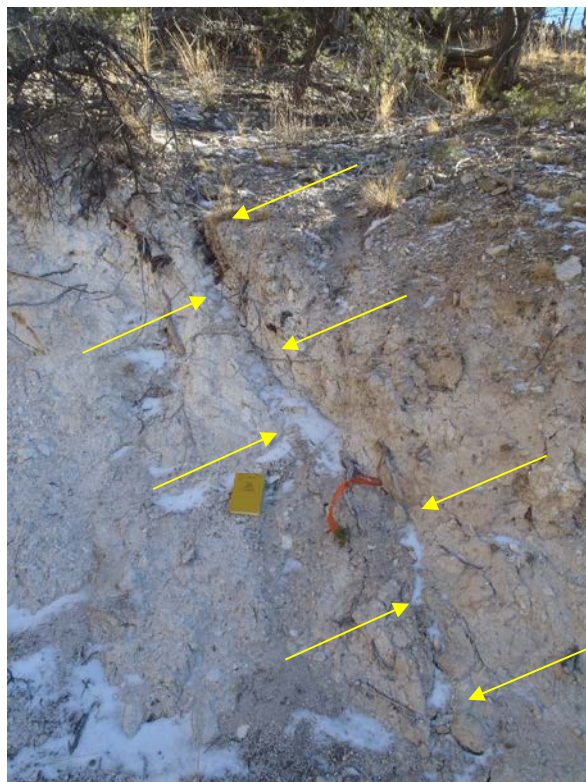
The observed tension crack is a sign of instability of the slope. The extent of a potential slope failure is uncertain based on site observations and needs to be investigated by a qualified specialist in structural geology and/or geotechnical stability. Concerns range from safety of the Operator to impacts to the environment, most likely the potential for material to enter the drainage outside the affected area boundary, below the pit floor to the southwest. The existence of the tension crack is cited as a problem on page 1 of this report.

Photo 4. Tension crack viewed in access road cut, ~100 feet NE of dozer (looking east).

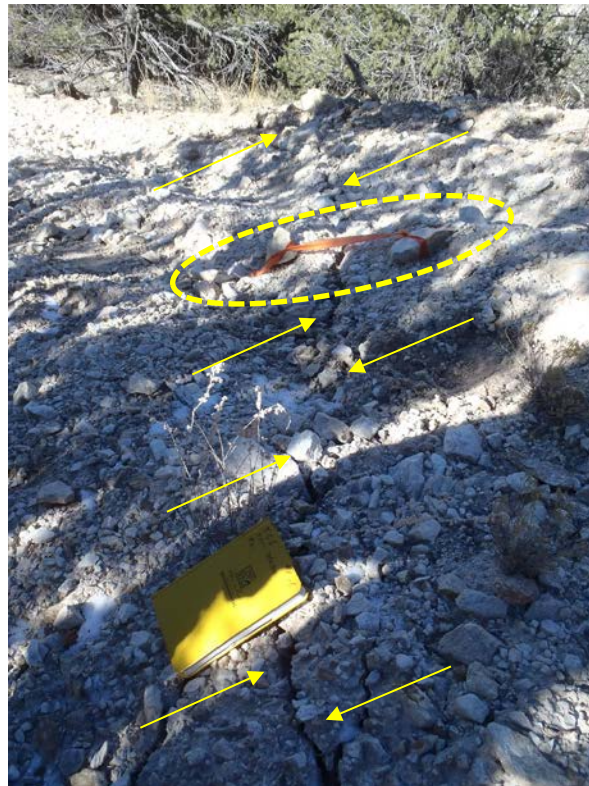
Photo 5. Tension crack viewed in access road/dozer trail, ~150 east of dozer (looking west).  
{Note: orange tape (circled) anchored on each end by rocks straddles tension crack}

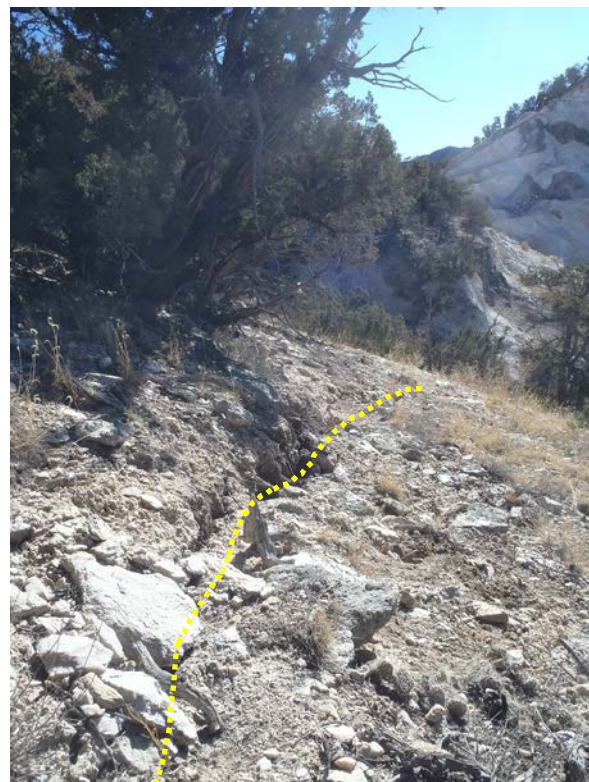
Photo 6. Tension crack viewed SE of access road/dozer trail (looking SE, north facing highwall beyond).
