MINERALS PROGRAM INSPECTION REPORT

MINE NAME: Sanders Gravel Pit	MINE/PROSPECTING ID#: M-2021-066	MINERAL: Sand and gravel	COUNTY: Routt
INSPECTION TYPE: Preoperation Inspection	INSPECTOR(S): Tabetha Lynch	INSP. DATE: December 13, 2021	INSP. TIME: 03:00
OPERATOR: Tara Sanders	OPERATOR REPRESENTATIVE: Tara Sanders	TYPE OF OPERATION: 110c - Construction Limited Impact

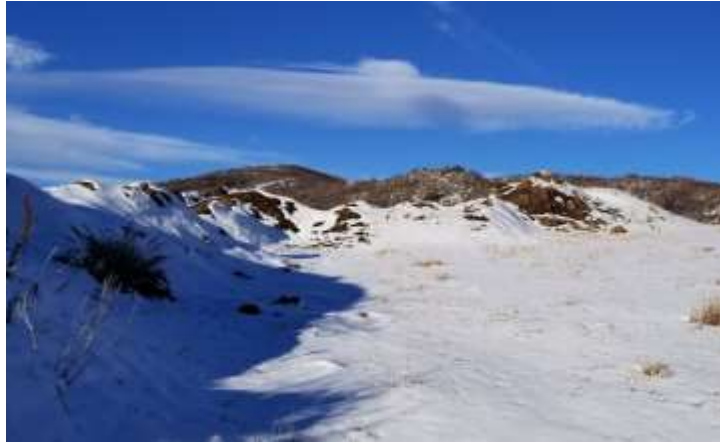
Looking northeast from road toward southern portion of the existing highwall

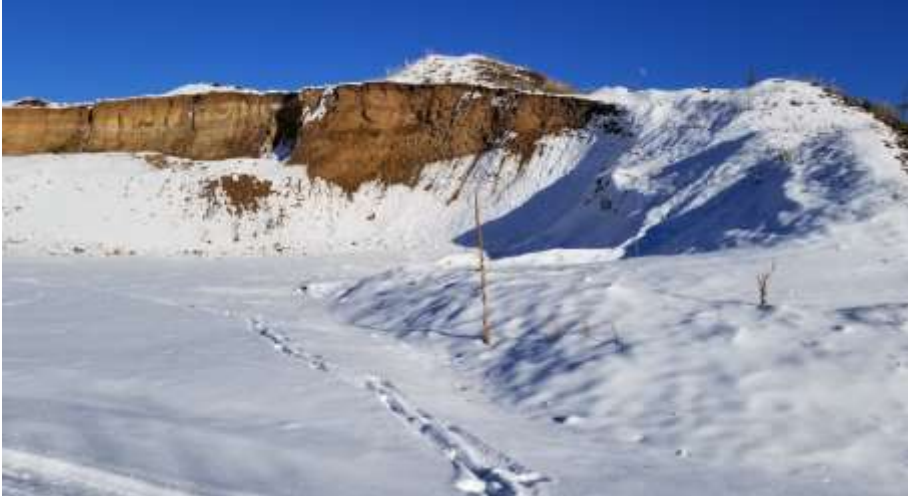
Looking south down FS Trail 1180
