MINERALS PROGRAM INSPECTION REPORT
PHONE: (303) 866-3567

MINE NAME: Chris Ageson Pit #2 Addition	MINE/PROSPECTING ID#: M-2019-049	MINERAL: Reclamation only per	COUNTY: Washington
INSPECTION TYPE: Monitoring	INSPECTOR(S): Brock Bowles	INSP. DATE: November 24, 2021	INSP. TIME: 12:15
OPERATOR: Washington County	OPERATOR REPRESENTATIVE: Robert Frick	TYPE OF OPERATION: 110c - Construction Limited Impact	
REASON FOR INSPECTION: Normal I&E Program	BOND CALCULATION TYPE: None	BOND AMOUNT: \$0.00	
DATE OF COMPLAINT: NA	POST INSP. CONTACTS: None	JOINT INSP. AGENCY: None	
WEATHER: Cloudy	INSPECTOR'S SIGNATURE:

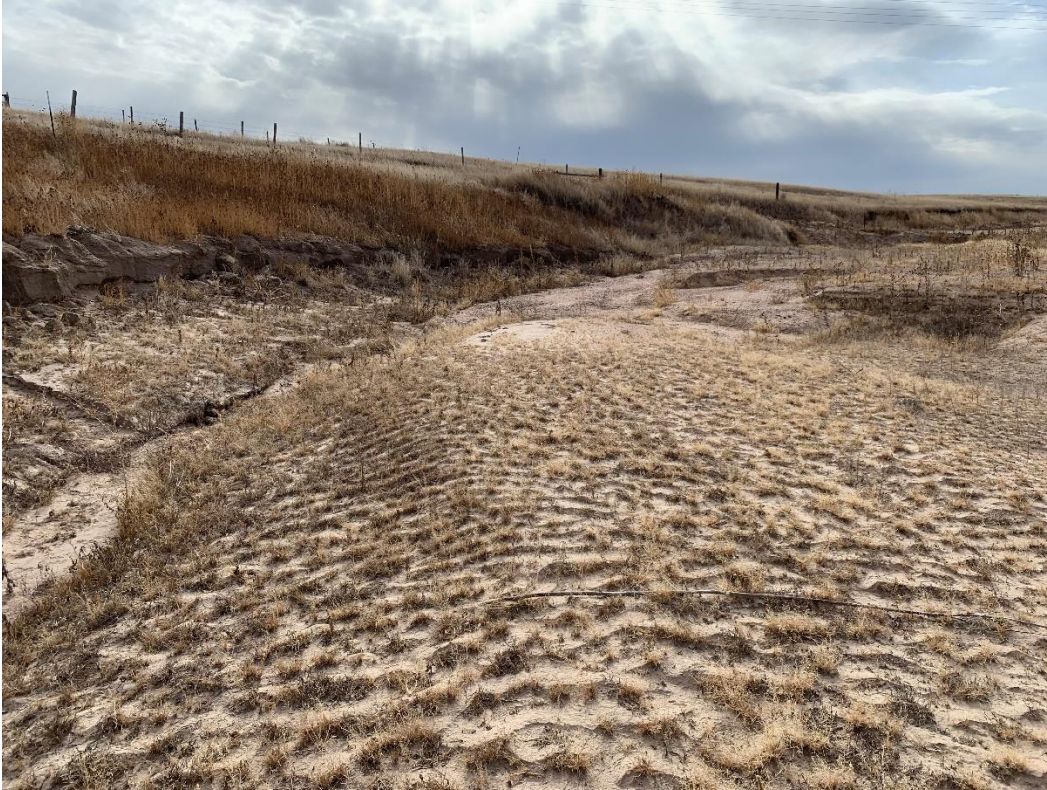
The lower part of the reclamation that is next to the creek was eroded from the heavy rain events this past year (photo 1). A large amount of material was deposited on the inside turn of the creek bed, forcing the water flow line to the outside bank of the creek and eroding the outside bank.

Photo 1 – The lower part of the reclamation that is next to the creek bed, facing south

The reclamation area was ripped up and down the slope. This created channels that directed water straight down the hill and increased erosion in the bottom of the channels. The area needs to be re-worked to remove all channels going up and down the hill. The final discing and seeding need to be driven along the contour of the hillside. This creates small trenches along the contour and slows surface water runoff, decreases erosion and increases infiltration. This step is very important to implement in the next couple of months before spring rains to prevent additional topsoil loss and to get the vegetation established.

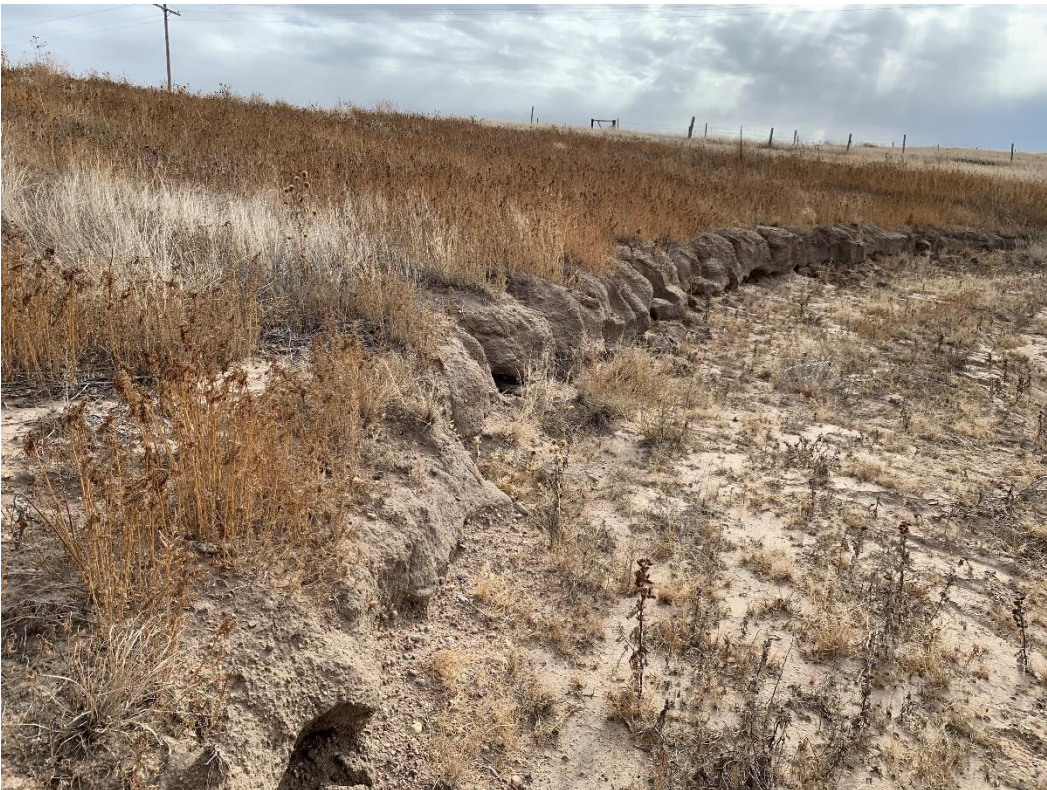
There were a few grasses in the reclamation but not a significant amount. In the current condition the reclamation area does not meet the standard for bond release. The area was dominated by annuals and does not appear that the perennial species are becoming established (photo 2).

Photo 2 – Reclamation dominated by annuals
