MINERALS PROGRAM INSPECTION REPORT
PHONE: (303) 866-3567

MINE NAME: Chris Aageson Pit #2	MINE/PROSPECTING ID#: M-2000-084	MINERAL: Gravel	COUNTY: Washington
INSPECTION TYPE: Monitoring	INSPECTOR(S): Brock Bowles	INSP. DATE: November 24, 2021	INSP. TIME: 12:00
OPERATOR: Washington County	OPERATOR REPRESENTATIVE: Robert Frick	TYPE OF OPERATION: 110c - Construction Limited Impact	
REASON FOR INSPECTION: Normal I&E Program	BOND CALCULATION TYPE: None	BOND AMOUNT: \$0.00	
DATE OF COMPLAINT: NA	POST INSP. CONTACTS: None	JOINT INSP. AGENCY: None	
WEATHER: Cloudy	INSPECTOR'S SIGNATURE:

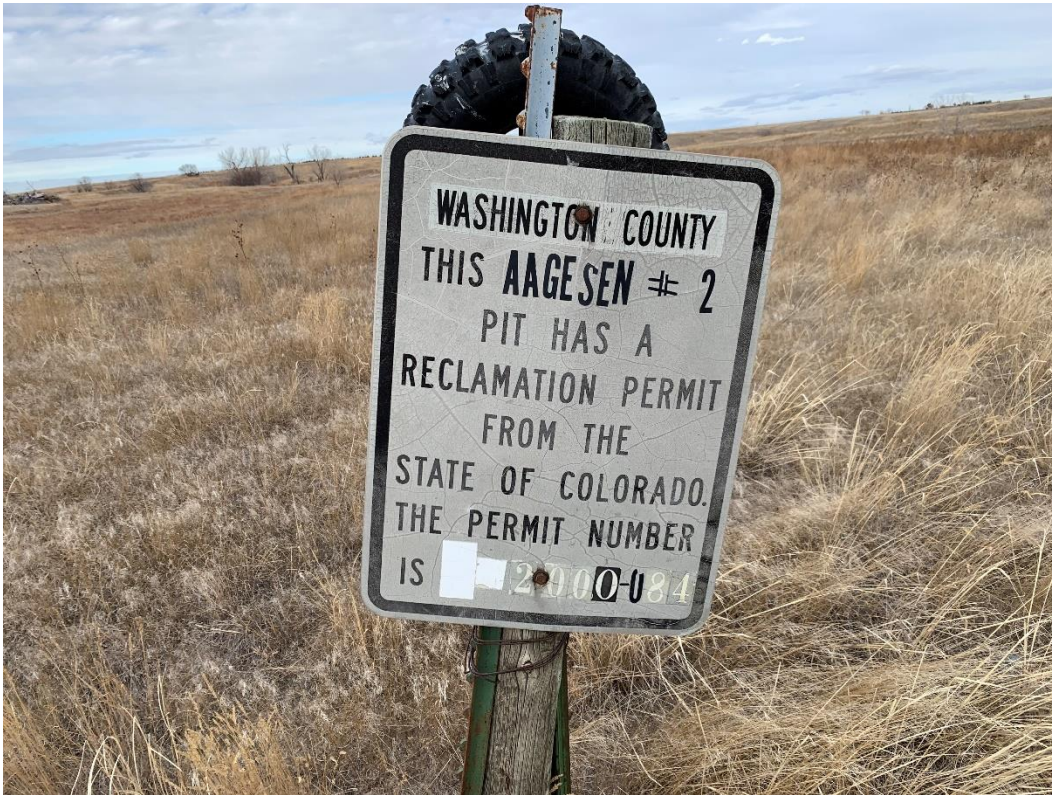
The mine entrance sign was in place facing CR 55 (photo 1).

Photo – Mine entrance sign facing CR 55

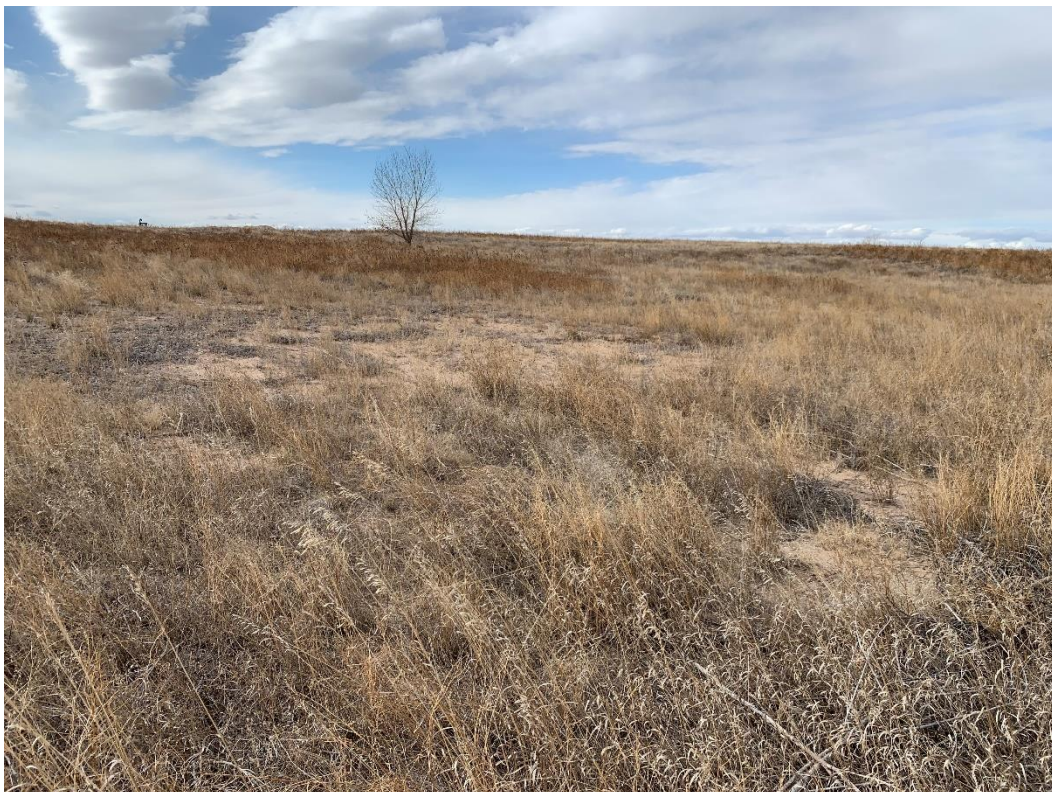
The Aageson Pit is completely reclaimed and no mining is taking place. The topsoil has been spread and the area has been seeded. The vegetation on the Aageson side (west of creek bed) looked good. There were a couple of thin spots but overall the vegetation was dense and some young shrubs were observed (photo 2 & 3). A willow thicket was well established in the creek bed (photo 4). A large pile of sediment was deposited just upstream of the willow patch (photo 5), indicating the willow patch is effectively controlling the water flow and limiting sediment movement down the creek.

Photo 2 – Reclaimed area looking west.

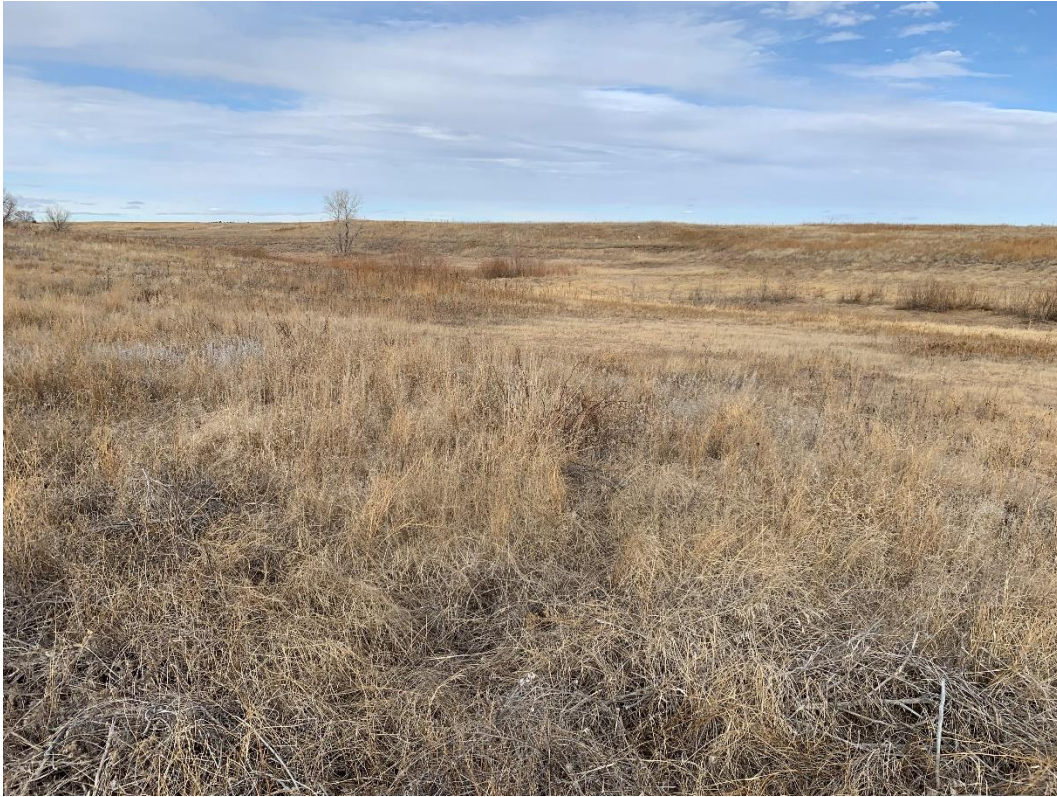
Photo 3 – Reclaimed area looking north, creek bed in far side of photo

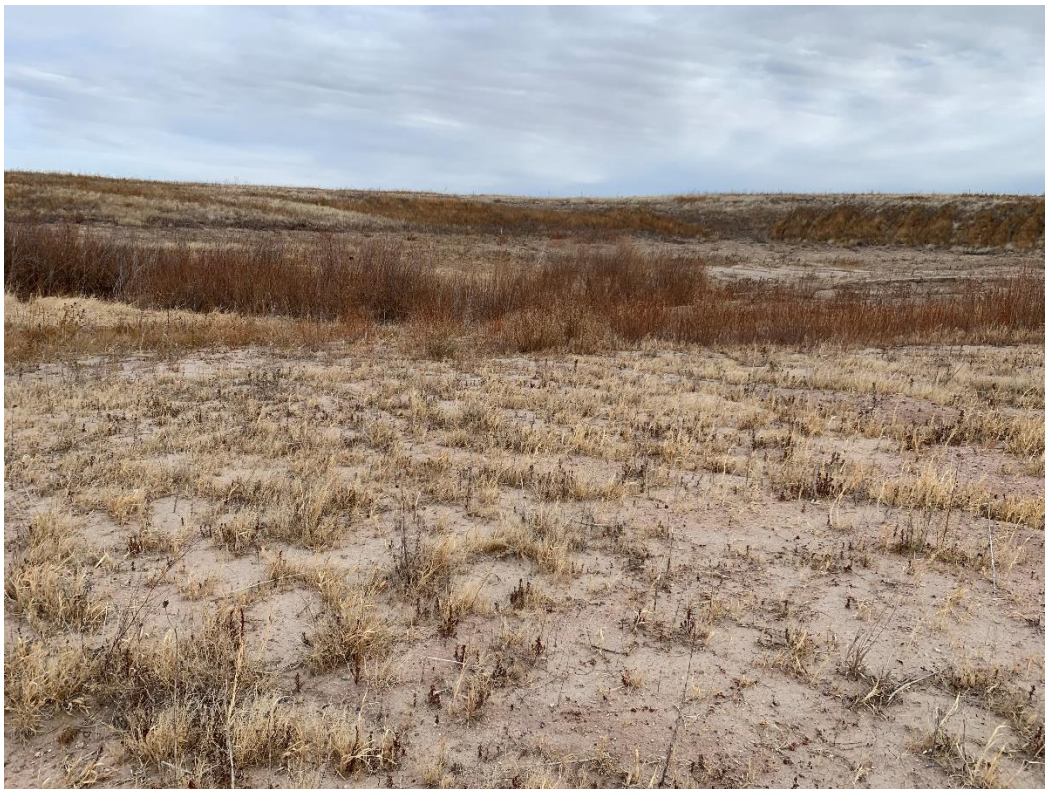
Photo 4 – Willow patch in creek bed

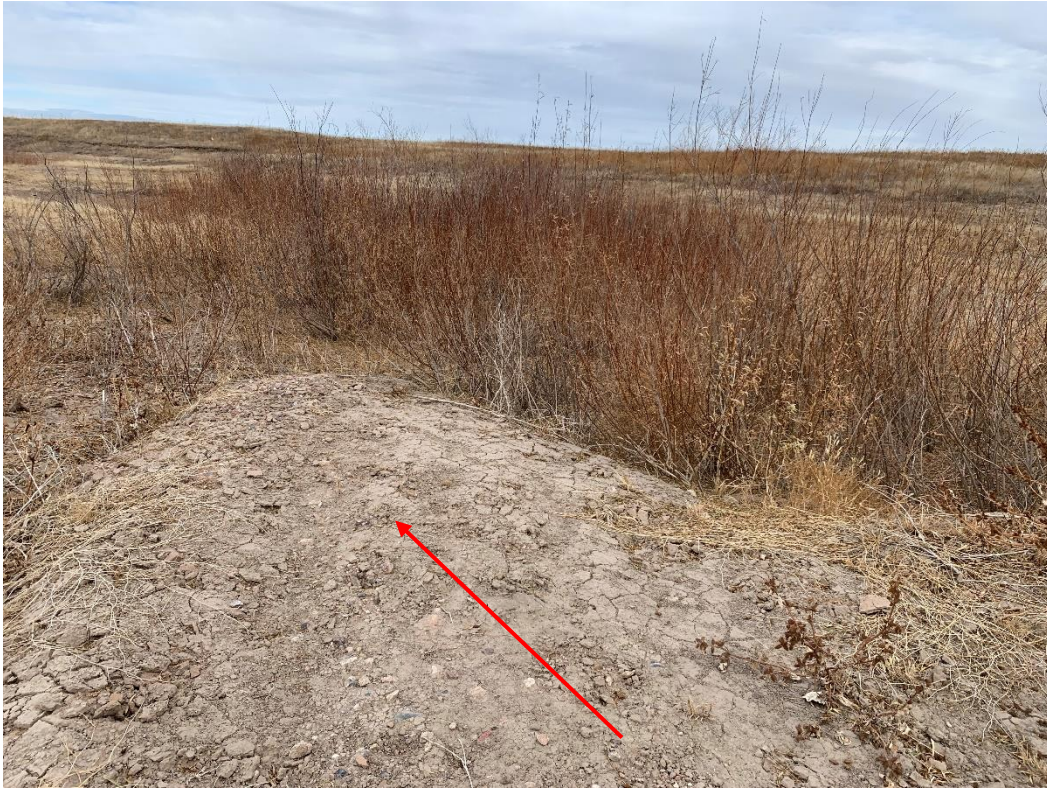
Photo 5 – Sediment deposit upstream of willow patch
