MINERALS PROGRAM INSPECTION REPORT PHONE: (303) 866-3567

MINE NAME:	MI	NE/PROSPECTING ID#:	MINERAL:	COUNTY:
Elrick Pit		1997-015	Sand and gravel and	Washington
			(general)	
INSPECTION TYPE:	INS	SPECTOR(S):	INSP. DATE:	INSP. TIME:
Monitoring		ock Bowles	November 24, 2021	11:00
OPERATOR:		ERATOR REPRESENTATIVE:	TYPE OF OPERATION:	
Washington County		bert Frick	112c - Construction Regular Operation	
REASON FOR INSPECTION:	ВО	OND CALCULATION TYPE:	BOND AMOUNT:	
Normal I&E Program		ne	\$0.00	
DATE OF COMPLAINT:		ST INSP. CONTACTS:	JOINT INSP. AGENCY:	
NA		ne	None	
WEATHER:	INSPECTOR'S SIGNATURE:		SIGNATURE DATE:	
Cloudy	Brak Sauls		December 22, 2021

PERMIT #: M-1997-015 INSPECTOR'S INITIALS: BFB INSPECTION DATE: November 24, 2021

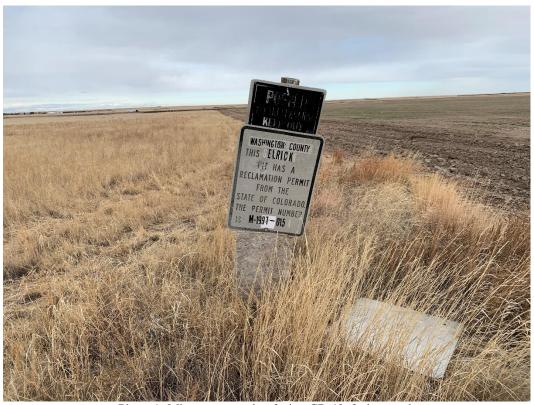
The mine entrance sign was in place facing CR 40 (photo 1). The eastern permit markers were in place.

Photo 1- Mine entrance sign facing CR 40, facing north

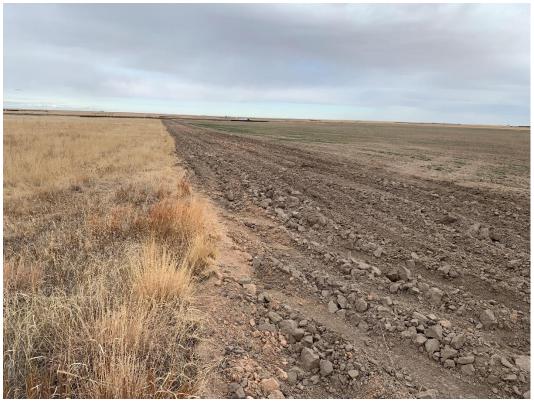
The mine site is in active reclamation. The access road from CR 40 has been ripped (photo 2). The pit area has been sloped to the east and southeast towards the existing creek bottom (photo 3). The creek channel has been re-established and no obstructions were noted. Eastern portion of permit area was not disturbed (photo 4). The operator plans to plant a sterile sorghum for the winter and then plant the final seeding next year.

Photo 2 – Access road from CR 40, facing north

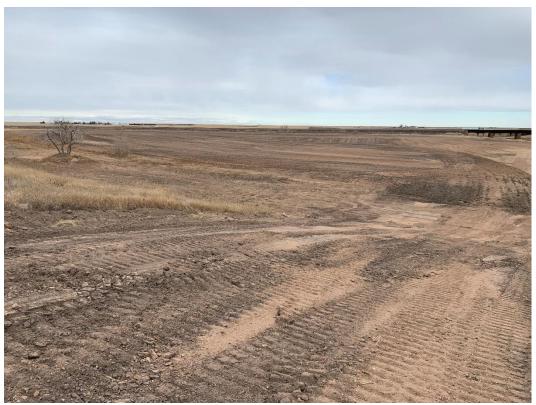
Photo 3- Pit bottom sloped toward creek in foreground, facing north

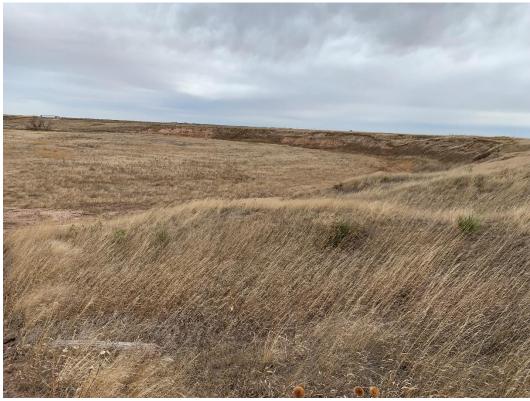
Photo 4 – South east section of permit area, facing east.
