**COLORADO**  
Division of Reclamation,  
Mining and Safety  
Department of Natural Resources

<b>Permit Number:</b> C-1981-014 <b>Mine Name:</b> Southfield Mine <b>Operator:</b> Energy Fuels Coal, Inc. <b>Operator Address:</b> Mr John Adams P.O. Box 773457 Steamboat Springs, CO 80477	<b>County:</b> Fremont <b>Operation Type:</b> Underground <b>Permit Status:</b> Revoked <b>Ownership:</b> Private
	<b>Operator Representative Present:</b>  None
<b>Operator Representative Signature: (Field Issuance Only)</b>

<b>Inspection Start Date:</b> December 23, 2021 <b>Inspection Start Time:</b> 10:00 <b>Inspection End Date:</b> December 23, 2021 <b>Inspection End Time:</b> 10:20		<b>Inspection Type:</b> Coal Complete Inspection <b>Inspection Reason:</b> Normal I&E Program <b>Weather:</b> Clear	
<b>Joint Inspection Agency:</b>  None		<b>Joint Inspection Contacts:</b>  None	
<b>Post Inspection Agency:</b>  None		<b>Post Inspection Contacts:</b>  None	
<b>Inspector(s):</b>  Zach Trujillo	<b>Inspector's Signature:</b>

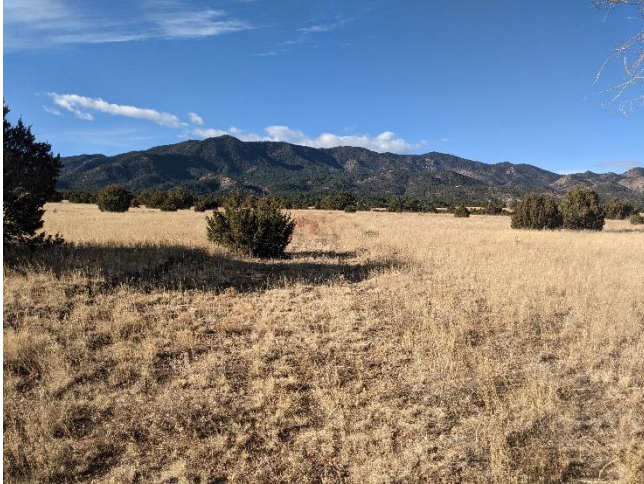
The two track road off County Road 51 was inspected. Vegetation continues to establish itself along the road. No signs of use was observed on the road.

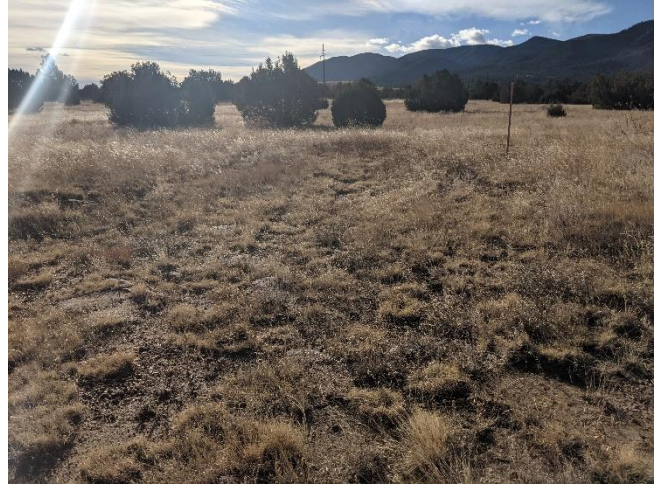
The reclaimed road spur and access road to the NW-MW well were inspected. The road spur is established with great vegetation and blends well with adjacent undisturbed land. The access road for the NW-MW well continues to show increased vegetation. The NW-MW well pad shows good signs of vegetation. No erosion or issues were observed.

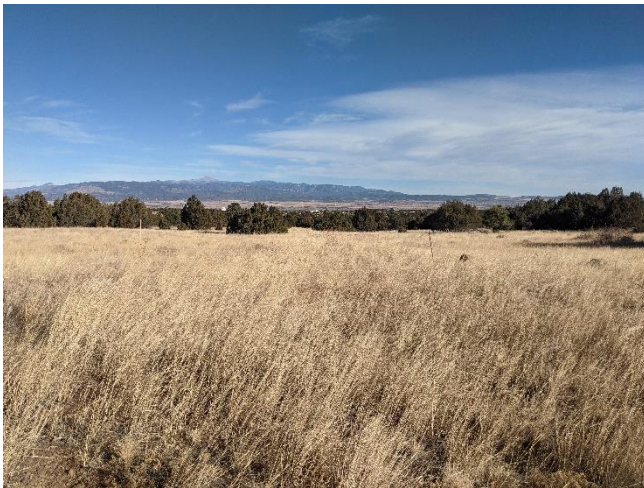
The reclaimed substation access road vegetation remains sparse due to usage post-reclamation. No recent use on the road was observed. The reclaimed substation pad is established with vegetation. The area blends well into the adjacent undisturbed lands. No issues were observed.

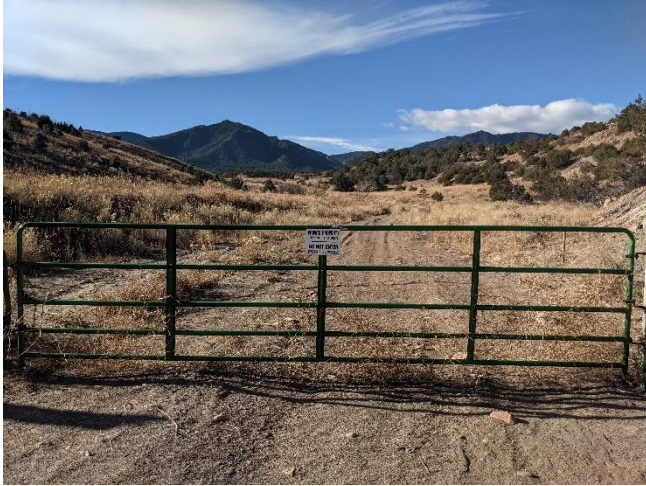
Locked gate at county road entrance.
