Geotechnical Analysis for Penrose Pit M1987-131

Subject: Geotechnical Engineering Consultation
Penrose Pit
Permit #M-1987-131
Portion of Sections 11, 12, 13, 14, and 15, T19S, R69W of the 6th PM
Fremont County, Colorado
Project No. 21.6198

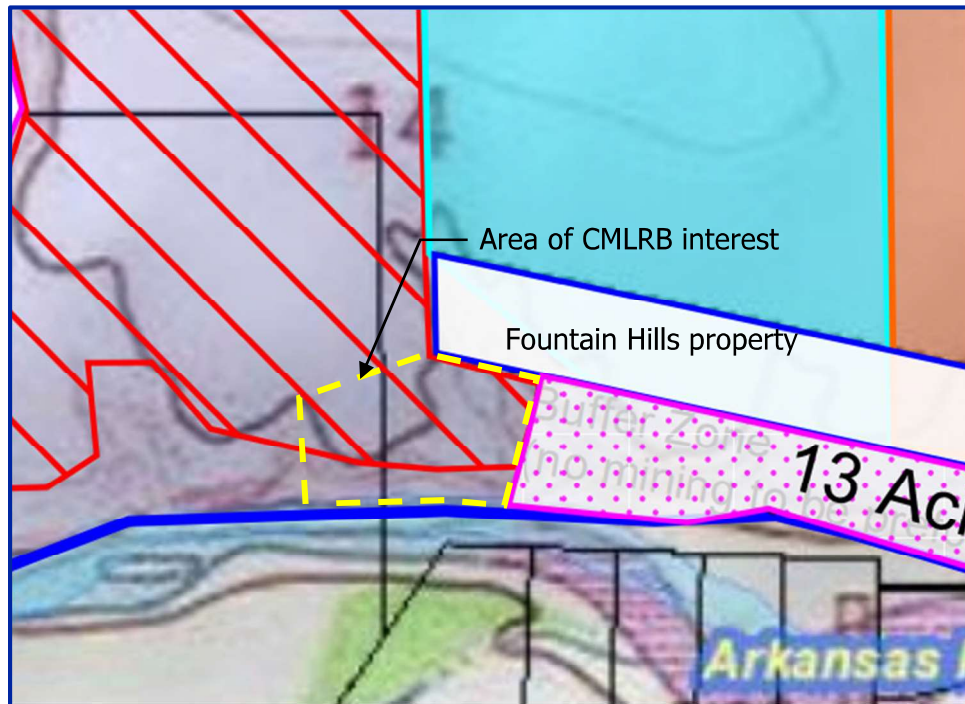
EXHIBIT 1. Area of CMLRB interest (dashed yellow line).

In the area of interest shown in Exhibit 1 Ary reports that excavation generally extended down to within a few feet of hard shale material that comprises the lower portion of the naturally occurring bluff and daylighted on the southerly facing bluff above the Arkansas River. The shale material that comprises the lower portion of the bluff was not disturbed. No mining is occurring in the area of interest, and other than some minor reclamation work, no equipment is operating in this area. Ary stated that the southerly end of the Mining/Stock Pile Area has been mined out and current/future mining is occurring north of the subject area and is progressing eastward. The attached mining plan indicates that no mining south of the Fountain Hills property, and this area will be undisturbed and managed by Ary as a protective buffer zone.

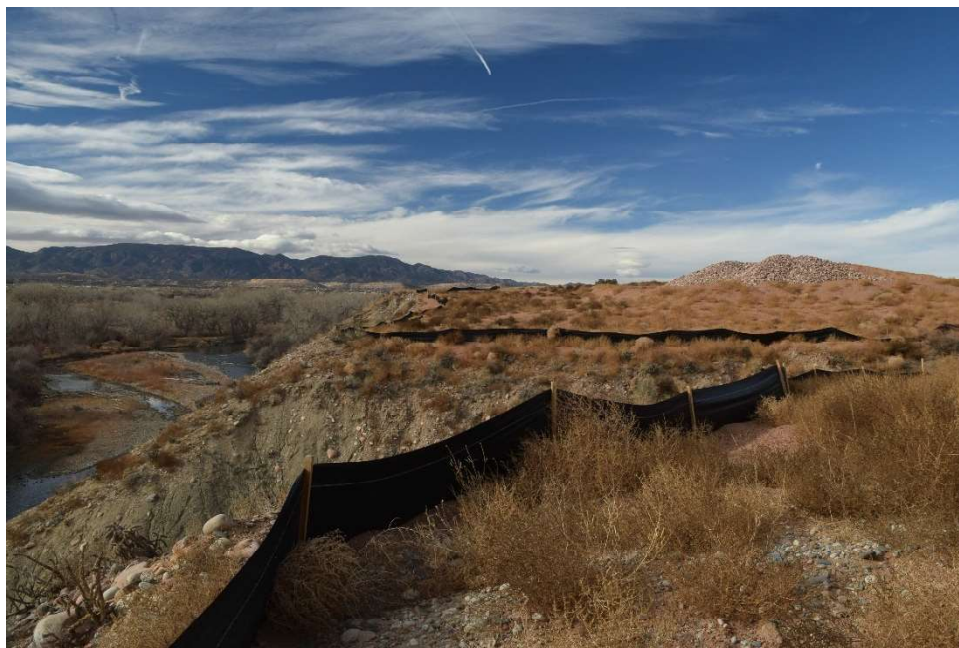
Photo 1. View looking west at area of interest.

On the western portion of the area of interest there is a relatively flat to gently sloping area between the silt fence at the crest of the undisturbed portion of the bluff and screening berms that are located roughly 60 to 80 feet north of the slope crest, see Photo 1. On the eastern portion of the area of interest, a reclaimed slope is present, see Photo 4. The reclaimed slope is estimated to have an inclination of about 3:1 (horizontal to vertical).

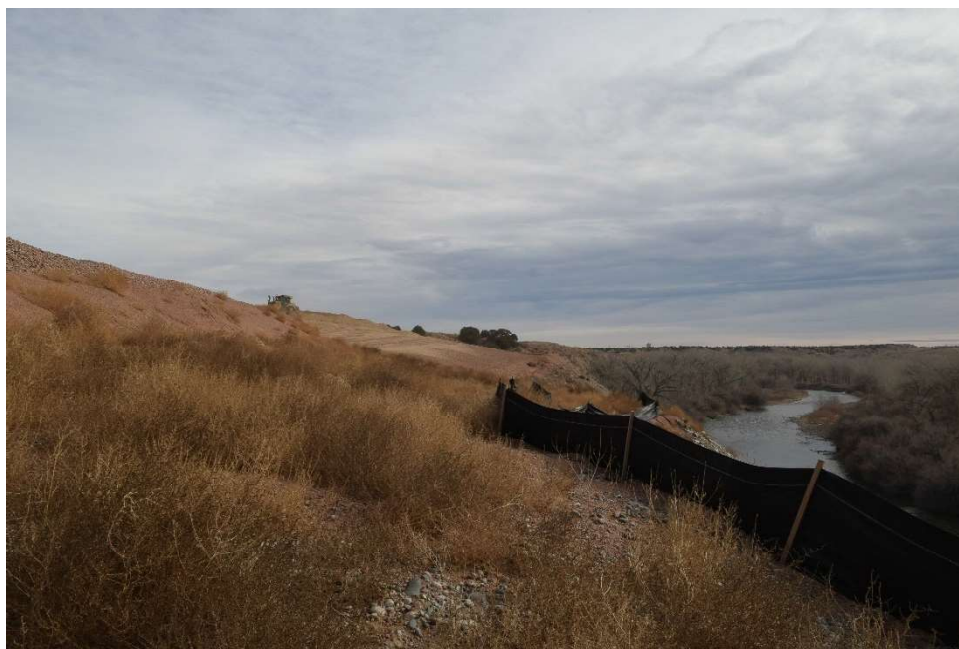
Photo 2. View looking east at area of interest.

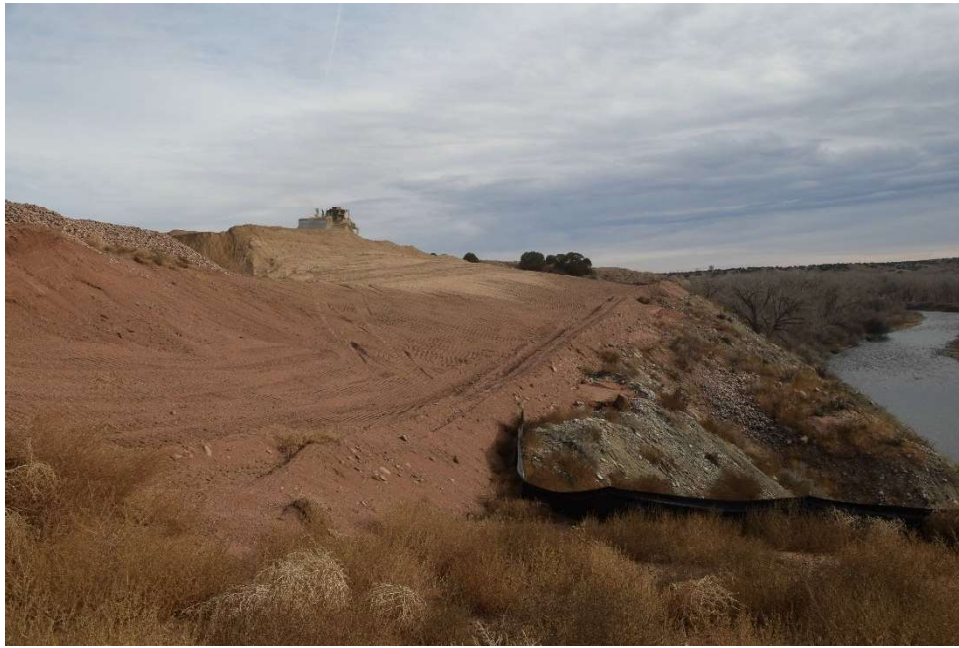
Photo 3. View looking east at area of interest.

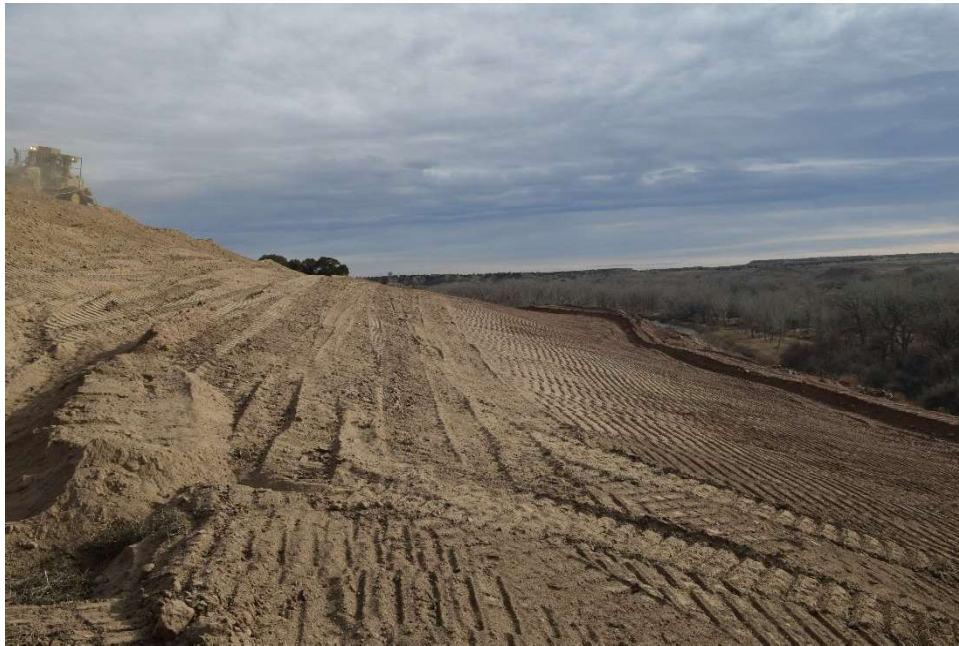
Photo 4. View looking east at area of interest.

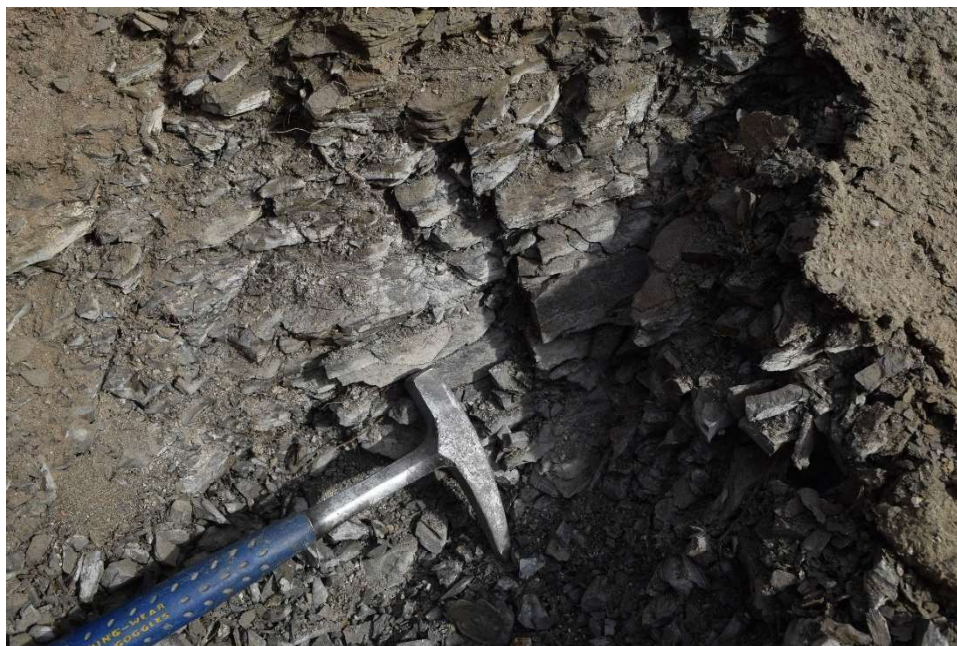
Cesare exposed the shale in the face of the bluff just below the silt fence that is visible in Photos 1 through 4. Photos 5 and 6 confirm that hard, blocky, platy, silty claystone is present in the native bluff that is consistent with the description on the geologic map.

Photo 5. View looking east at shale exposed in face of native slope.

It is Cesare's opinion that removal of the overburden soil (waste and sand and gravel product) from atop the mesa down to near the top of the shale and the current configuration visible in Photos 1 through 5 has not increased the risk of slope instability in the area of interest. The bench or setback from the crest of the bluff to the screening berms on the western end is favorable for stability and the flattened slopes along the eastern end also are favorable to stability of the underlying claystone bluff, compared to the slope configuration that existed prior to mining. Typically, grade flattening and removal of earthen material/load from the top of a slope inherently increases the stability of the slope.

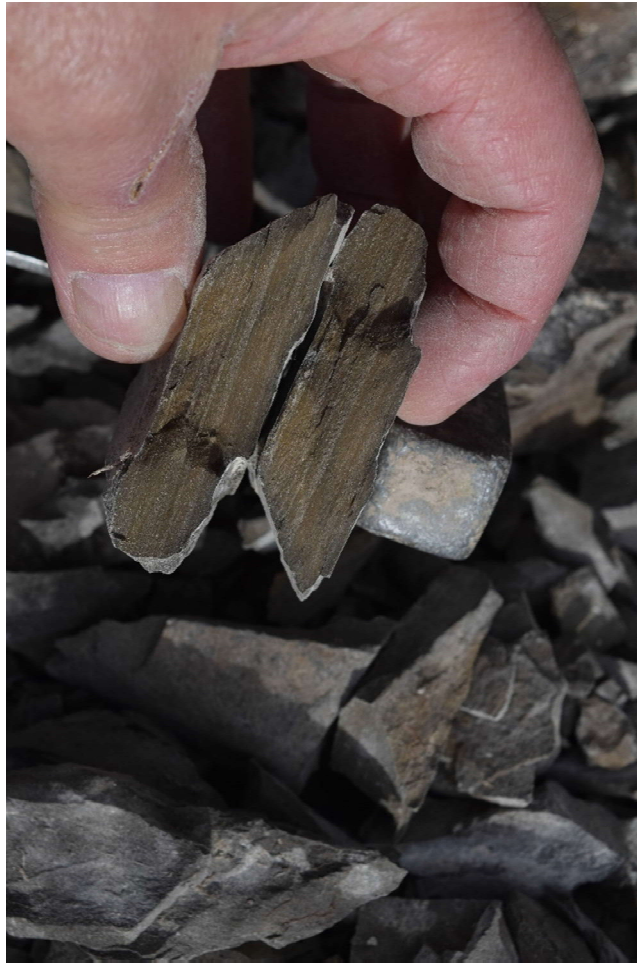
Photo 6. Close-up view of shale material.
