To: Jerald Schnabel From: Paul Kos
Continental Materials Corp. Denver, CO 80222
File: November 2021 Monitoring Summary Date: December 31, 2021

Reference: November 2021 Geotechnical Monitoring Summary Pikeview Quarry

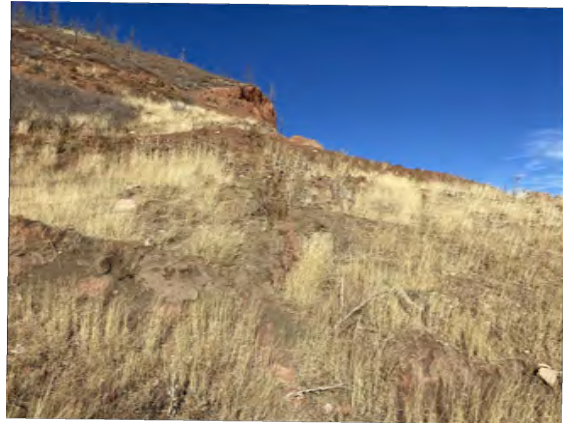
- Crack Free: No cracking was observed on the native granite slopes above the extents of the disturbed area. The hummocky field in the area immediately above the southern extent of the slide shows evidence of cracking but they are not fresh or active. No new or open cracks were found immediately inside or next to the slide area. (Photo 5 and 6)

6. SLOPES ON THE SOUTH END - UNCHANGED

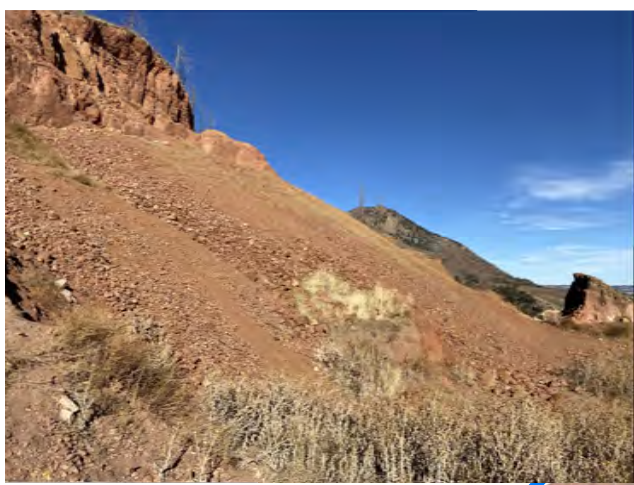
5. SLOPE BELOW SOUTH PEAK

NOTE 1:
NO CRACKS

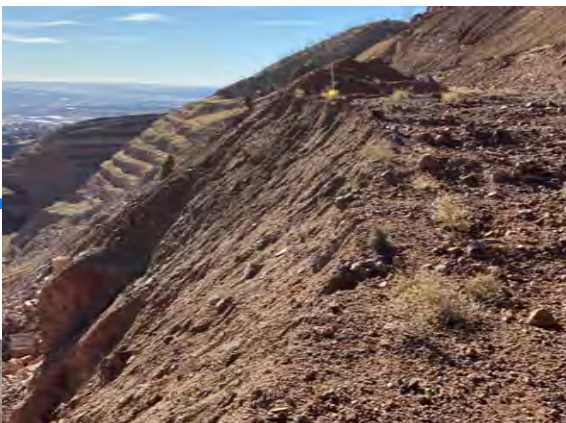
- Prisms: Several prisms were passed along the walking route and appeared to be in their original position and operating normally. Control points and most of the monitoring points are permanently cemented into the ground while some of the monitoring points are cemented into 5-gal buckets to be portable as needed. (Photo 4)

NOTE 1:
NO CRACKS

4. PRISM ABOVE SLIDE AREA AND BENCHES

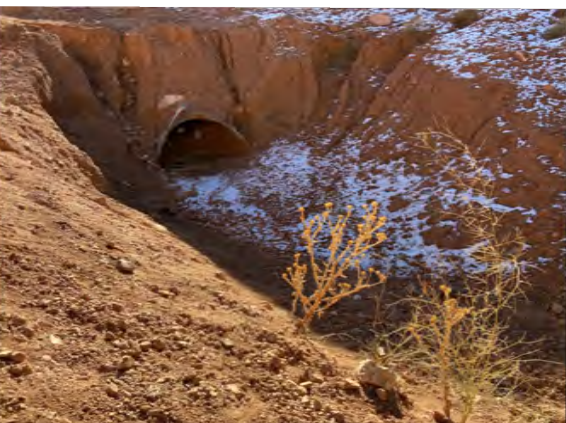
- The culvert remains cleared but mostly blocked inside. CMC has partially cleared the debris, but access limitations and supports within the culvert inhibit clearing all the debris. CMC has procured a pump and will begin pumping operations if any water collects behind the culvert. CMC inspects the culvert for ponded water following rain events, and should any water be observed, it will be removed using pumps. To date, no ponding has been observed. (Photo 3)

3. UPSTREAM END OF CULVERT WITH PIPE

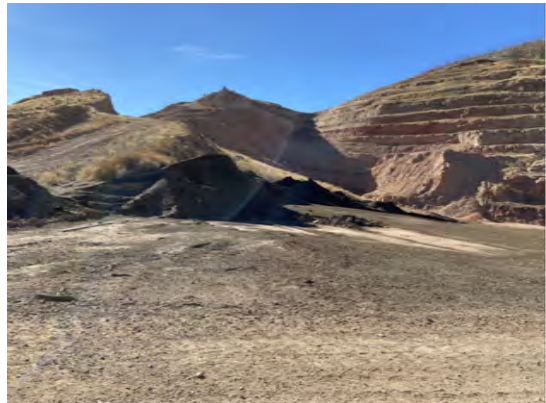
- Growth Medium: Mulch and soil are being processed on the production floor to produce growth medium. (Photo 7)
- Healed Cracks: Older cracks and recent cracks are being monitored for changes. Currently the cracks are not growing in any of the areas on the slopes of the site. (Photo 8)

7. GROWTH MEDIUM ON PRODUCTION FLOOR

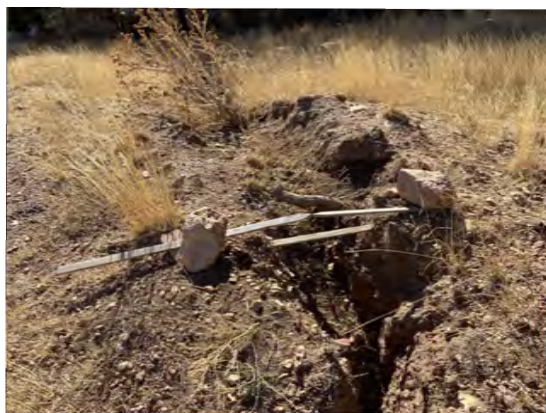
8. CRACKS ON THE SOUTH END - UNCHANGED

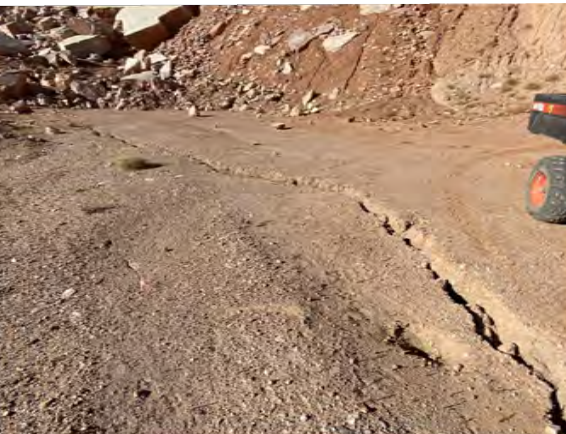
- Imported fill material and topsoil are being stockpiled in several areas on the production floor. (Photos 1)
- Previously Observed Cracks: Previously observed tension cracks remain on the production floor and at the crest of fill slopes. These cracks appeared the same as in previous inspections. (Photo 2)

2. CRACKING NEAR PRODUCTION FLOOR

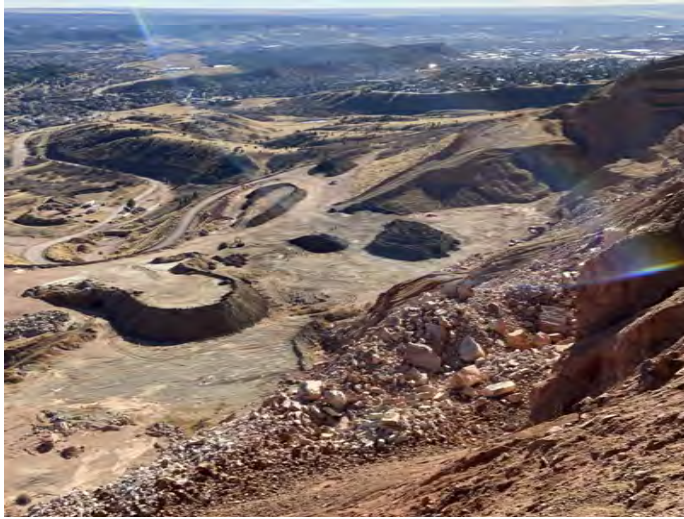
1. PIT AND STOCKILES ON THE PRODUCTION FLOOR

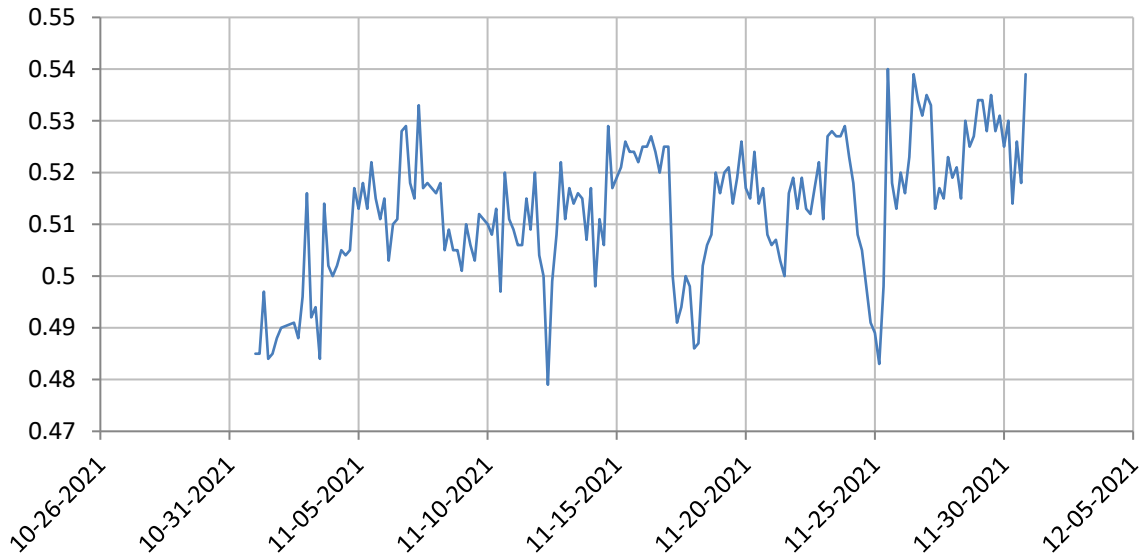
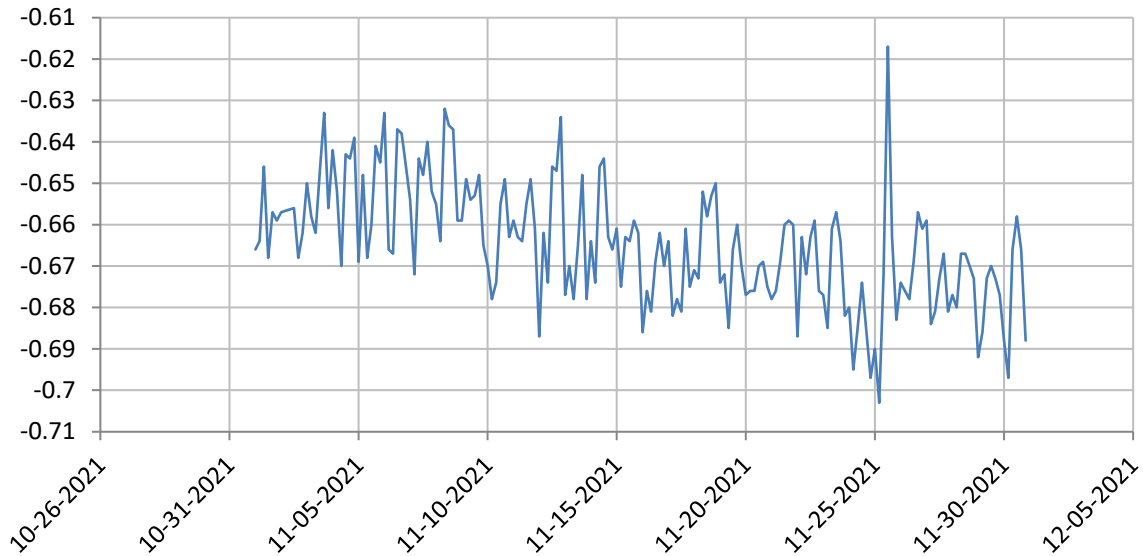
The data show stable conditions with no movement for 17 of 20 prisms with recorded displacements limited to data scatter and not actual movements. Prisms P63 and TOE3 are located at the toe of the landslide, and these locations showed slope creep movements at slow velocities (approximately 0.001 feet per day or less). Prism NP66 is located above the landslide, and this prism also recorded slope creep movements at slow

1. Survey accuracy is ± 0.016 feet.
2. Alarm threshold is ± 0.35 feet.
3. Transverse displacement is in the horizontal direction. Positive direction means closer to the robotic station.
4. Height displacement is in the vertical direction. Positive direction means higher in elevation.
5. Slope creep movements at slow velocity.

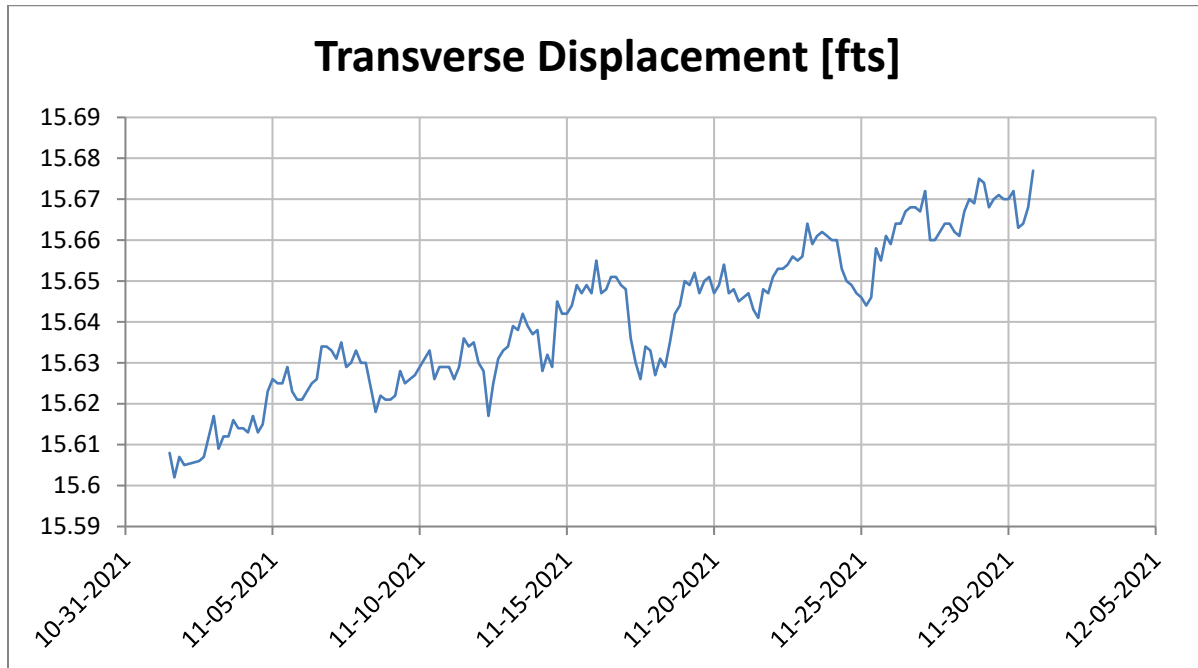
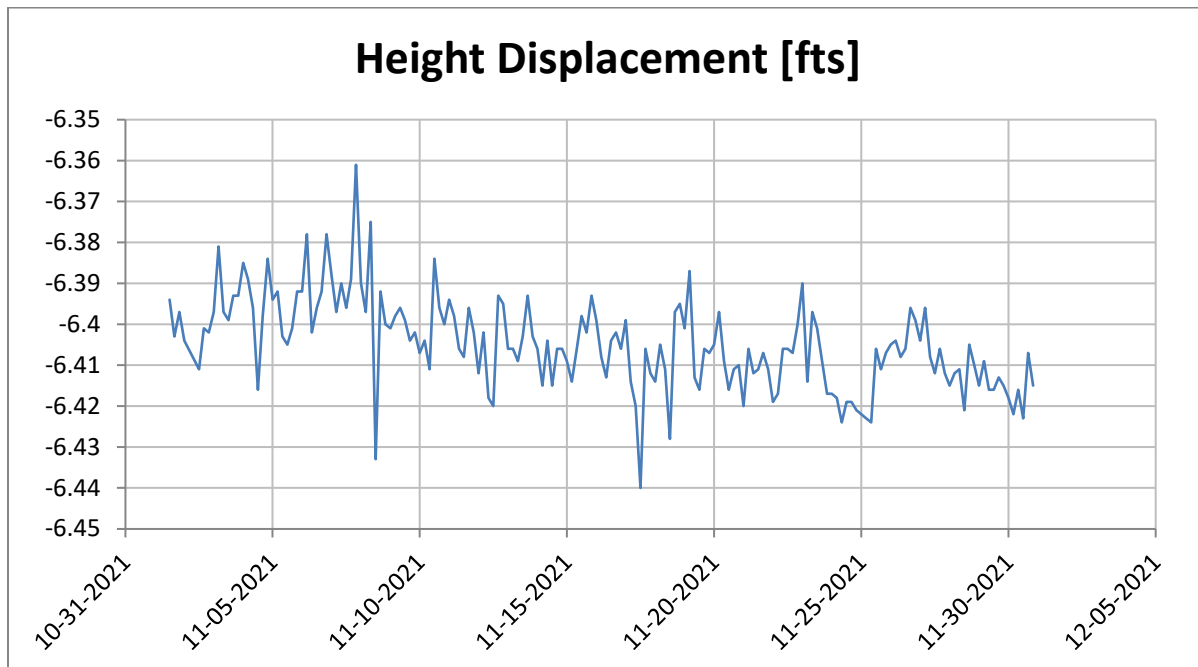
Prism P63

1. Survey accuracy is ± 0.016 feet.
2. Alarm threshold is ± 0.35 feet.
3. Transverse displacement is in the horizontal direction. Positive direction means closer to the robotic station.
4. Height displacement is in the vertical direction. Positive direction means higher in elevation.
5. Slope creep movements at slow velocity.

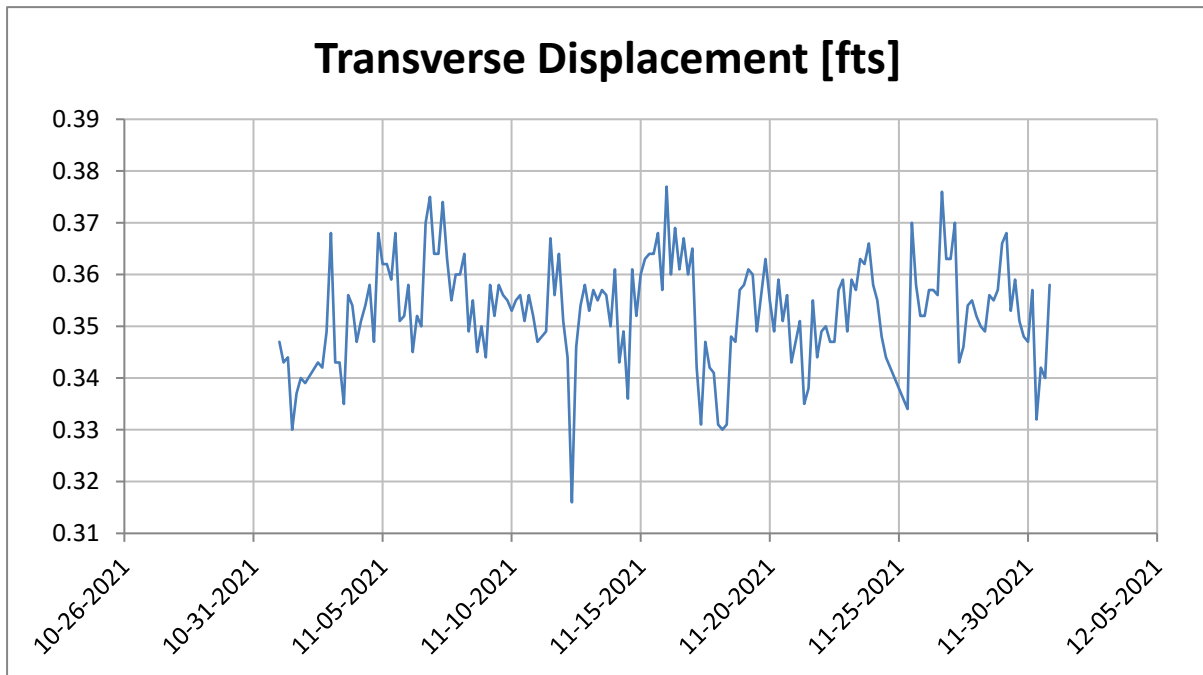
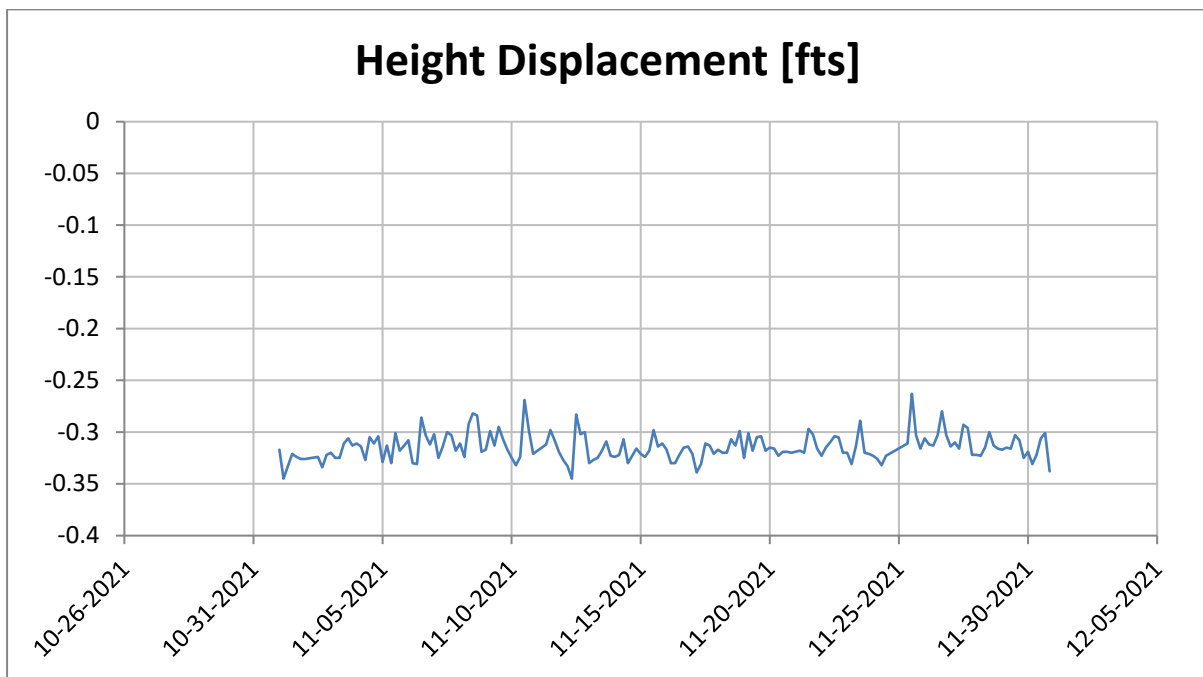
Prism P70

Date(s)	Alarm	Cause/Actions taken	Issue Resolved
11/01/2021– 11/02/2021	All prisms could not be found on multiple scans	Fog and Frost. Operators worked away from the toe area on this day.	11/02/2021
11/21/2021	P70 could not be found on multiple scans	Location inspected and no evidence of movement was found. Droppings present at location, and possibly moved or blocked by wildlife.	11/21/2021
11/24/2021– 11/25/2021	All prisms could not be found on multiple scans	Fog and Frost. Site closed and empty for Thanksgiving holiday.	11/25/2021
11/28/2021	P25 regression limit check level 1 exceeded	Location inspected and no evidence of movement was found. Droppings present at location, and possibly moved or blocked by wildlife.	11/28/2021

1. Survey accuracy is ± 0.016 feet.
2. Alarm threshold is ± 0.35 feet.
3. Transverse displacement is in the horizontal direction. Positive direction means closer to the robotic station.
4. Height displacement is in the vertical direction. Positive direction means higher in elevation.
5. Level 1 Regression alarm on November 28. Likely caused by wildlife.

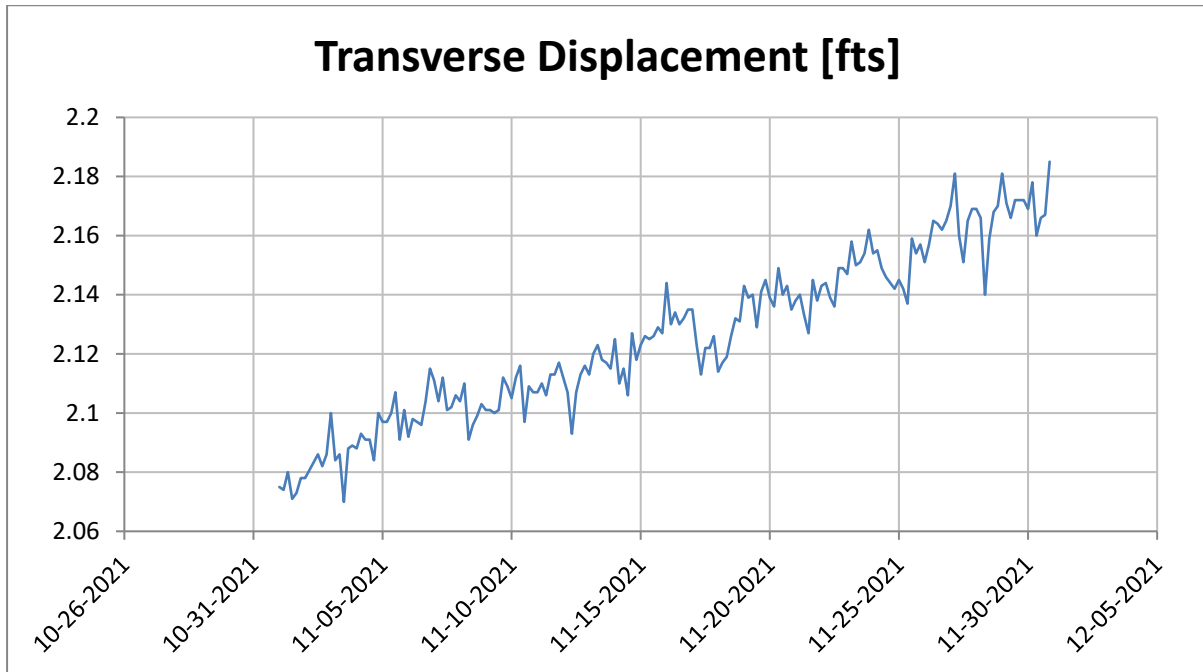
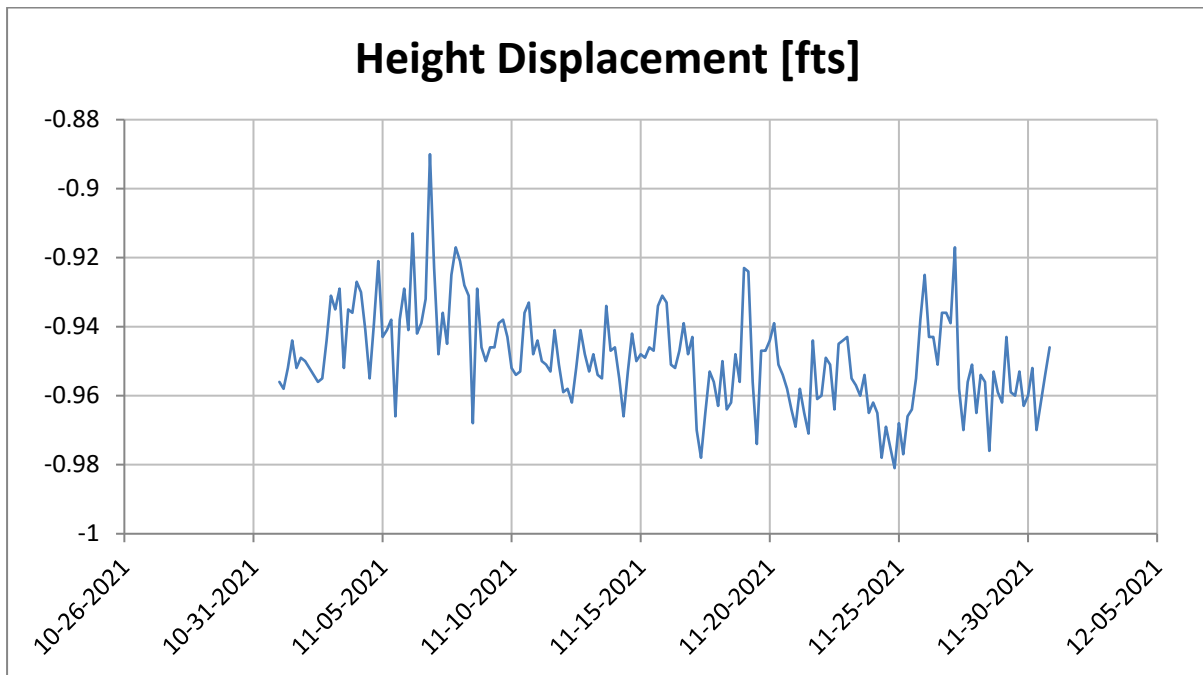
Prism TOE3

1. Survey accuracy is ± 0.016 feet.
2. Alarm threshold is ± 0.35 feet.
3. Transverse displacement is in the horizontal direction. Positive direction means closer to the robotic station.
4. Height displacement is in the vertical direction. Positive direction means higher in elevation.
5. Slope creep movements with slow velocity.
