**Mountain Coal Company, LLC**  
A subsidiary of Arch Resources, Inc.  
West Elk Mine  
5174 Highway 133  
Somerset, CO 81434

January 3, 2022

**Re: Mountain Coal Company, LLC - West Elk Mine, CDRMS Permit No. C-1980-007  
Pond and Mine Site Quarterly Self-Inspection Reports –4<sup>th</sup> Quarter 2021**

**Mountain Coal Company, LLC- West Elk Mine**  
**Quarterly Self Mine Site Inspection Report**  
**Somerset, Colorado Gunnison County**

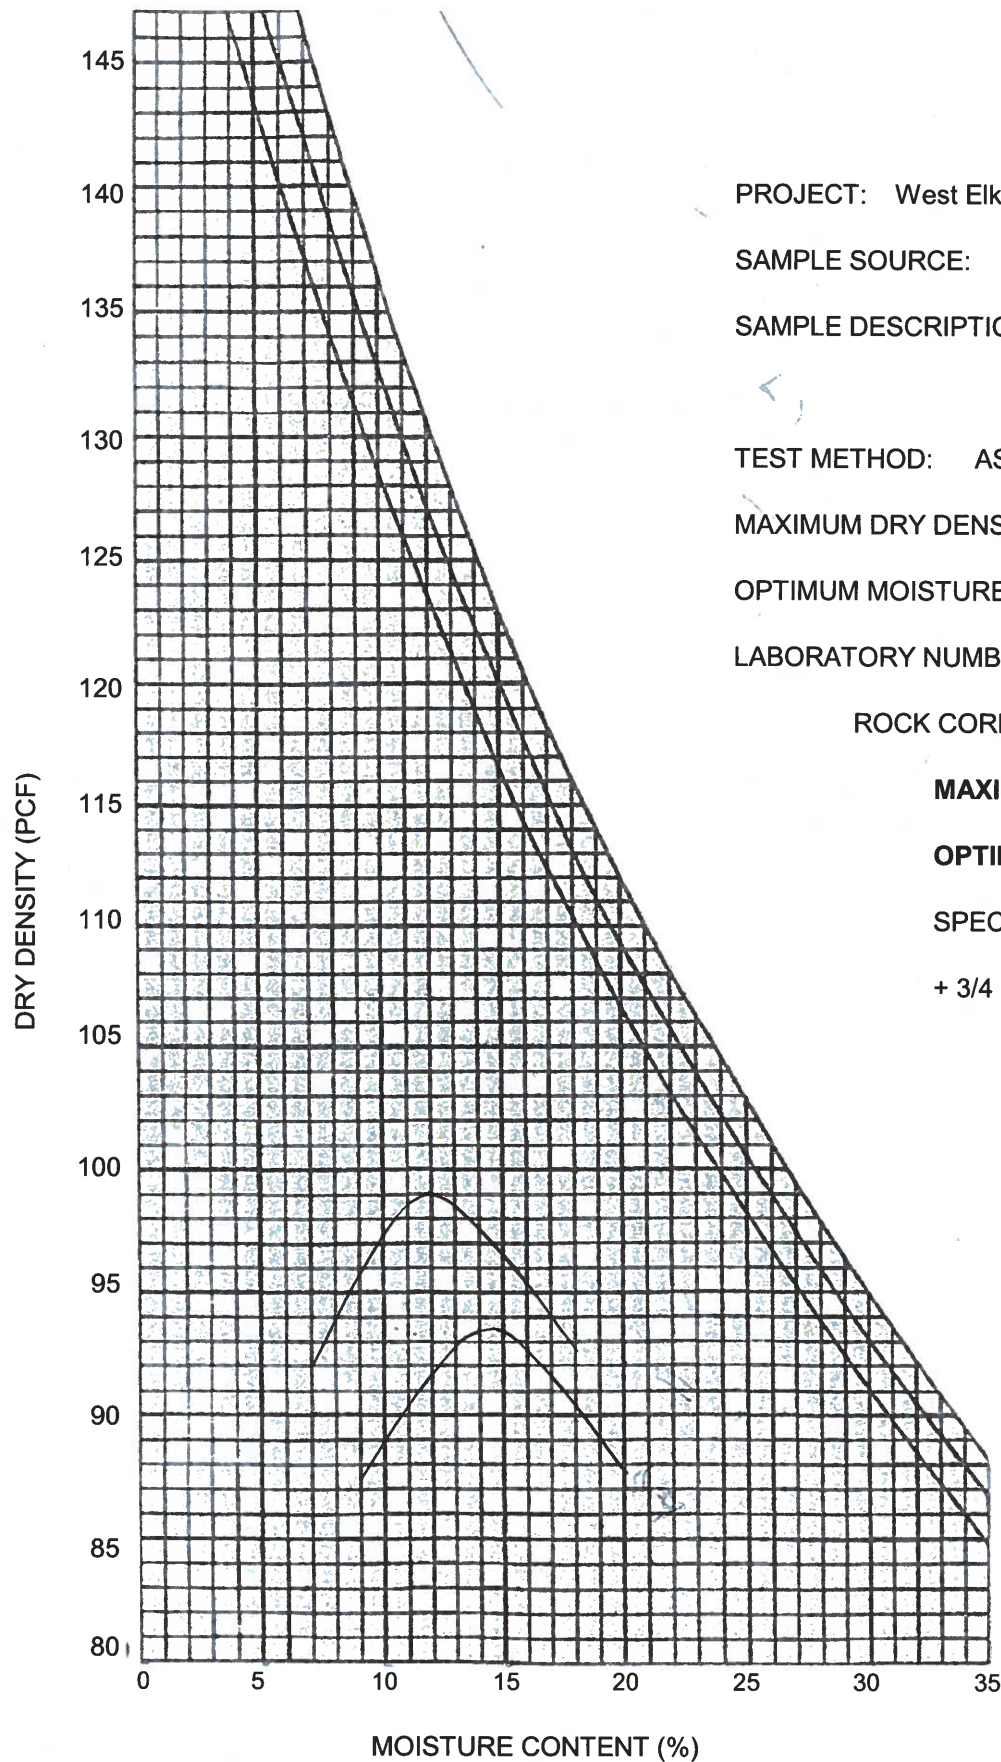
Figure: 1

SAMPLE DESCRIPTION: Coal Gob, Black

TEST METHOD: ASTM D698C

MAXIMUM DRY DENSITY: 93.5 pcf

OPTIMUM MOISTURE CONTENT: 14.5 %

**MAXIMUM DRY DENSITY: 99.0 pcf**

**OPTIMUM MOISTURE CONTENT: 12.0%**
