**MINERALS PROGRAM INSPECTION REPORT**  
**PHONE: (303) 866-3567**

<b>MINE NAME:</b> Golden Wonder Mine	<b>MINE/PROSPECTING ID#:</b> M-1978-091-UG	<b>MINERAL:</b> Gold	<b>COUNTY:</b> Hinsdale
<b>INSPECTION TYPE:</b> Multi Person Inspection	<b>INSPECTOR(S):</b> Lucas West	<b>INSP. DATE:</b> December 8, 2021	<b>INSP. TIME:</b> 11:15
<b>OPERATOR:</b> LKA International Inc.	<b>OPERATOR REPRESENTATIVE:</b> Kye Abraham	<b>TYPE OF OPERATION:</b> 110d - Designated Limited Impact	
<b>REASON FOR INSPECTION:</b> High Priority	<b>BOND CALCULATION TYPE:</b> None	<b>BOND AMOUNT:</b> \$136,046.10	
<b>DATE OF COMPLAINT:</b> NA	<b>POST INSP. CONTACTS:</b> None	<b>JOINT INSP. AGENCY:</b> None	
<b>WEATHER:</b> Cloudy	<b>INSPECTOR'S SIGNATURE:</b>

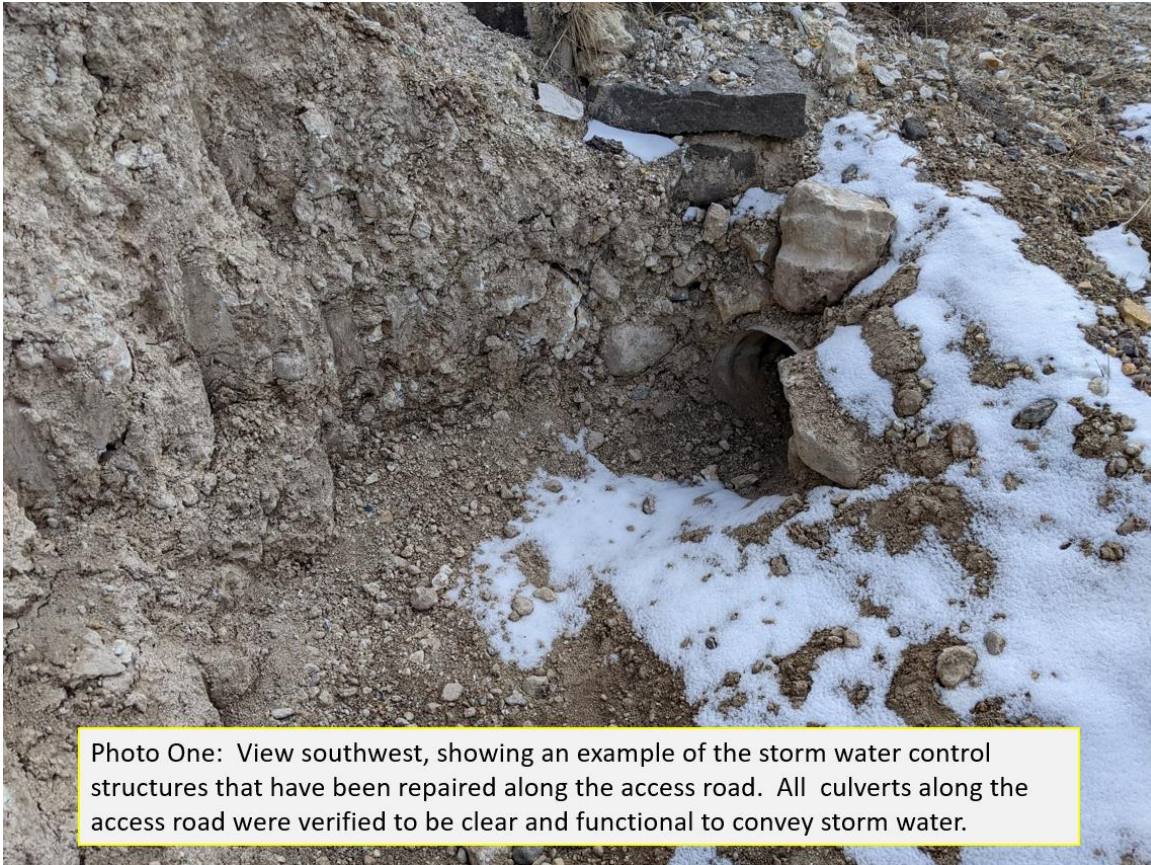
Photo One: View southwest, showing an example of the storm water control structures that have been repaired along the access road. All culverts along the access road were verified to be clear and functional to convey storm water.

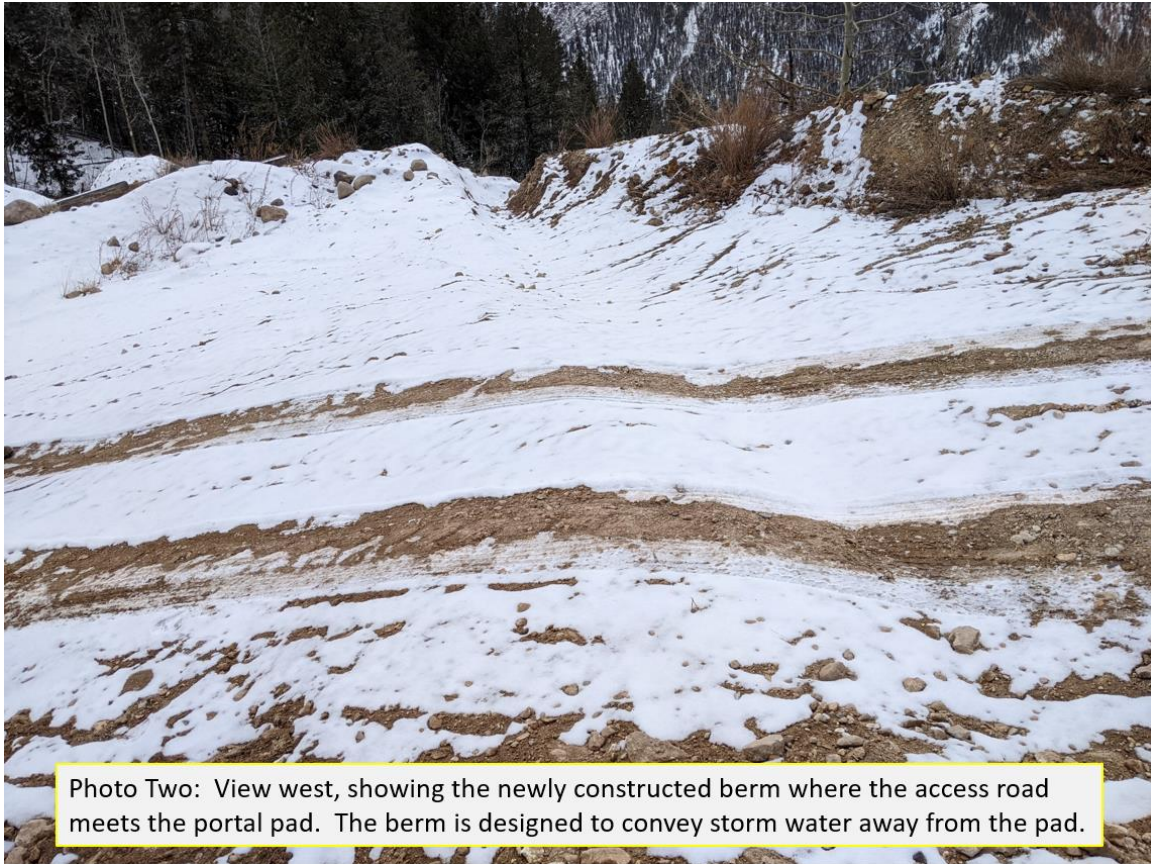
In general, the Corrective Actions required were for the Operator to repair the Storm Water Control Structures located along the access road to prevent additional storm water from entering the pad area, repair the water conveyance structures delivering water from the portal discharge to the Mine Water Pond, make repairs to the Water Treatment System and resume treating and discharging water from the Mine Water and Storm Water Ponds. All treatment and discharging activities are to be done in compliance with the approved DRMS and CDPHE Permits. The storm water control structures, specifically culverts used to divert storm water away from the pad, have been cleaned out and repaired. An example one of the culverts can be seen in Photo One. Additionally the Operator constructed a small berm where the access road meets the portal pad. The berm is designed to assist in diverting storm water and can be seen in Photo Two.

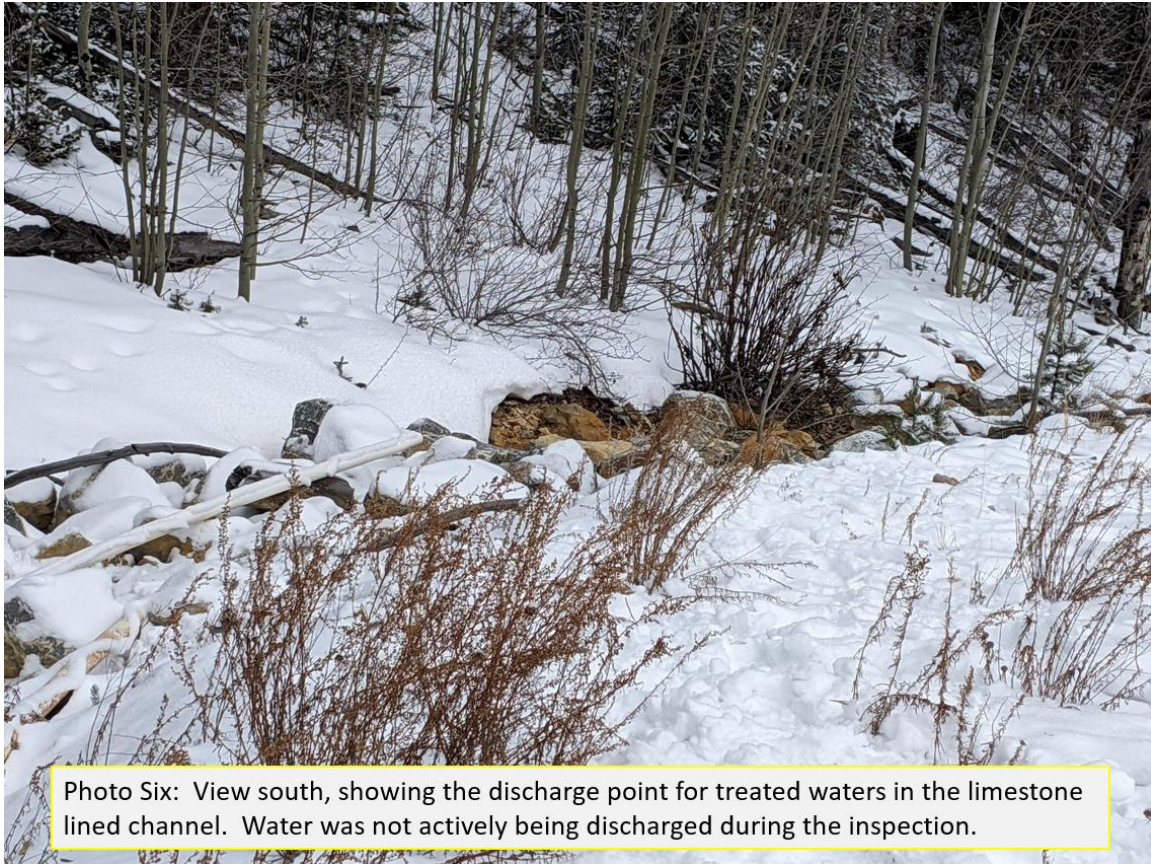
During the inspection, water treatment operations were actively being conducted. Water from the Mine Water Pond was being pumped into the 5,000 gallon treatment tank, where chemicals were being added to adjust the pH and precipitate out metals. Once the precipitant had settled, the sludge was pumped to a smaller holding tank, and treated water was tested and discharged. The condition of the Mine Water Pond can be seen in Photo Three. Photo Four shows the tanks being utilized in the treatment process. Discussions with the Operator indicate that once the Mine Water Pond was pumped down sufficiently the Storm Water Pond would be pumped and treated in the same manner. Photo Five shows the condition of the Storm Water Pond as observed at the time of the inspection. The treated water is being conveyed down the limestone channel via PVC pipe and discharged as seen in Photo Six.

Photo Six: View south, showing the discharge point for treated waters in the limestone lined channel. Water was not actively being discharged during the inspection.

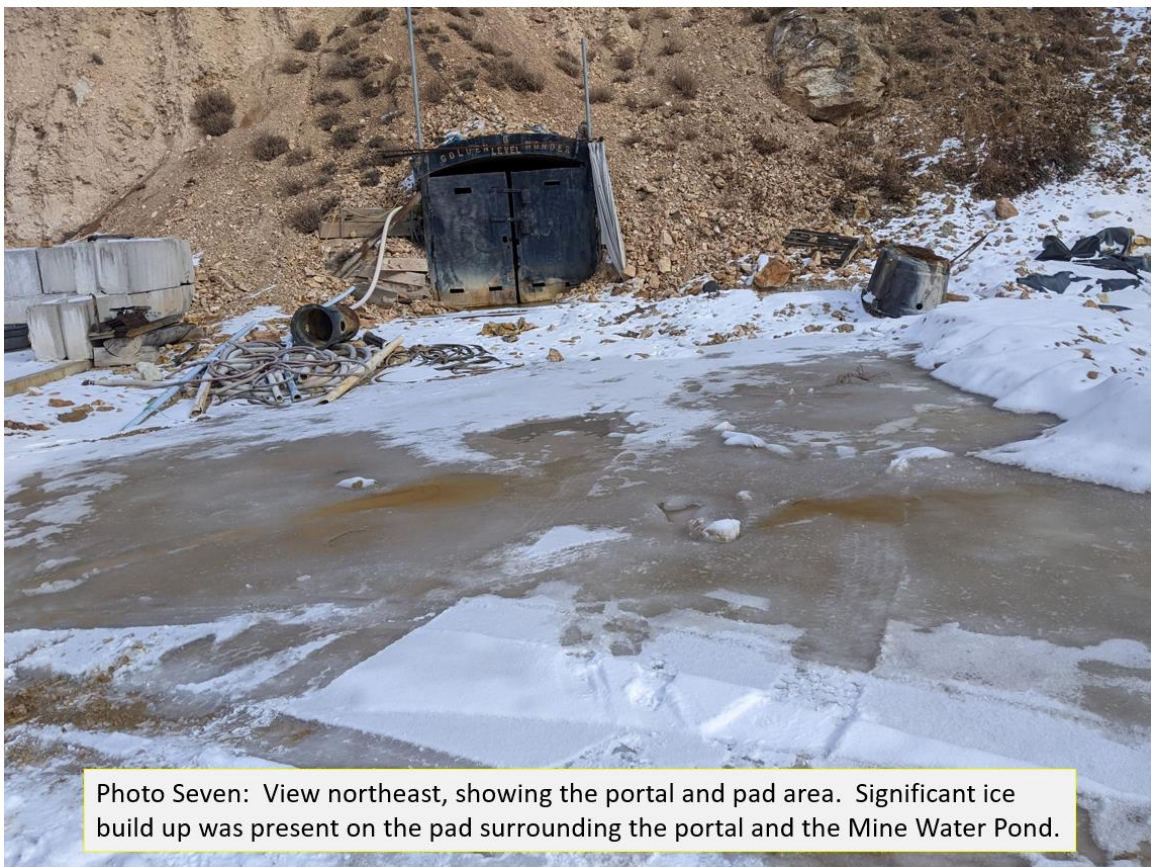
The portal pad is covered in a considerable amount of ice, suggesting that additional surface flow was present prior to the freezing temperatures and has caused ice to accumulate on the pad. The pad and portal can be seen in Photo Seven. The conveyance system designed to deliver mine discharge water to the Mine Water Pond appears to have been cleared, and no flowing discharge was observed. Photo Eight shows the conveyance system.

Photo Seven: View northeast, showing the portal and pad area. Significant ice build up was present on the pad surrounding the portal and the Mine Water Pond.

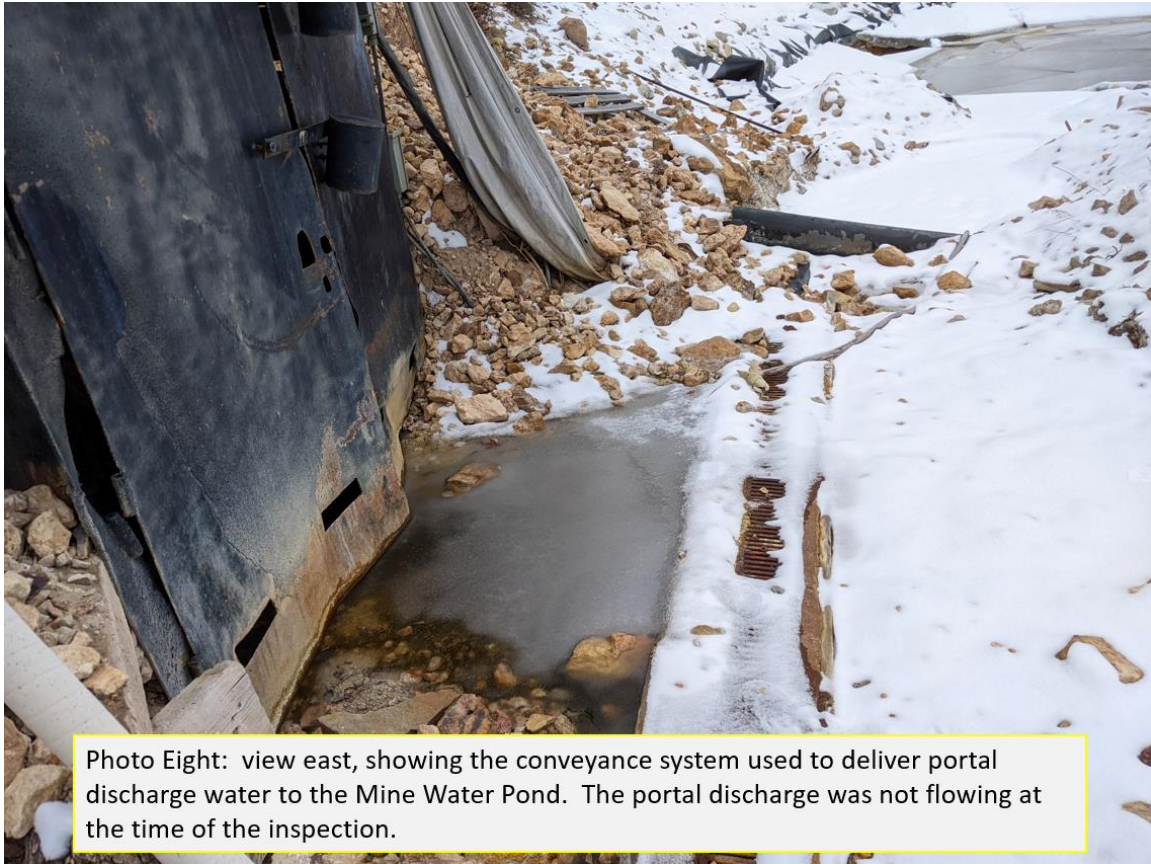
Photo Eight: view east, showing the conveyance system used to deliver portal discharge water to the Mine Water Pond. The portal discharge was not flowing at the time of the inspection.
