MINERALS PROGRAM INSPECTION REPORT
PHONE: (303) 866-3567

MINE NAME: Burros Mine	MINE/PROSPECTING ID#: M-1977-297	MINERAL: Uranium and vanadium	COUNTY: San Miguel
INSPECTION TYPE: Multi Person Inspection	INSPECTOR(S): Lucas West	INSP. DATE: December 9, 2021	INSP. TIME: 12:01
OPERATOR: Gold Eagle Mining, Inc.	OPERATOR REPRESENTATIVE: Don Coram	TYPE OF OPERATION: 110d - Designated Limited Impact	
REASON FOR INSPECTION: Normal I&E Program	BOND CALCULATION TYPE: None	BOND AMOUNT: \$100.00	
DATE OF COMPLAINT: NA	POST INSP. CONTACTS: None	JOINT INSP. AGENCY: None	
WEATHER: Cloudy	INSPECTOR'S SIGNATURE:

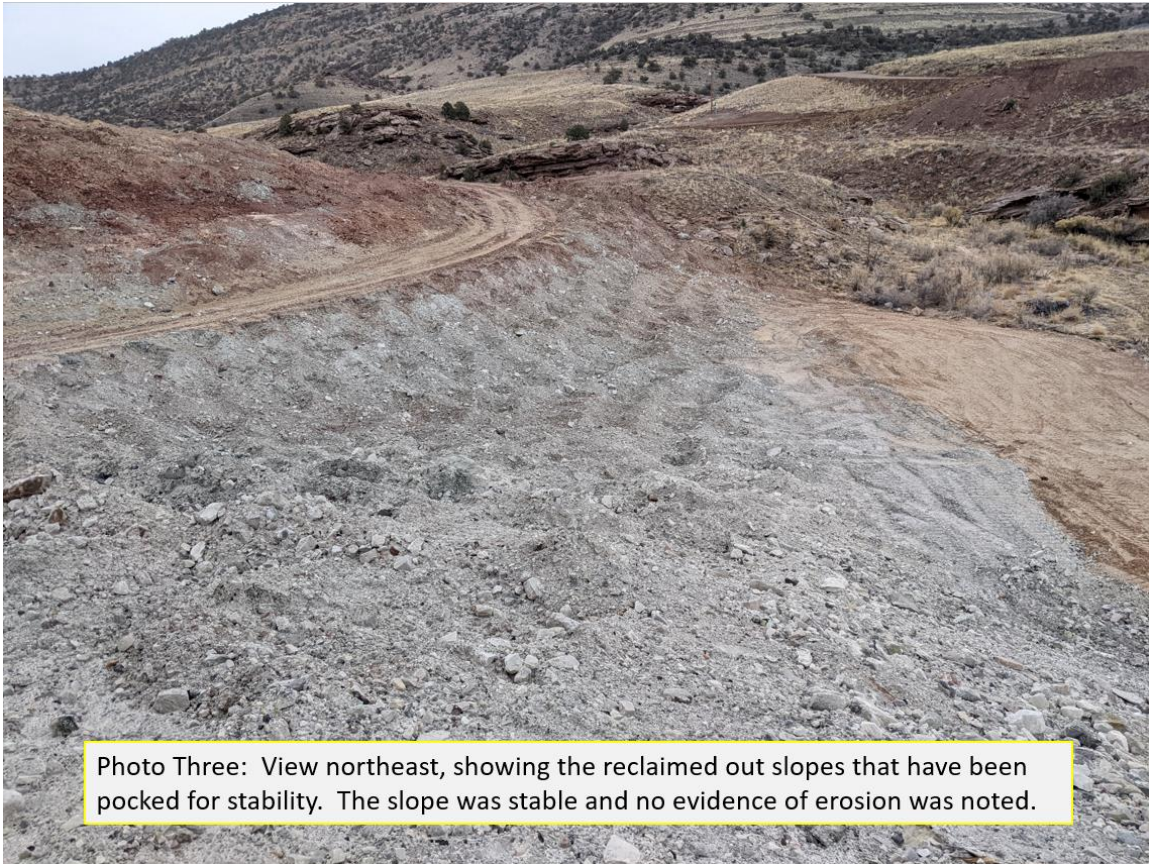
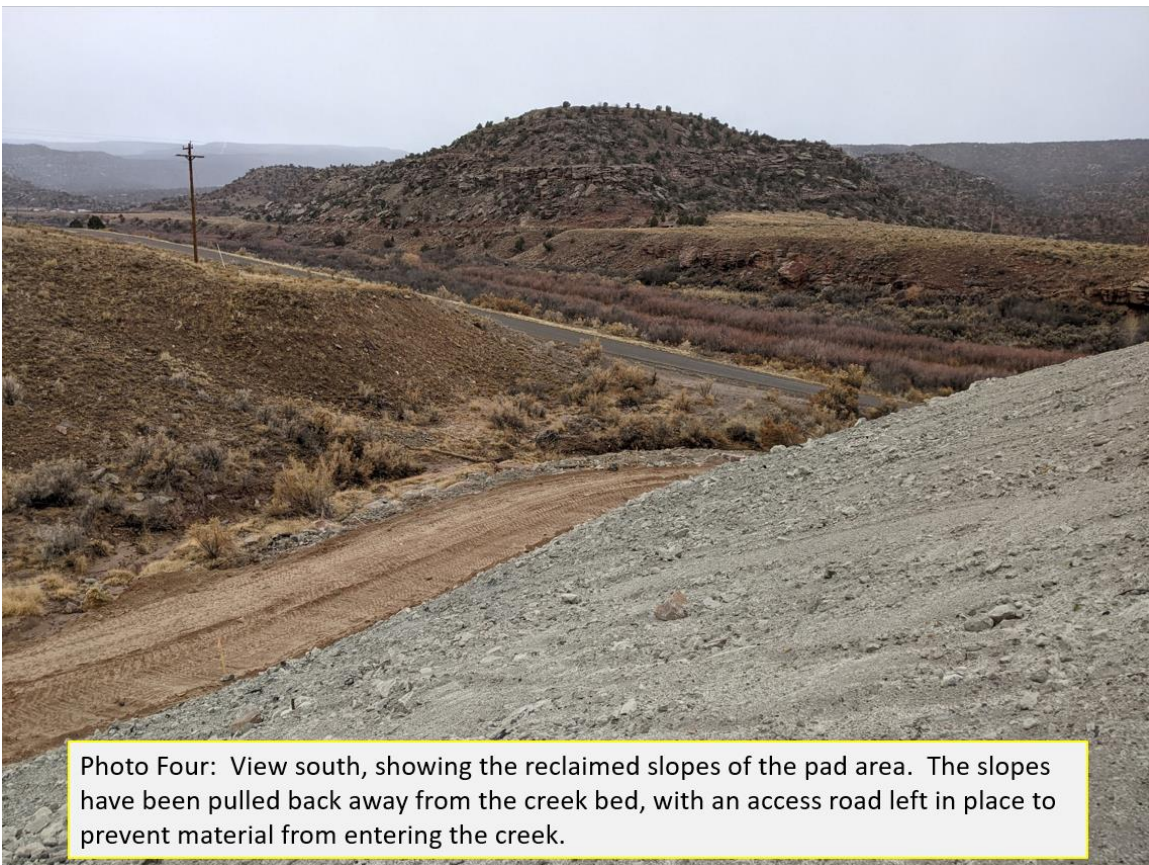
The primary focus of this inspection was to observe the conditions of the site after the completion of the DOE materials relocation project. As part of the project, the DOE and its contractor relocated a series of stockpile to a chosen nearby repository facility. The stockpiles were located on a large storage pad adjacent to the Burro Tunnel Portal. The work also included regrading of the slopes on the storage pad, armoring of sediment control features around the portal and other general regrading of the site. The pad where the stockpiles were located can be seen in Photos One and Two. The top of the pad was stable at the time of the inspection and clear of all materials. The out slopes have been regraded to pull the toe away from the dry creek bed of Burro Creek to prevent sediment from entering the creek. A portion of the slopes have been pocked for stability, and all out slopes observed appeared to be stable at the time of the inspection. Examples of the pocking and out slopes can be seen in Photos Three and Four. No erosion or stability concerns were observed.

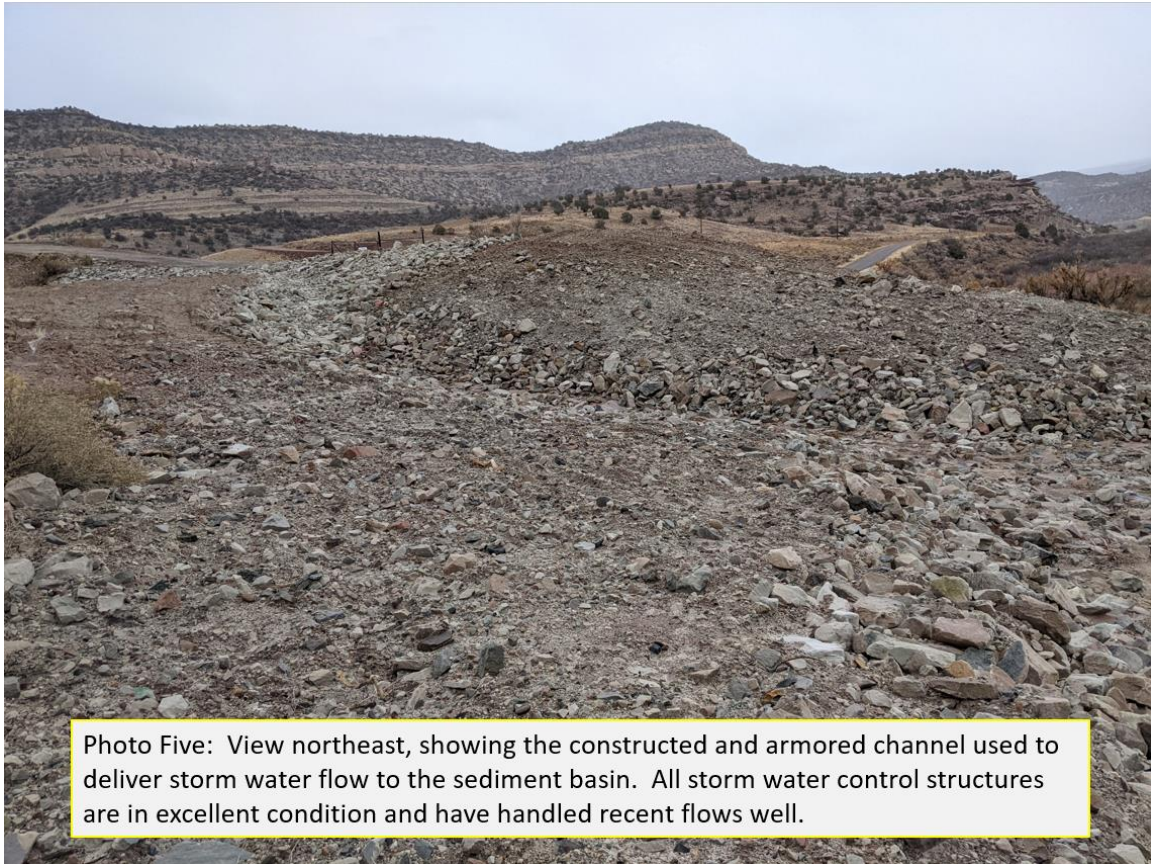
Other work included armoring and upgrading the storm water control features to divert storm water flow from the affected lands to a sediment basin near the county road, adjacent to a historic ore hopper located on site. The features were in excellent condition, and have handled recent storm water flows very well. The channels are rock lined, leading to the sediment basin. An example of the channels can be seen in Photo Five. Photo Six shows the sediment basin as well as the historic ore hopper.

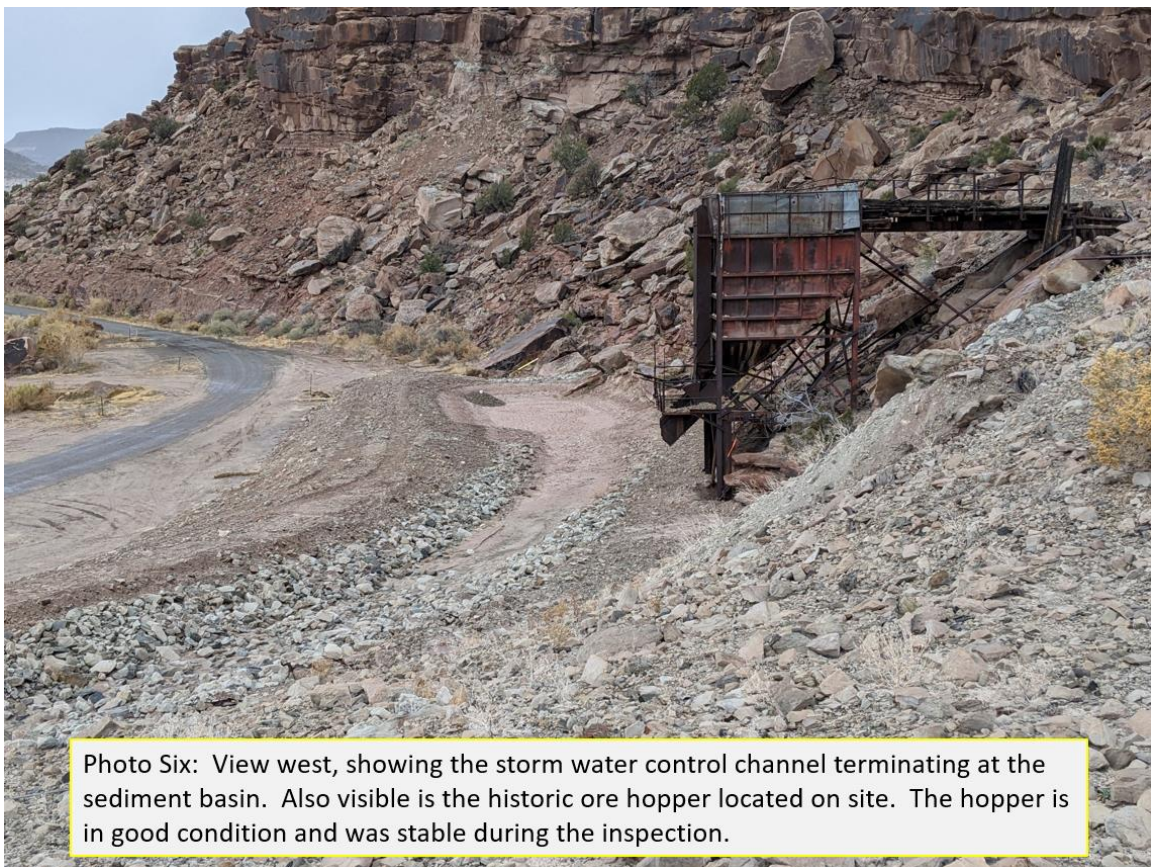
The ore hopper was stable at the time of the inspection and in good condition. On site discussions centered around the preservation of the hopper, and possible securing efforts to prevent trespassing. The Operator expressed interest in leaving the structure as a permanent structure, which should be addressed through the Technical Revision Process, which was also discussed in length. The portal of the Burro Tunnel was observed, and verified to be secure as seen in Photo Seven. The portal is closed with a locking metal gate closure and shows no signs of vandalism or attempted unauthorized entry. Various items including historic air lines and other items surround the portal.

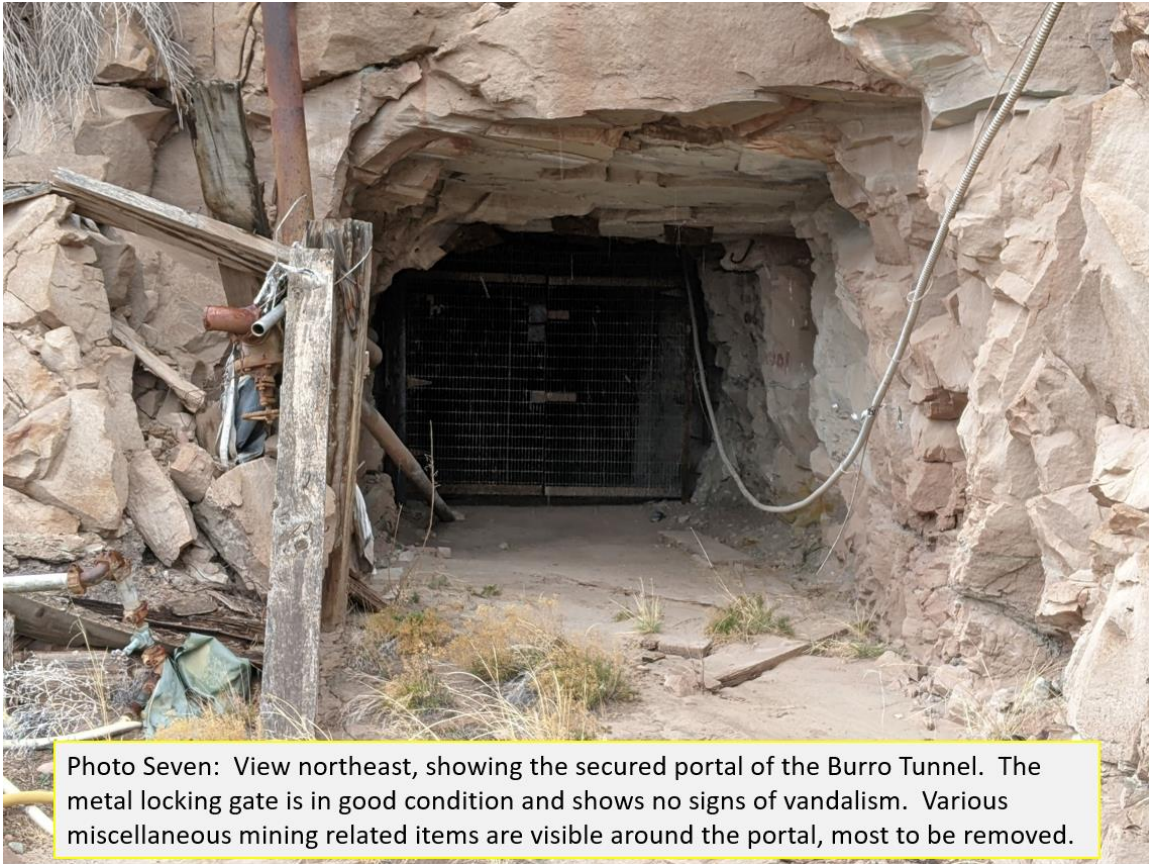
Photo Seven: View northeast, showing the secured portal of the Burro Tunnel. The metal locking gate is in good condition and shows no signs of vandalism. Various miscellaneous mining related items are visible around the portal, most to be removed.
