MINERALS PROGRAM INSPECTION REPORT
PHONE: (303) 866-3567

MINE NAME: Ellison Mine	MINE/PROSPECTING ID#: M-1978-342	MINERAL: Uranium and vanadium	COUNTY: San Miguel
INSPECTION TYPE: Multi Person Inspection	INSPECTOR(S): Lucas West	INSP. DATE: December 9, 2021	INSP. TIME: 12:55
OPERATOR: Gold Eagle Mining, Inc.	OPERATOR REPRESENTATIVE: Don Coram	TYPE OF OPERATION: 110d - Designated Limited Impact	
REASON FOR INSPECTION: Normal I&E Program	BOND CALCULATION TYPE: None	BOND AMOUNT: \$100.00	
DATE OF COMPLAINT: NA	POST INSP. CONTACTS: None	JOINT INSP. AGENCY: None	
WEATHER: Cloudy	INSPECTOR'S SIGNATURE:

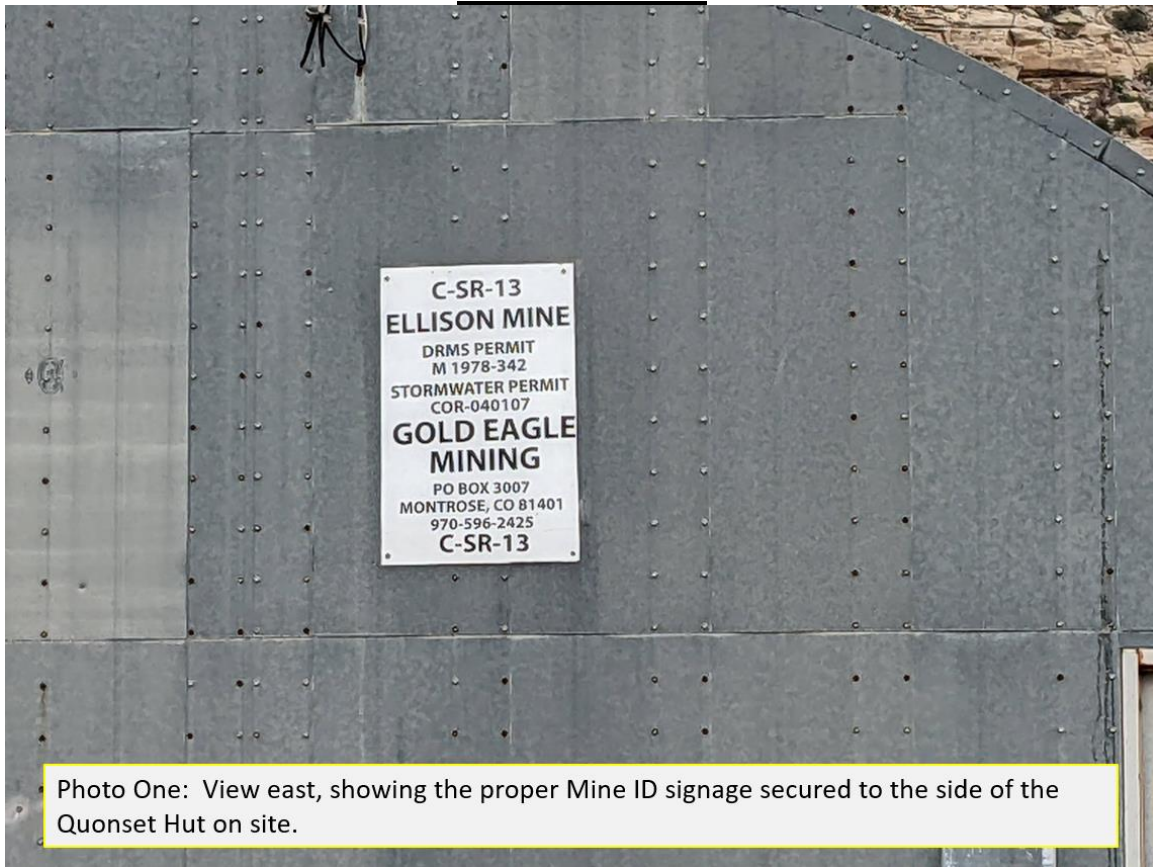
The proper Mine Identification sign was posted near the entrance to the site on the Quonset Hut shown in Photo One. Photo Two shows the Quonset hut style structure located on site. The structure was secure and in good condition at the time of this inspection. Also located on is a shipping container used for storage that was also secured and in good condition. The main pad and work area that the structure, container and portal are located on was in good condition and well vegetated with native grasses and shrubs. The shipping container can be seen in Photo Three. The portal, shown in Photo Four is enforced with a Quonset style structure leading underground, and secured with a locked, welded steel grate. All components associated with the portal are in good condition and show no signs of attempted unauthorized entry.

Photo One: View east, showing the proper Mine ID signage secured to the side of the Quonset Hut on site.

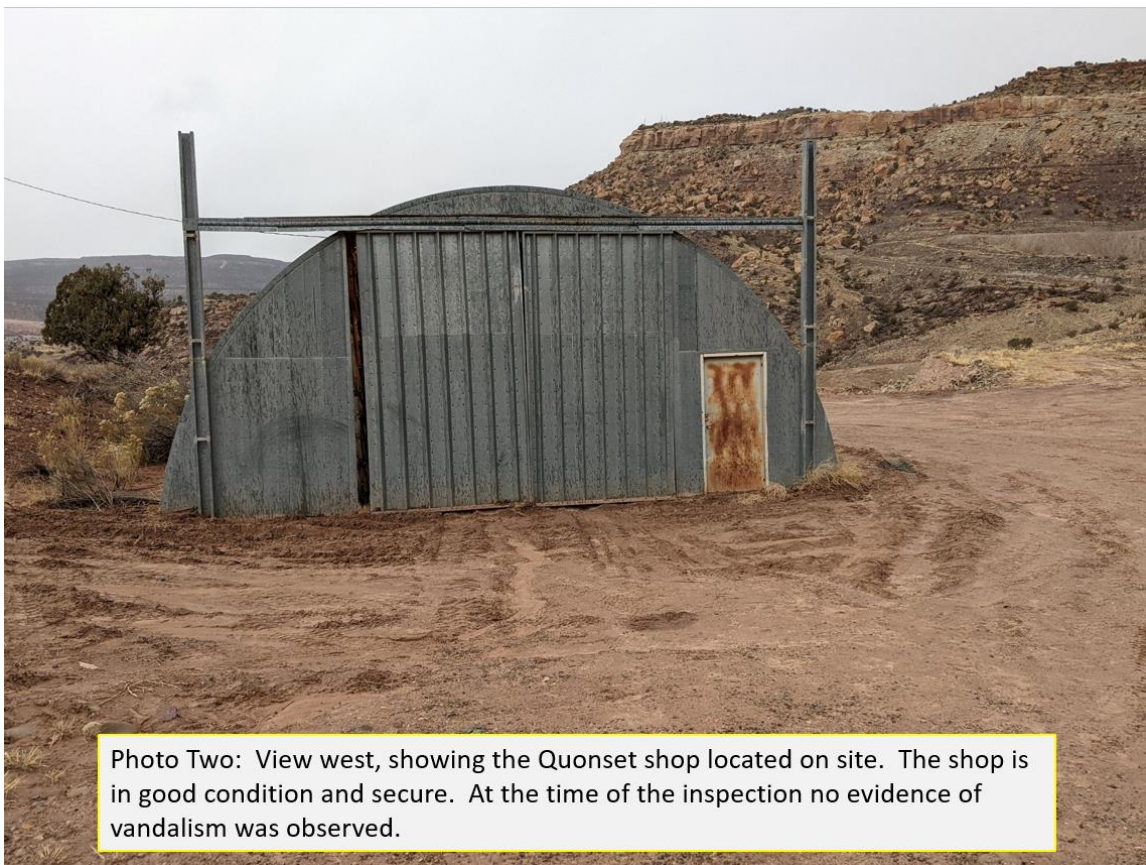
Photo Two: View west, showing the Quonset shop located on site. The shop is in good condition and secure. At the time of the inspection no evidence of vandalism was observed.

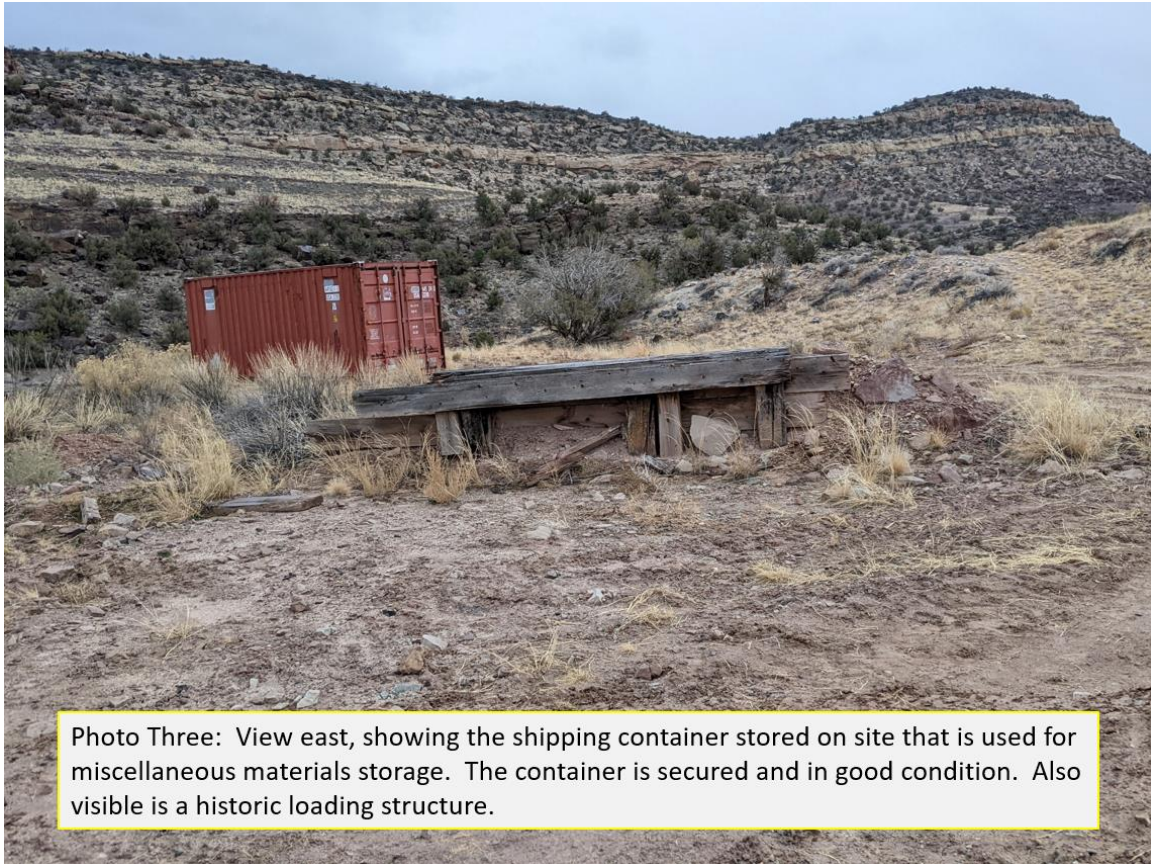
Photo Three: View east, showing the shipping container stored on site that is used for miscellaneous materials storage. The container is secured and in good condition. Also visible is a historic loading structure.

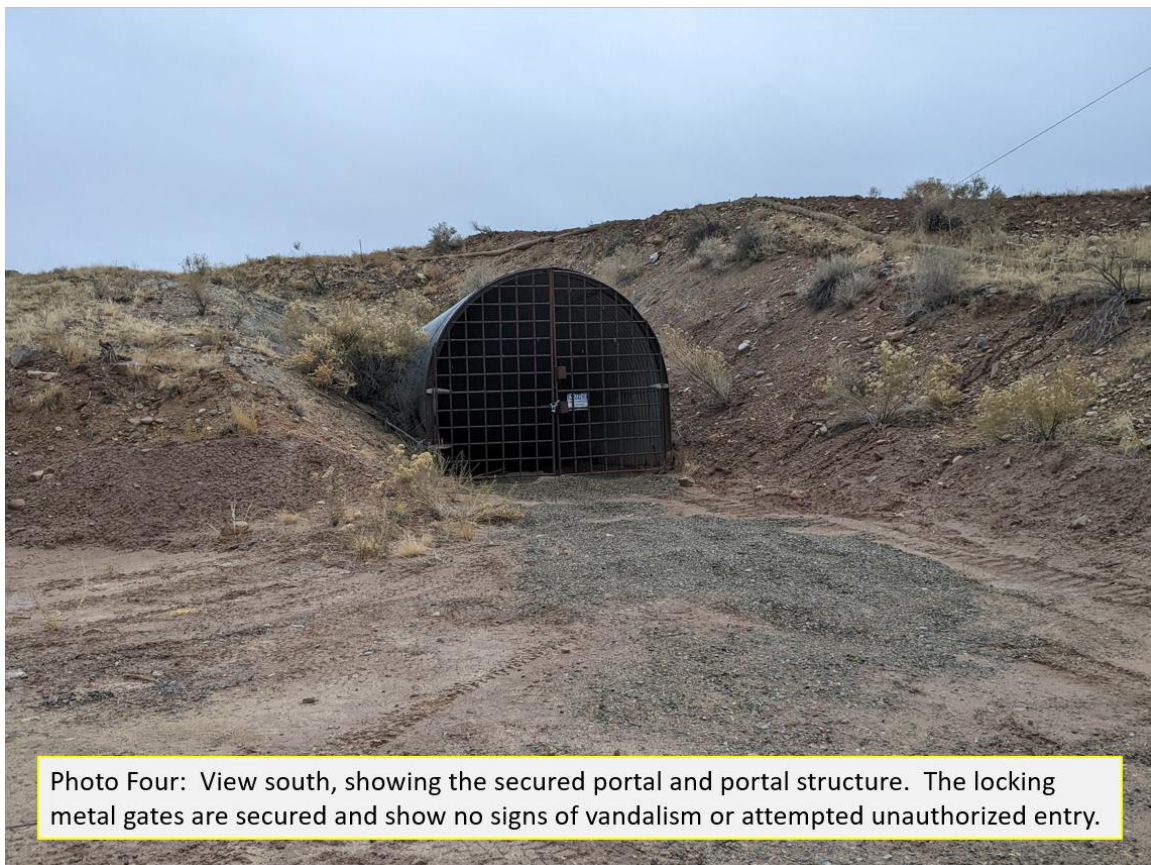
Photo Four: View south, showing the secured portal and portal structure. The locking metal gates are secured and show no signs of vandalism or attempted unauthorized entry.
