MINERALS PROGRAM INSPECTION REPORT
PHONE: (303) 866-3567

MINE NAME: Hawkeye Mine	MINE/PROSPECTING ID#: M-1978-311	MINERAL: Uranium and vanadium	COUNTY: San Miguel
INSPECTION TYPE: Multi Person Inspection	INSPECTOR(S): Lucas West	INSP. DATE: December 9, 2021	INSP. TIME: 13:21
OPERATOR: Gold Eagle Mining, Inc.	OPERATOR REPRESENTATIVE: Don Coram	TYPE OF OPERATION: 110d - Designated Limited Impact	
REASON FOR INSPECTION: Normal I&E Program	BOND CALCULATION TYPE:	BOND AMOUNT: \$100.00	
DATE OF COMPLAINT: NA	POST INSP. CONTACTS: None	JOINT INSP. AGENCY: None	
WEATHER: Cloudy	INSPECTOR'S SIGNATURE:

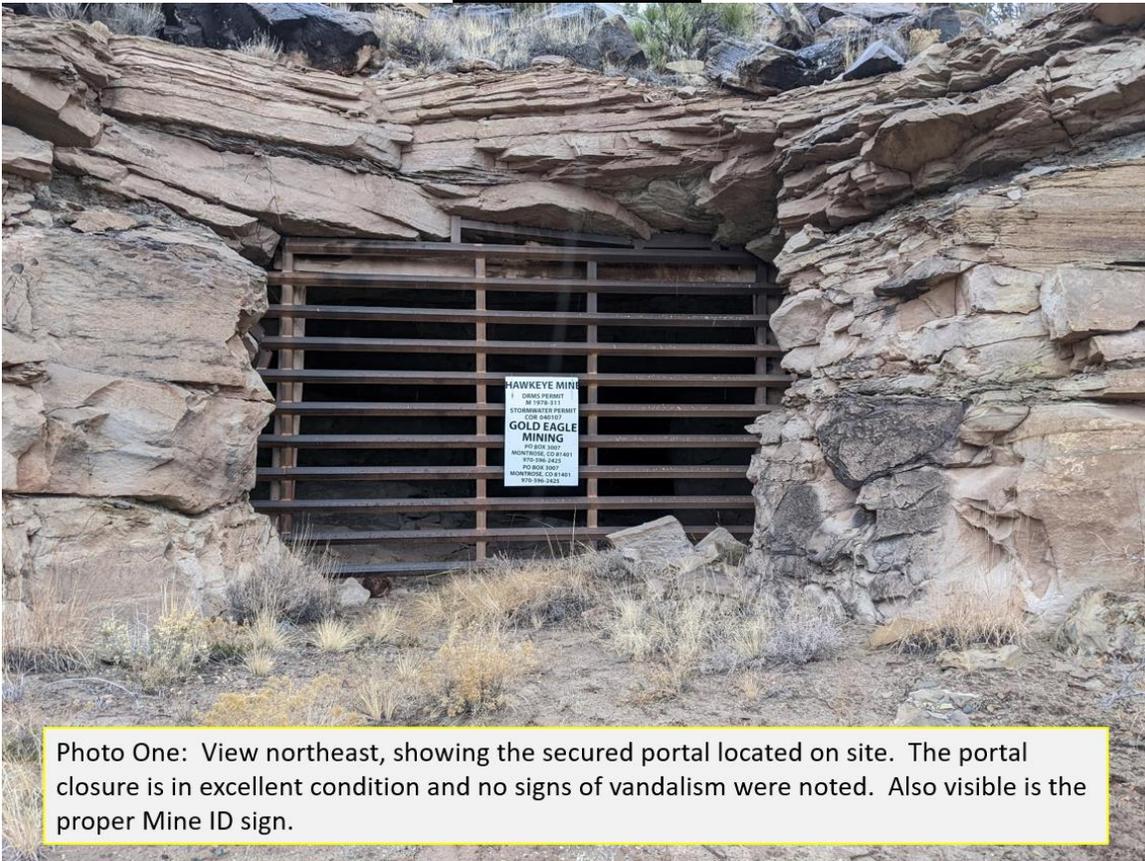
The site contains a secured portal onsite leading to the underground workings that is closed with a welded steel closure. The portal closure, seen in Photo One, is stable and in good condition. The proper Mine Identification signage is secured to the portal closure. It shows no signs of vandalism or attempted unauthorized entry. The access road leading to the portal is equipped with various storm water control structures and appears to be stable. The access road can be seen in Photo Two. Adjacent to the portal is a natural drainage leading down toward the county road. The storm water controls lead through the site, down the natural drainage to a small "sediment pond" near the County Road. The sediment pond is well vegetated to dissipate flows and was in good condition.

Photo One: View northeast, showing the secured portal located on site. The portal closure is in excellent condition and no signs of vandalism were noted. Also visible is the proper Mine ID sign.

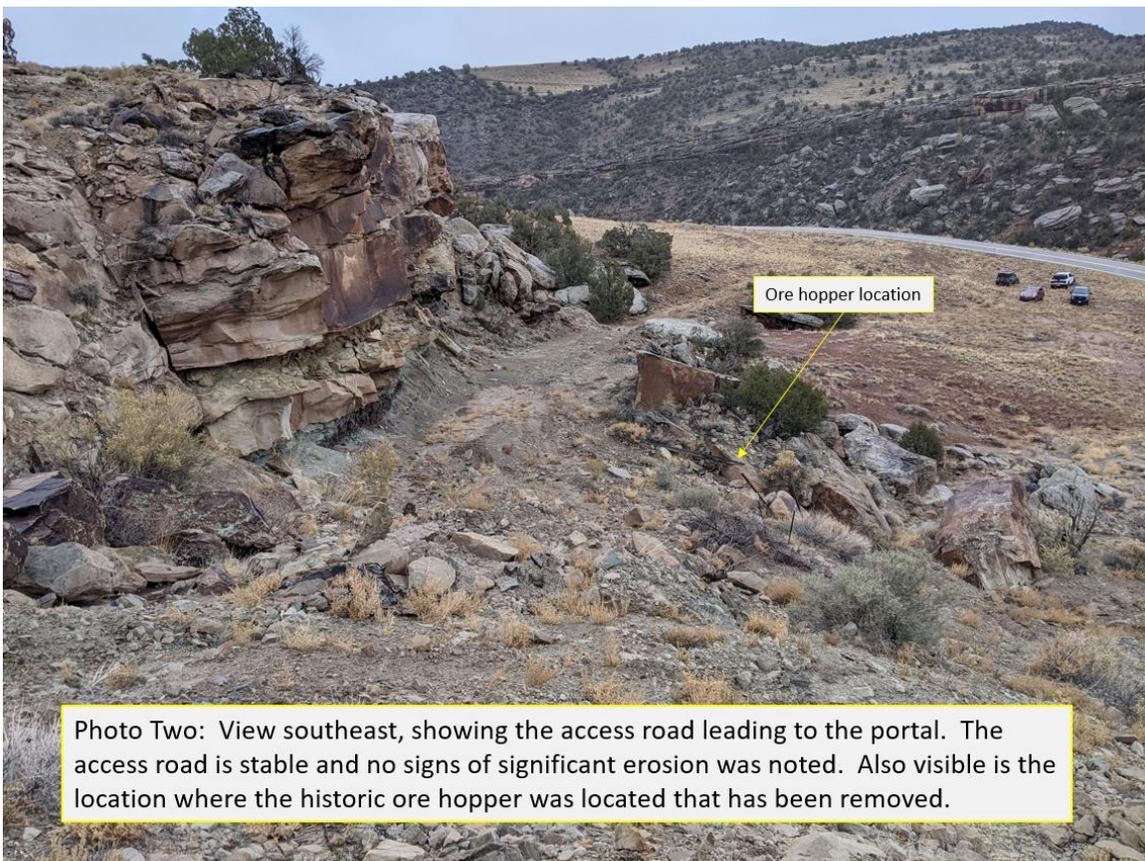
Photo Two: View southeast, showing the access road leading to the portal. The access road is stable and no signs of significant erosion was noted. Also visible is the location where the historic ore hopper was located that has been removed.

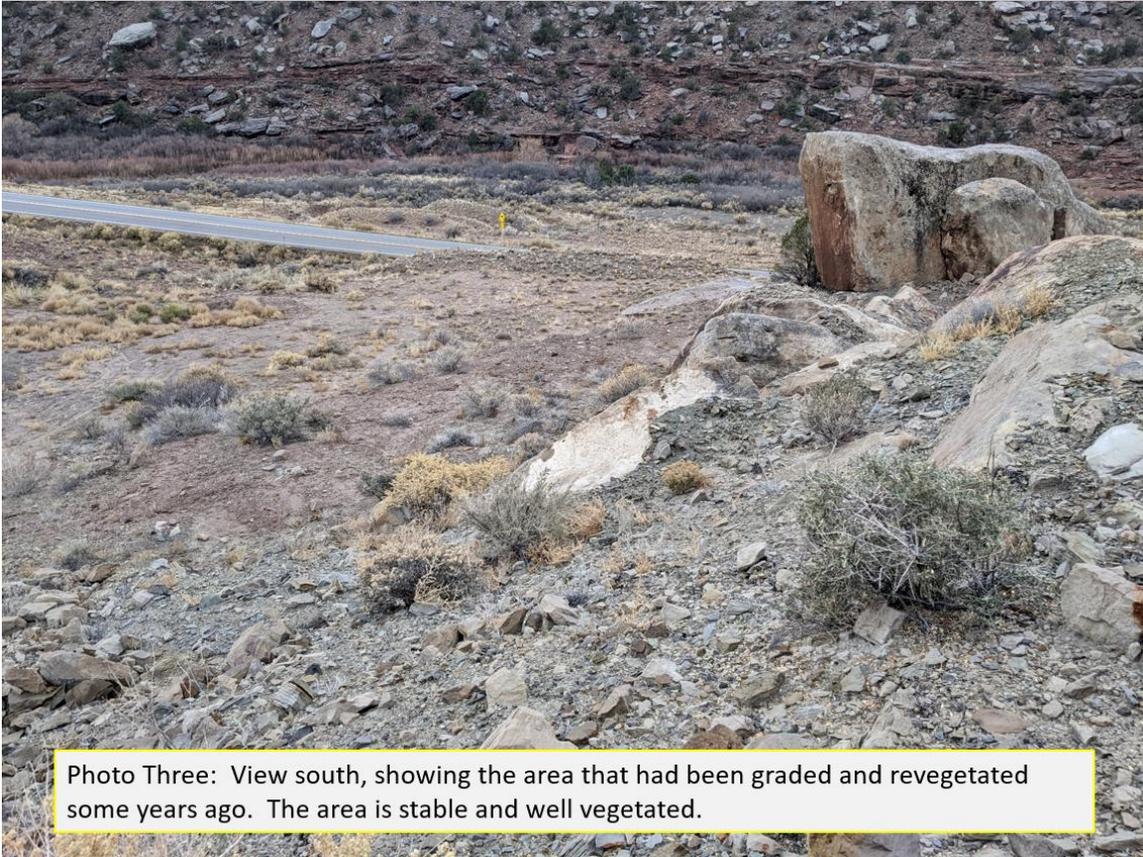
The historic ore hopper has been removed and the area has been stabilized. Also located on site is the historic waste rock pile that had been recontoured and topsoiled some time ago. The area can be seen in Photo Three. The vegetation is well established and appears to be healthy given the time of year and growing season. The vegetative cover across the site is well established and in good condition. Multiple year's growth was noted indicating the vegetation is self-sufficient and capable of self-regeneration. The vegetation is currently as good as or better than adjacent undisturbed lands.

Photo Three: View south, showing the area that had been graded and revegetated some years ago. The area is stable and well vegetated.
