**MINERALS PROGRAM INSPECTION REPORT**  
**PHONE: (303) 866-3567**

<b>MINE NAME:</b> Mendota Properties	<b>MINE/PROSPECTING ID#:</b> M-1990-147	<b>MINERAL:</b> Silver	<b>COUNTY:</b> Clear Creek
<b>INSPECTION TYPE:</b> Monitoring	<b>INSPECTOR(S):</b> Peter Hays	<b>INSP. DATE:</b> December 17, 2021	<b>INSP. TIME:</b> 11:30
<b>OPERATOR:</b> Jack Pine Mining Company	<b>OPERATOR REPRESENTATIVE:</b> Deb Rutzebeck	<b>TYPE OF OPERATION:</b> 110(2) - Hard Rock Limited Impact	
<b>REASON FOR INSPECTION:</b> Normal I&E Program	<b>BOND CALCULATION TYPE:</b> Partial Bond	<b>BOND AMOUNT:</b> \$5,000.00	
<b>DATE OF COMPLAINT:</b> NA	<b>POST INSP. CONTACTS:</b> None	<b>JOINT INSP. AGENCY:</b> None	
<b>WEATHER:</b> Windy	<b>INSPECTOR'S SIGNATURE:</b>

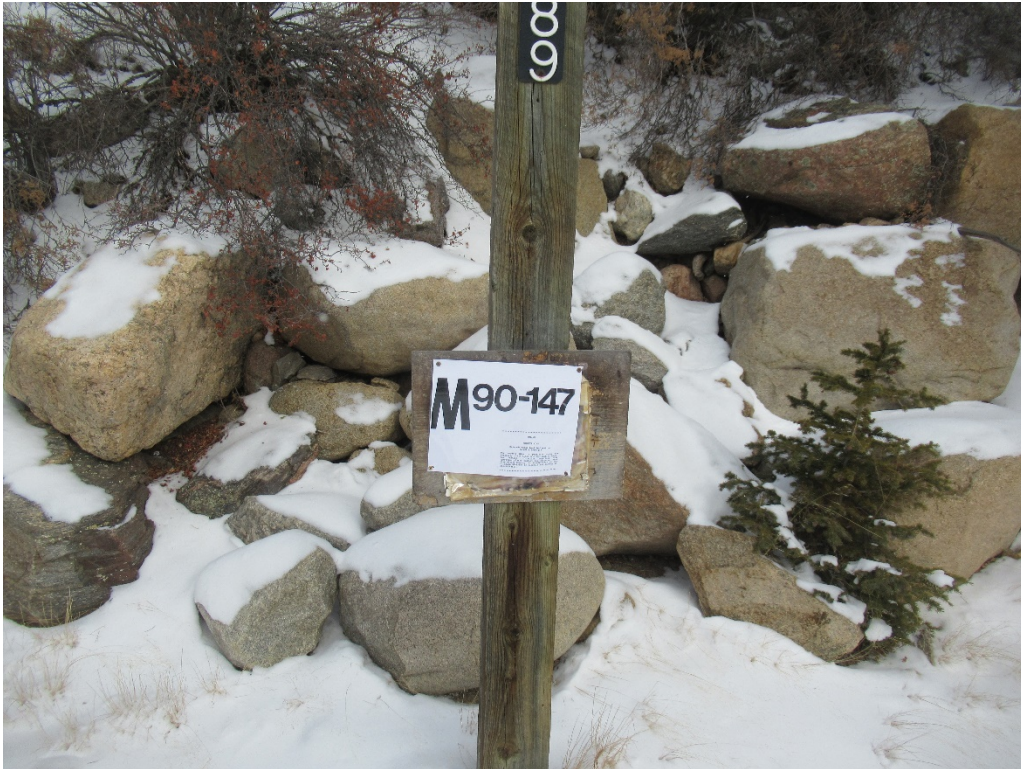
The permit sign was posted at the site entrance as required by Rule 3.1.12. The Operator stated no activities have occurred at the site since the previous inspection. The Operator is working on an agreement with the Town of Silver Plume to place the site in preservation with the town. If the property is placed in preservation, the Operator will request final release of the permit from the Division.

Mendota Properties mine sign

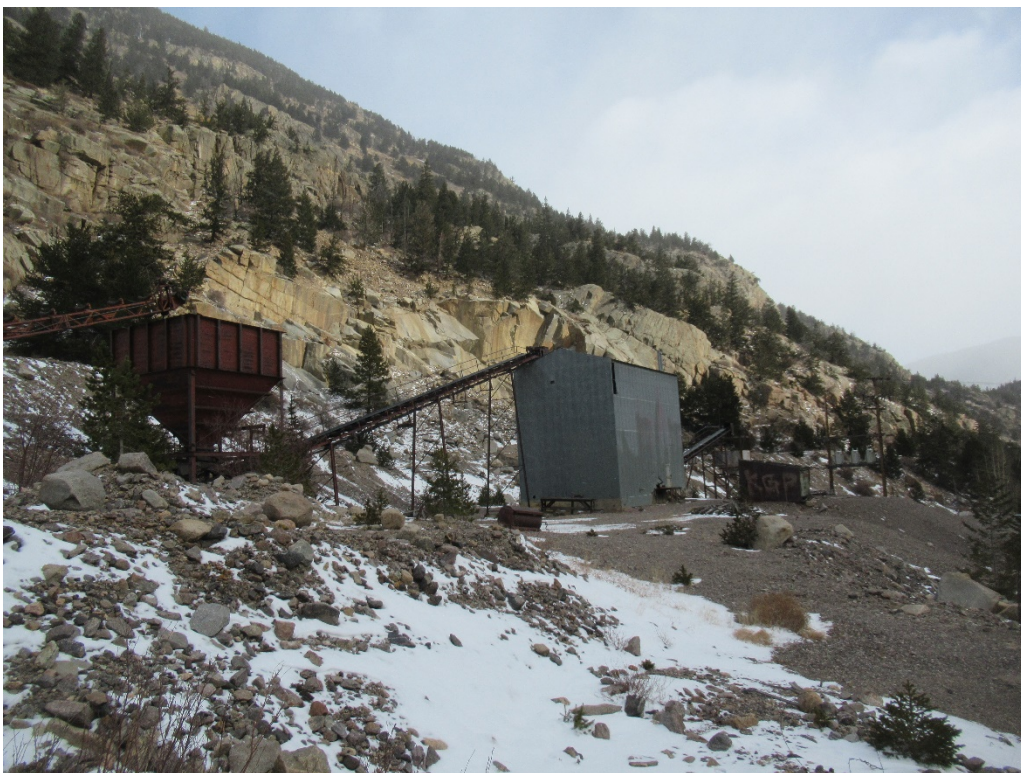
View of the Heavy Media building

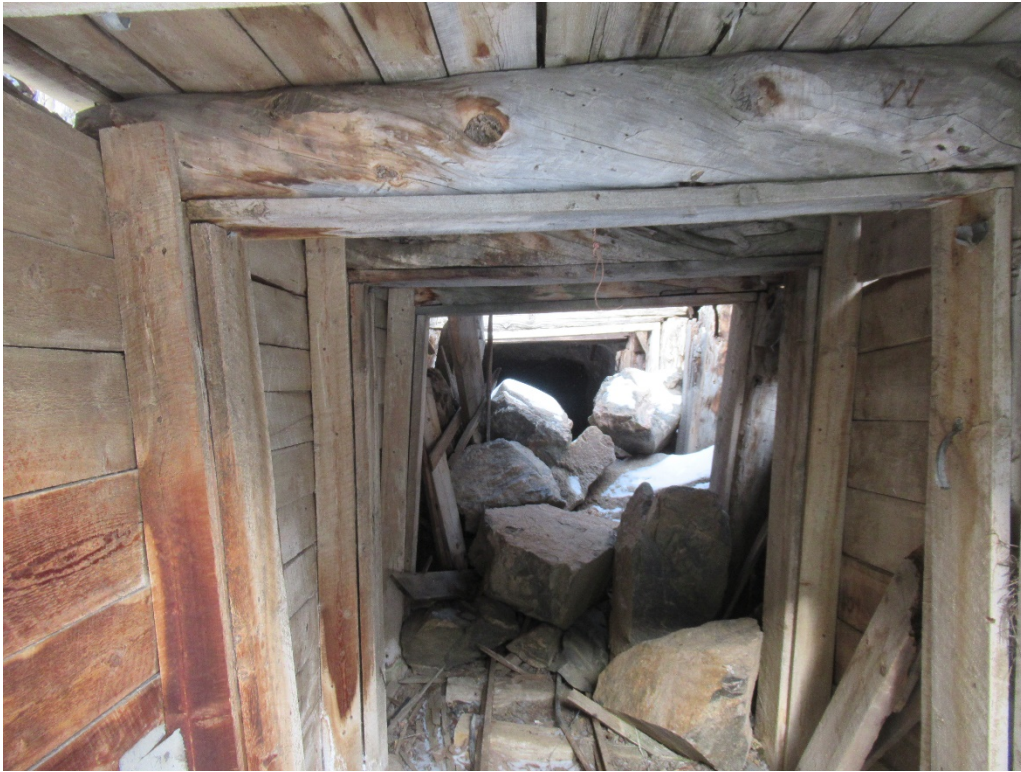
The eastern portion of the mine site includes the mine office, Mendota Adit, tailings ponds and equipment storage area. The mine office was not secured at the time of the inspection. The Division observed the windows of the office were broken, the doors were unlocked and there were signs of vandalism within the office. The Mendota Adit contains a set of steel doors, which were secured at the time of the inspection. A timbered portal extends from the Mendota Adit. Large boulders from the mountain above have fallen onto the timbered portal, partially collapsed the structure and blocked access to the steel doors. The Division did not observe any discharge of water from the Mendota Adit.

Partially collapsed Mendota Adit portal

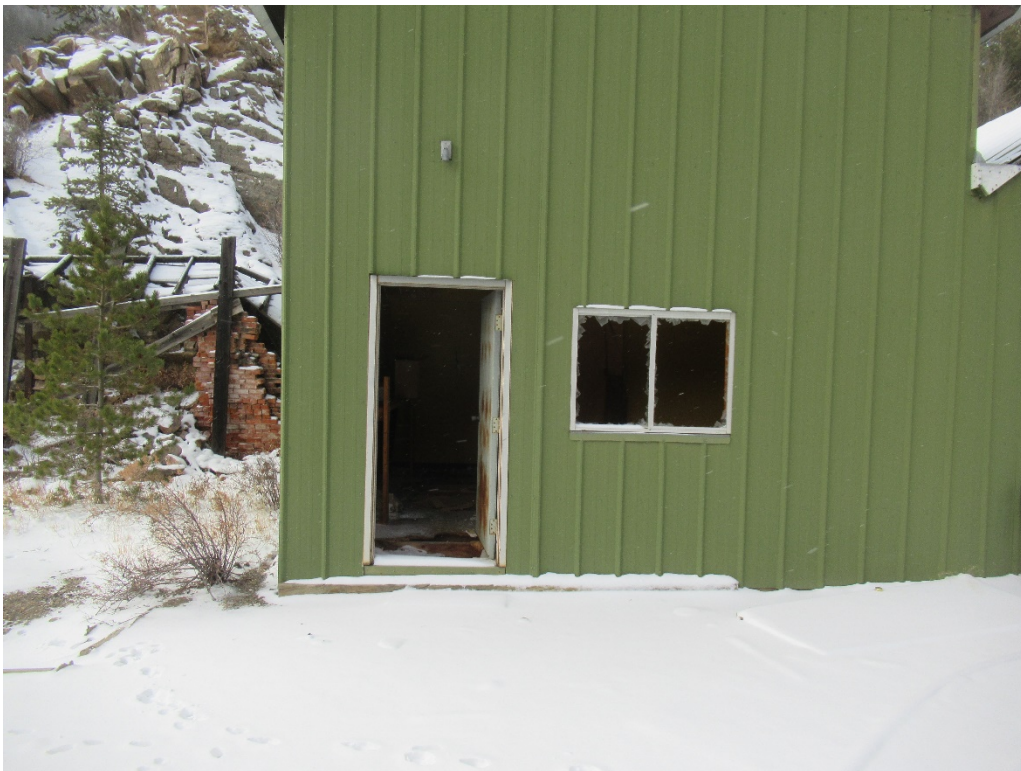
View of the mine office building

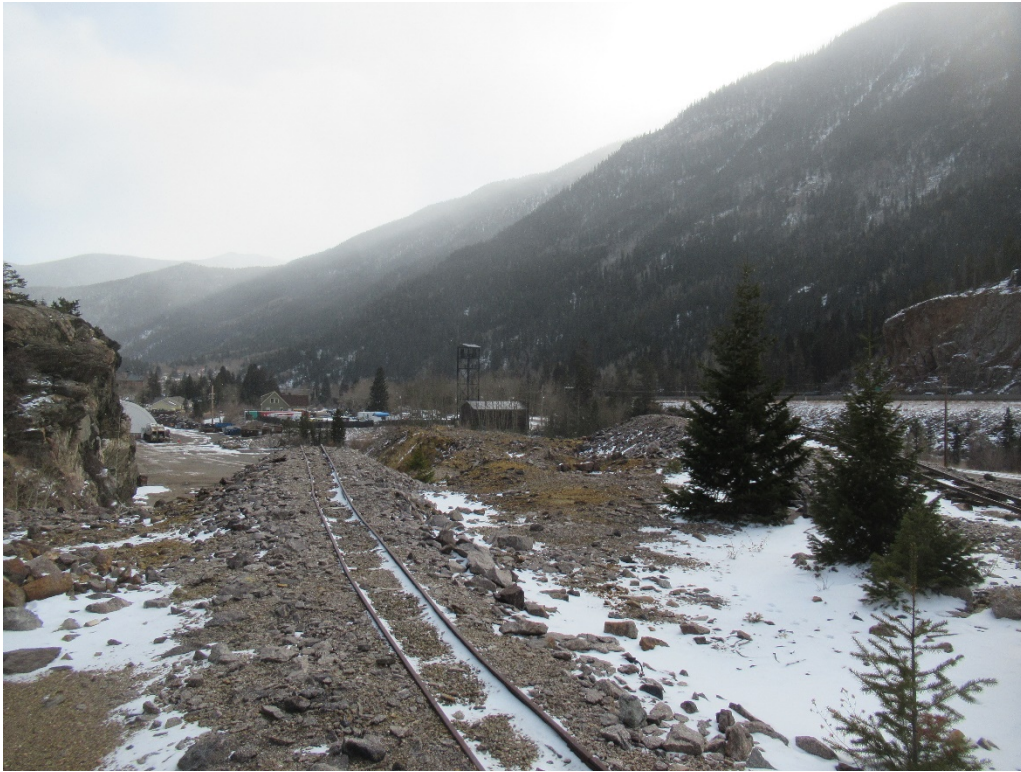
The Mendota Properties site was a pre-law mine which has been in operation since the Reclamation Permit was issued in 1990. All of the disturbance at the site is considered to be pre-law and therefore is not subject to reclamation until the site commences mining and those areas are re-disturbed by mining activities. The three (3) historic mine dumps located on the western portion of the permit area were partially observed during the inspection. The mine dumps appeared stable. Brown Gulch flows between Smuggler dump and the Slide dump and was not flowing and frozen in places at the time of the inspection.

View of the mine dumps
