MINERALS PROGRAM INSPECTION REPORT
PHONE: (303) 866-3567

MINE NAME: Hukill Gulch Millsite	MINE/PROSPECTING ID#: M-2009-076	MINERAL: Silver and gold	COUNTY: Clear Creek
INSPECTION TYPE: Monitoring	INSPECTOR(S): Peter Hays	INSP. DATE: December 17, 2021	INSP. TIME: 12:30
OPERATOR: Venture Resources, Inc.	OPERATOR REPRESENTATIVE: Patrick Maher	TYPE OF OPERATION: 110d - Designated Limited Impact	
REASON FOR INSPECTION: Normal I&E Program		BOND CALCULATION TYPE: None	
DATE OF COMPLAINT: NA		BOND AMOUNT: \$107,742.72	
POST INSP. CONTACTS: None		JOINT INSP. AGENCY: None	
WEATHER: Windy	INSPECTOR'S SIGNATURE:

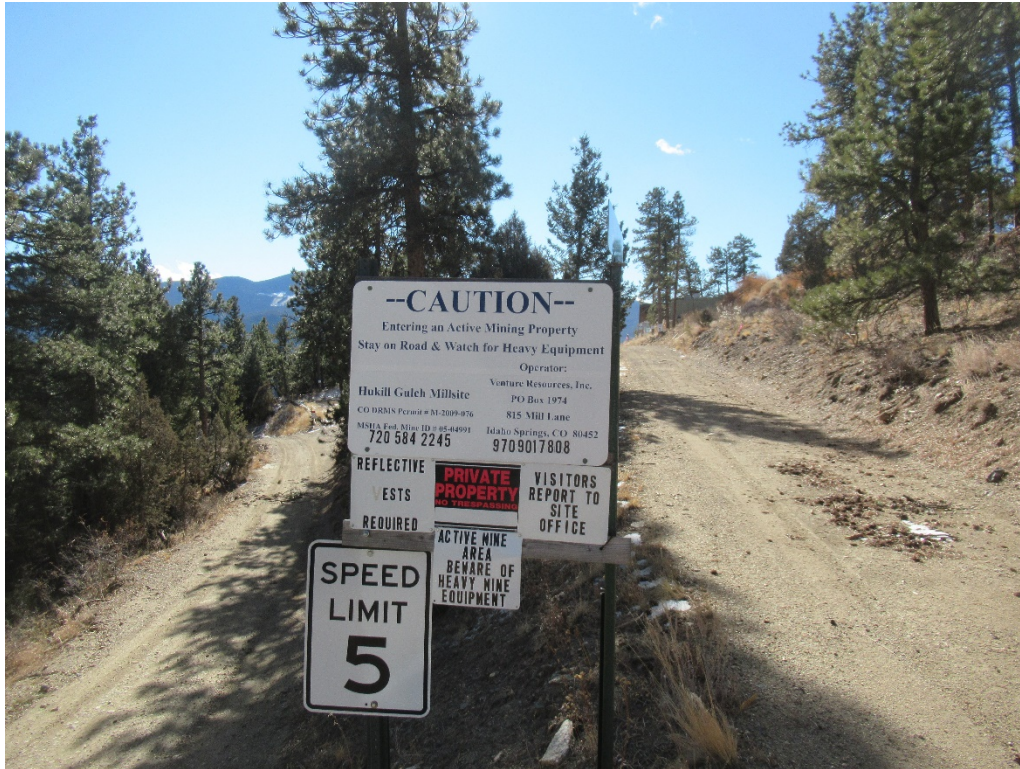
The mine identification sign and boundary markers were observed as required by Rule 3.1.12. The Division currently holds a financial warranty in the amount of \$107,742.72, which appears adequate to reclaim the site based on the observations from this inspection.

Hukill Gulch Millsite sign

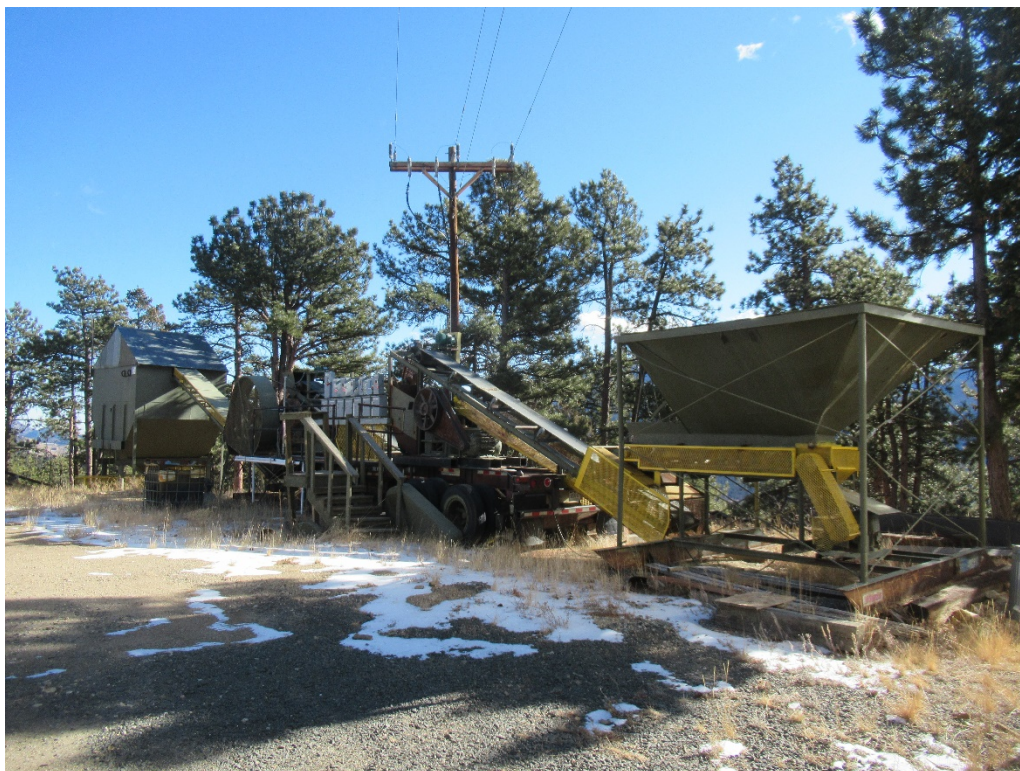
View of the crusher feed bin, primary crusher trailer and ore bin

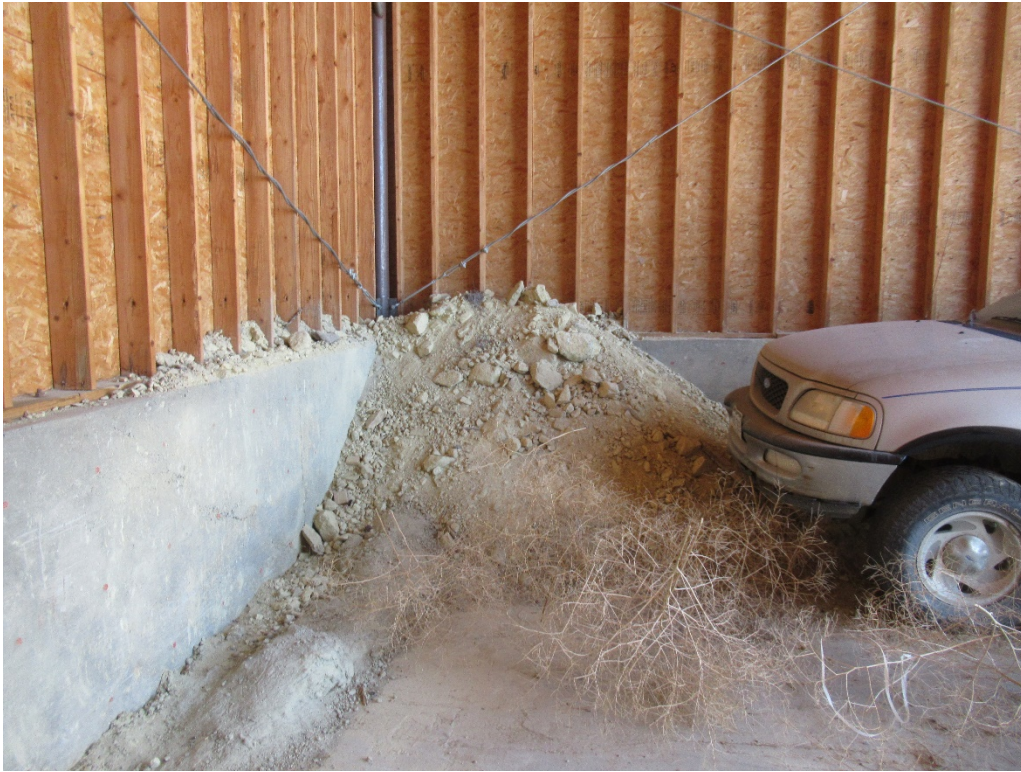
Ore stockpile in the ore stockpile building

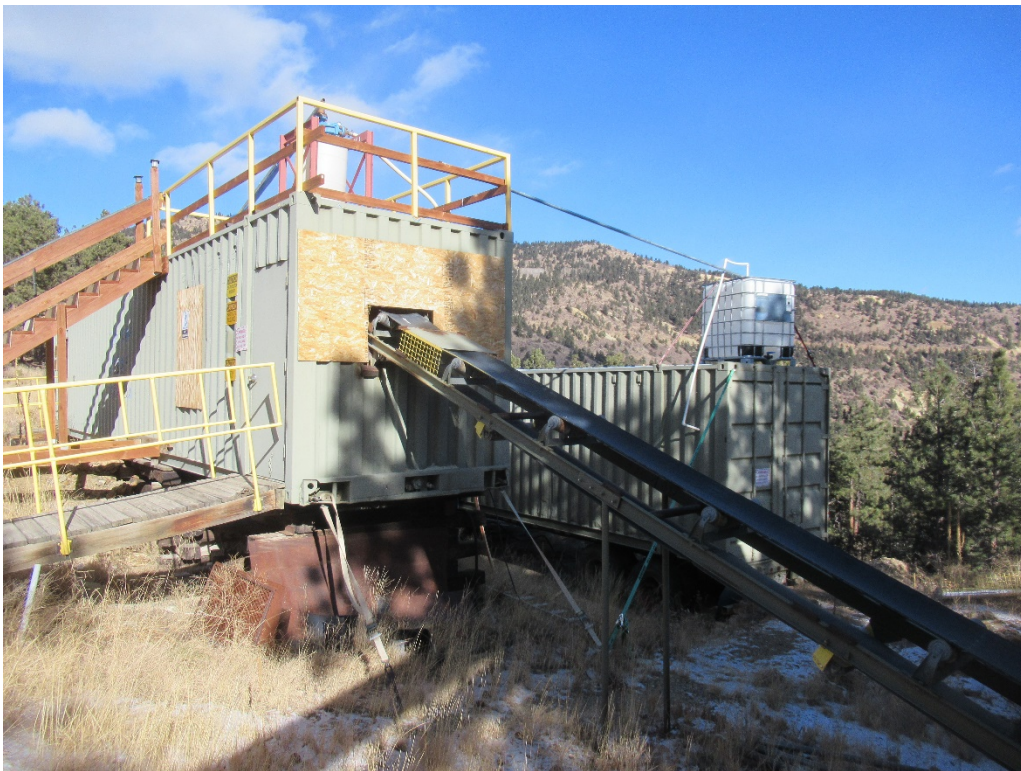
View of the ball mill and flotation trailers
