COLORADO
Division of Reclamation,
Mining and Safety
Department of Natural Resources

Permit Number: C-1981-041 Mine Name: Roadside Portals Operator: Snowcap Coal Company, Inc. Operator Address: MS Tonya Hammond P.O. Box 1430 Palisade, CO 81526	County: Mesa Operation Type: Underground Permit Status: Active Ownership: Private
	Operator Representative Present: NA
Operator Representative Signature: (Field Issuance Only)

Inspection Start Date: January 10, 2022 Inspection Start Time: 13:00 Inspection End Date: January 10, 2022 Inspection End Time: 13:05		Inspection Type: Aerial Inspection Inspection Reason: Normal I&E Program Weather: Clear	
Joint Inspection Agency: None		Joint Inspection Contacts: None	
Post Inspection Agency: None		Post Inspection Contacts: None	
Inspector(s): Clayton Wein	Inspector's Signature: <i>Clayton Wein</i>		Signature Date: 1/11/2022

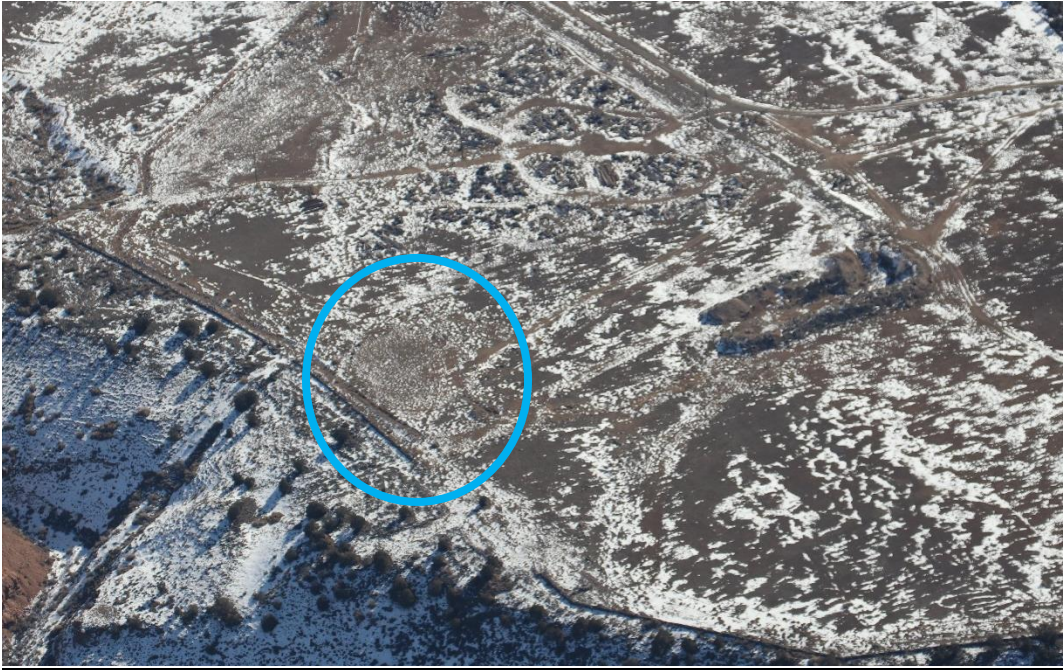
The remaining permitted disturbance at the mine site is approximately 0.4 acres located on Tract 71, in the southwestern portion of the permit area. The site was partly covered with snow during the inspection (Photo 1). The site was stable with vegetative cover. There were no indications of surface settling or erosion at the site. The disturbed area boundary markers were intact. The straw waddles were intact and in good condition. There were no off site impacts observed.

Photo 1: The remaining Disturbance at the Roadside Mine is outlined in the blue circle in the photo above. The photo was taken looking to the southeast.

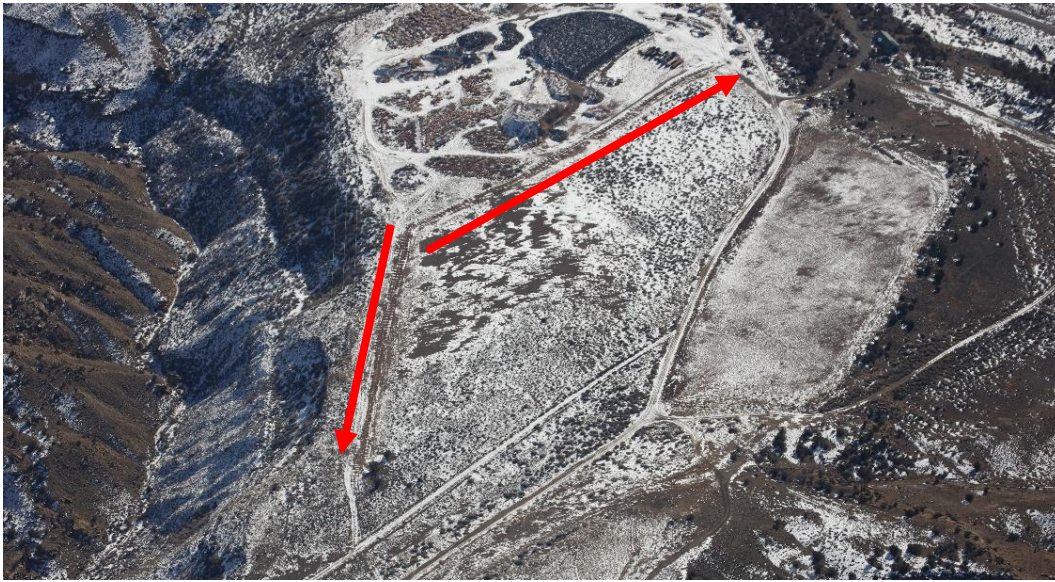
It was noted that earthwork had been conducted within the permit boundary in the south eastern and northwestern areas. This earthwork was not conducted by SCC. The work was conducted within the Minerals Permit No. M-1996-076. There appears to have been completed earthwork (Photo 2) in the southeastern portion of the C-1981-041 permit, which appears in the photos in a linear feature. This work was not conducted by SCC and therefore SCC is not liable for the disturbance. The other earthwork located on top of the Tract 70 mesa, in the northwestern portion of the C-041 permit appears to have been in middle of completion (Photo 3). The area of work being conducted is a part of the landowner's pipeline, buried on top of the Tract 70 Mesa. SCC is not liable for this disturbance.

Photo 2: The disturbance within the southeastern portion of the permit area created by the landowner is marked by the breed arrows in the photo above.

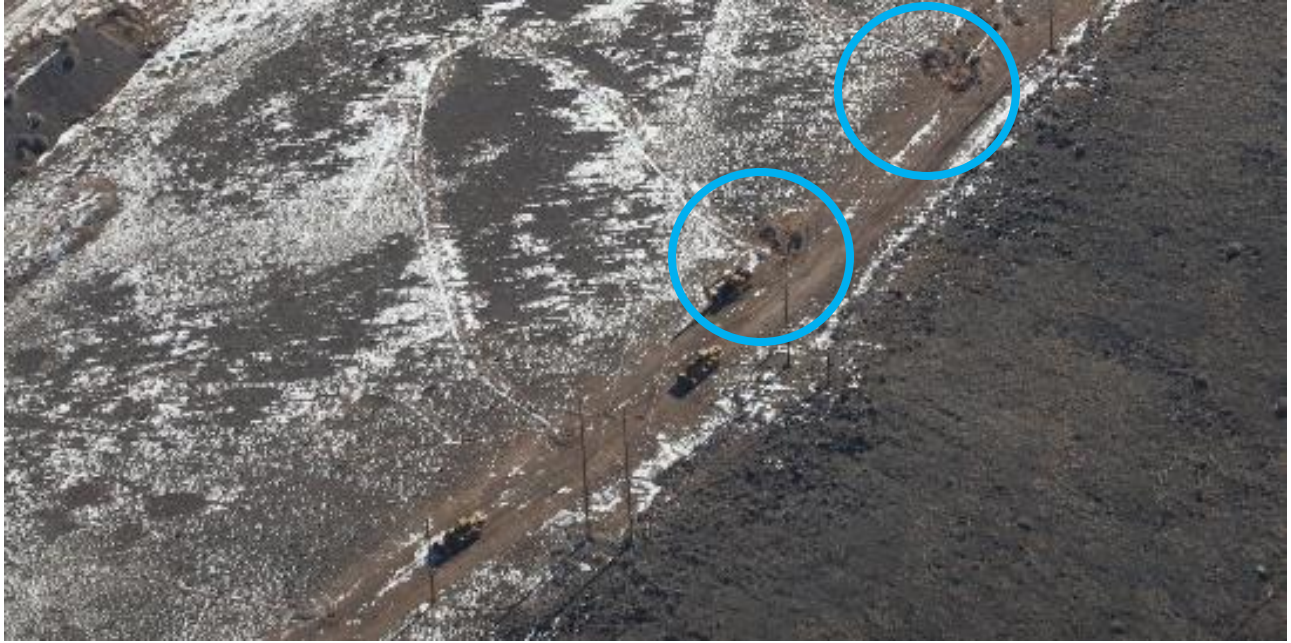
Photo 3: The equipment on Tract 70 are not associated with SCC and the disturbances observed on Tract 70 were not created by SCC. The disturbances are outlined in the blue circles above.
