PERMIT INFORMATION

Permit Number: C-1996-083	County: Delta			
Mine Name: Bowie No. 2 Mine	Operation Type: Underground			
Operator: Bowie Resources, LLC	Permit Status: Active			
Operator Address:	Ownership: Private			
Mr. Basil Bear	_			
P.O. Box 1488	Operator Representative Present:			
Paonia, CO 81428				
	None			
Operator Representative Signature: (Field Issuance Only)

INSPECTION INFORMATION

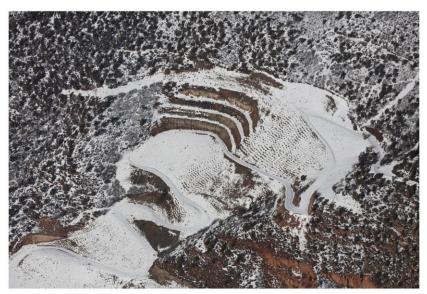
East Mine, upper area

No erosion was seen at the reclaimed areas of the East Mine or West Mine.

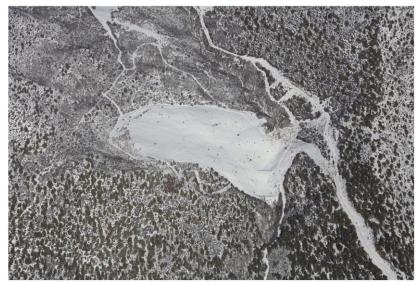
West Mine

The ponds at the West Mine, loadout, and the Coal Storage Area (near Black Bridge Road) contained snow. No problems were identified with these ponds.

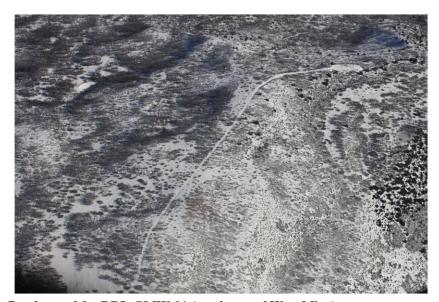
Road to pad for BRL-GMW-01 (northwest of West Mine)

Two drill pads and roads to them were inspected: BV-2 and BRL-GMW-01. No erosion or other problems were identified within these areas.

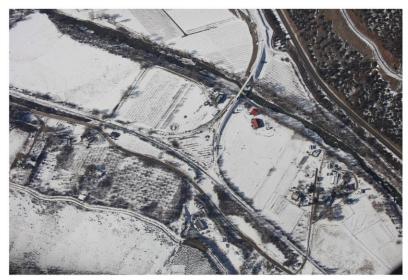
Loadout - northeast area with bridge

No erosion or other problems were seen at the loadout. This includes the "Y" and the bridge at the northeast side
