Bowie #1 Mine inspection report

| Permit Number: C-1981-038 Mine Name: Bowie No. 1 Mine Operator: Bowie Resources, LLC Operator Address: Mr. Basil R Bear P.O. Box 1488 Paonia, CO 81428 | County: Delta Operation Type: Underground Permit Status: Active Ownership: Private |

| Inspection Start Date: January 10, 2022 Inspection Start Time: 13:00 Inspection End Date: January 10, 2022 Inspection End Time: 13:15 | | Inspection Type: Coal Partial Inspection Inspection Reason: Normal I&E Program Weather: Clear | |

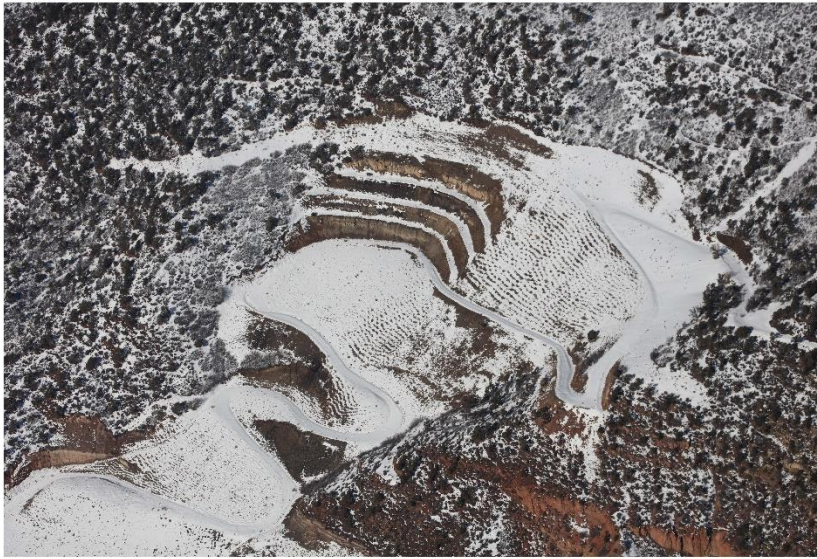
East Mine, upper area

No erosion was seen at the reclaimed areas of the East Mine or West Mine.

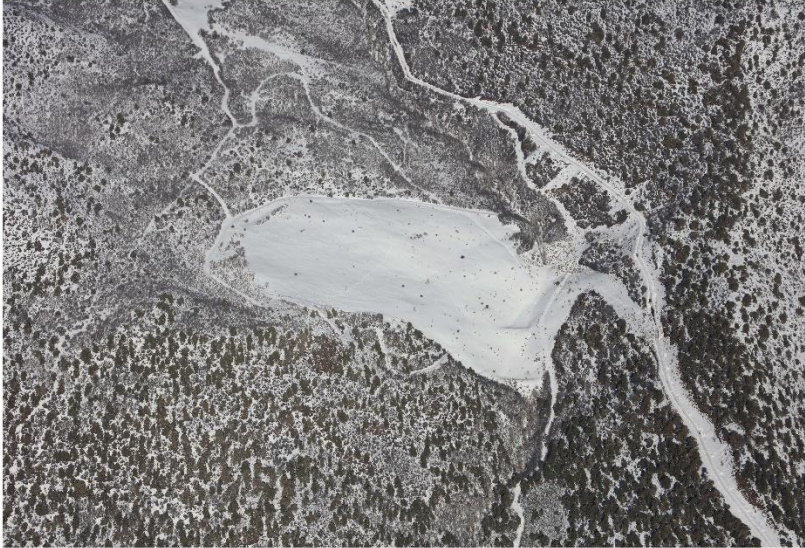
West Mine

The ponds at the West Mine, loadout, and the Coal Storage Area (near Black Bridge Road) contained snow. No problems were identified with these ponds.

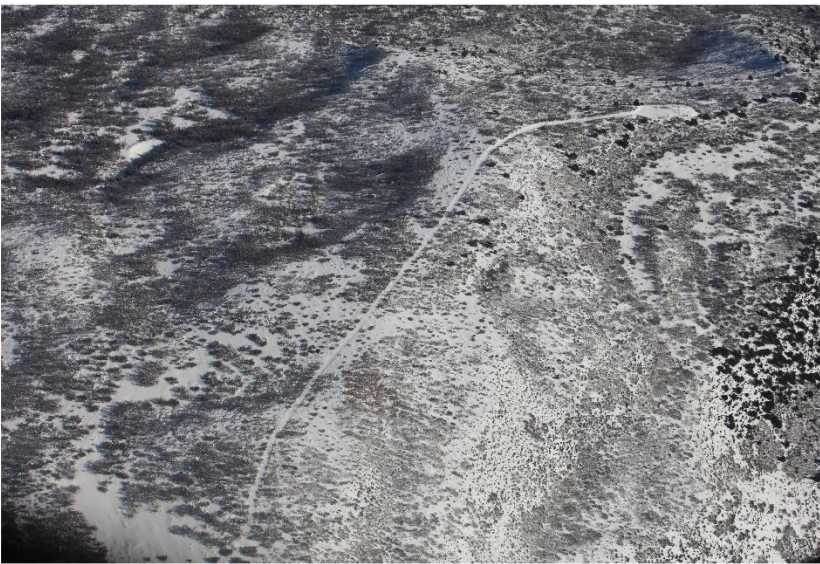
Road to pad for BRL-GMW-01 (northwest of West Mine)

Two drill pads and roads to them were inspected: BV-2 and BRL-GMW-01. No erosion or other problems were identified within these areas.

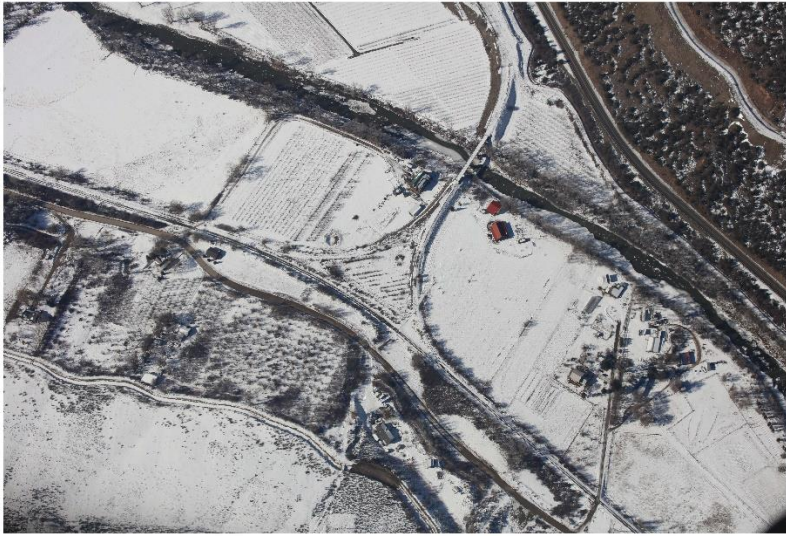
Loadout – northeast area with bridge

No erosion or other problems were seen at the loadout. This includes the “Y” and the bridge at the northeast side of the loadout area.
