Bowie #2 inspection report

PERMIT INFORMATION

Permit Number: C-1996-083 Mine Name: Bowie No. 2 Mine Operator: Bowie Resources, LLC Operator Address: Mr. Basil Bear P.O. Box 1488 Paonia, CO 81428	County: Delta Operation Type: Underground Permit Status: Active Ownership: Private
	Operator Representative Present: None
Operator Representative Signature: (Field Issuance Only)

Inspection Start Date: January 10, 2022 Inspection Start Time: 13:00 Inspection End Date: January 10, 2022 Inspection End Time: 13:15	Inspection Type: Coal Partial Inspection Inspection Reason: Normal I&E Program Weather: Clear
Joint Inspection Agency: None	Joint Inspection Contacts:
Post Inspection Agency: None	Post Inspection Contacts:
Inspector(s): Robert Zuber, P.E. Brock Bowles	Inspector's Signature: <i>Robert D. Zuber</i> Signature Date: 1/11/2022

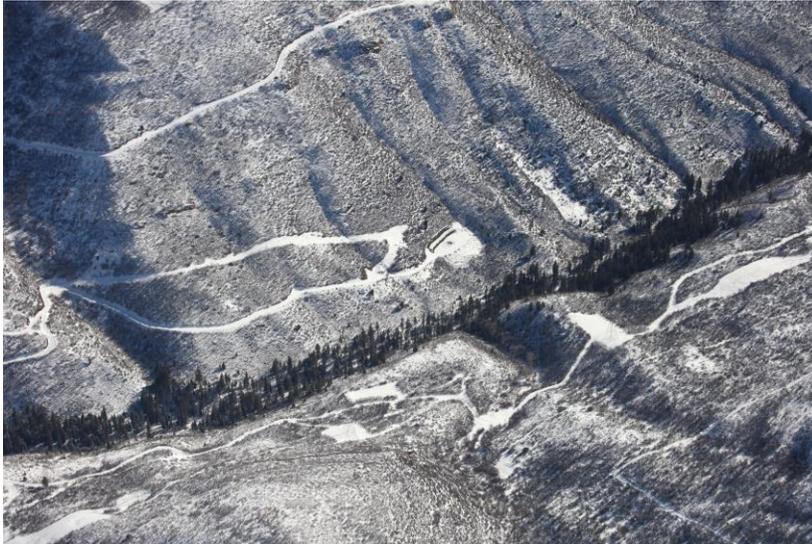
Pad and road for Terror Creek Vent Shaft

The pad for the Terror Creek Vent Shaft was inspected. No problems were identified. Also, no problems were seen at the pads for GVB-B17A, GVB-B17B, GVB-B17C, or GVB-B17D.

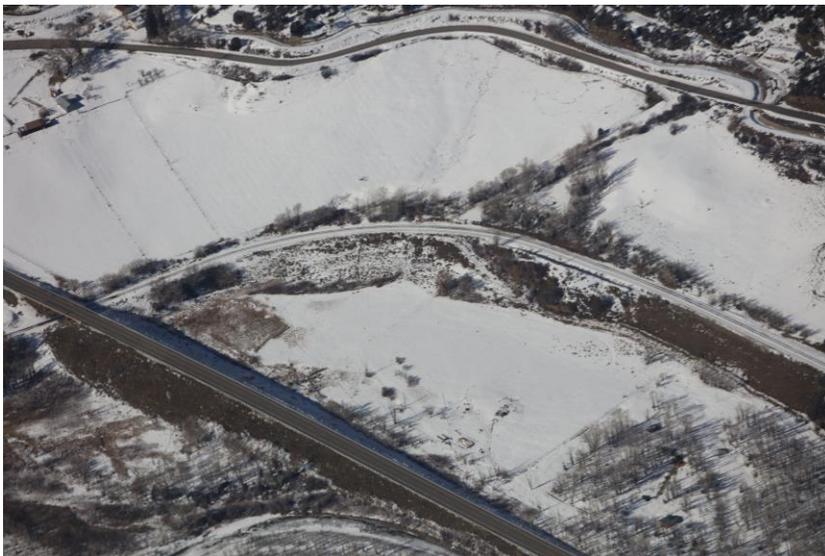
SAE along railroad tracks west of facility area

No problems were identified with any facility areas, including the following: the Utility Bench, the D Portal Bench, the B Portal Bench, the Material Storage Area by Curve #4, the Conveyor Corridor, the Coal Stockpile Pad, the office, the Preparation Plant area, the storage area and buildings near Pond D, the Pump House and Filter Building, the train loadout area, the train tracks between the loadout and Highway 133 (an area designated as a Small Area Exemption or SAE).

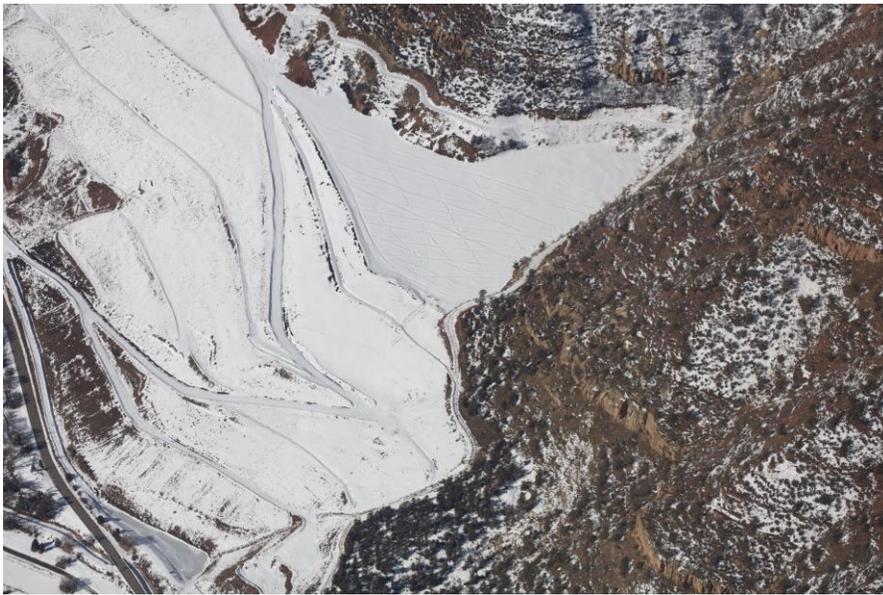
Gob Pile #2 and Pond F

The following ponds were inspected: B, C, D, F, J, and K. All of these ponds contained ice and/or snow. No problems were identified with embankments or other features of the ponds.

No problems were detected with any of the surface water control ditches. This includes the diversion ditches above Gob Pile #2 and Gob Pile #4 and the ditches between Gob Pile #3 and Pond J.

No erosion or other problems were seen with any of the gob piles.
