MINERALS PROGRAM INSPECTION REPORT
PHONE: (303) 866-3567

MINE NAME: Bennett Pit	MINE/PROSPECTING ID#: M-2016-085	MINERAL: Sand and gravel	COUNTY: Weld
INSPECTION TYPE: Monitoring	INSPECTOR(S): Peter Hays	INSP. DATE: November 30, 2021	INSP. TIME: 09:30
OPERATOR: Northern Colorado Constructors	OPERATOR REPRESENTATIVE: Chris Zadel	TYPE OF OPERATION: 112c - Construction Regular Operation	
REASON FOR INSPECTION: Citizen Complaint	BOND CALCULATION TYPE: Partial Bond	BOND AMOUNT: \$1,556,607.00	
DATE OF COMPLAINT: NA	POST INSP. CONTACTS: None	JOINT INSP. AGENCY: None	
WEATHER: Clear	INSPECTOR'S SIGNATURE:

November 30, 2021 CT-02 Inspection Map

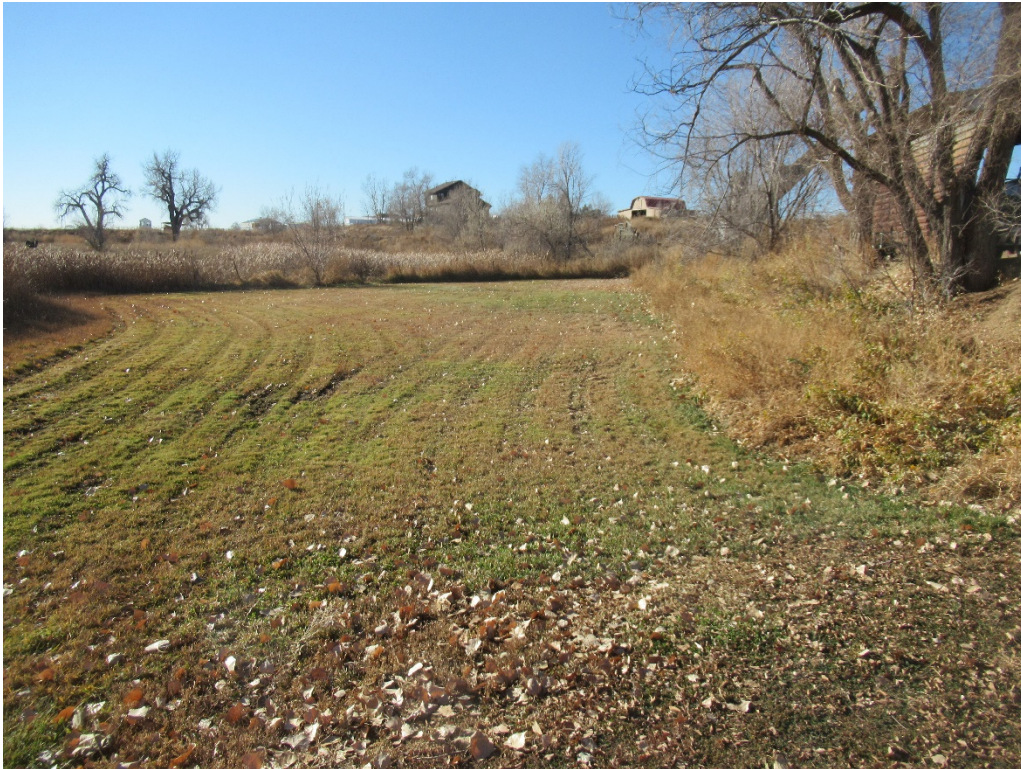
The focus of this inspection was to investigate the concerns detailed in the complaint. The complaint investigation included observation of the Karlik field near the residence, the residential foundation and the field located in the northeast corner of Mr. Karlik's property. The Karlik property consists primarily of a well-vegetated wetlands with a residence, out-building, a lawn and a field. The vegetation in the wetlands consisted of well-established trees, grasses and wetland species. The field near the residence and the field in the northeast corner of the property were saturated and appeared to have had standing water on them recently based on the appearance of the vegetation.

View of Karlik field looking south

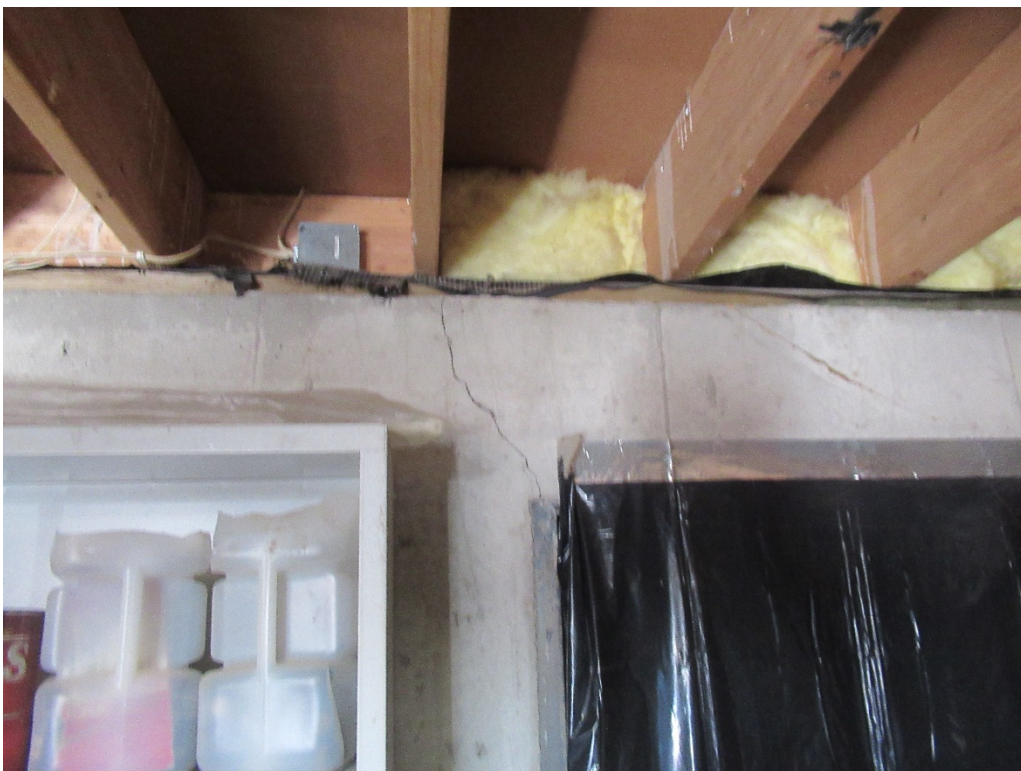
The Division does not have any evidence the foundation cracking occurred within the timeframe of the complaint. The cracking appeared to be typical of foundation settling, but did not appear to disrupt the function of the door and windows in the basement.

View of foundation crack above basement window

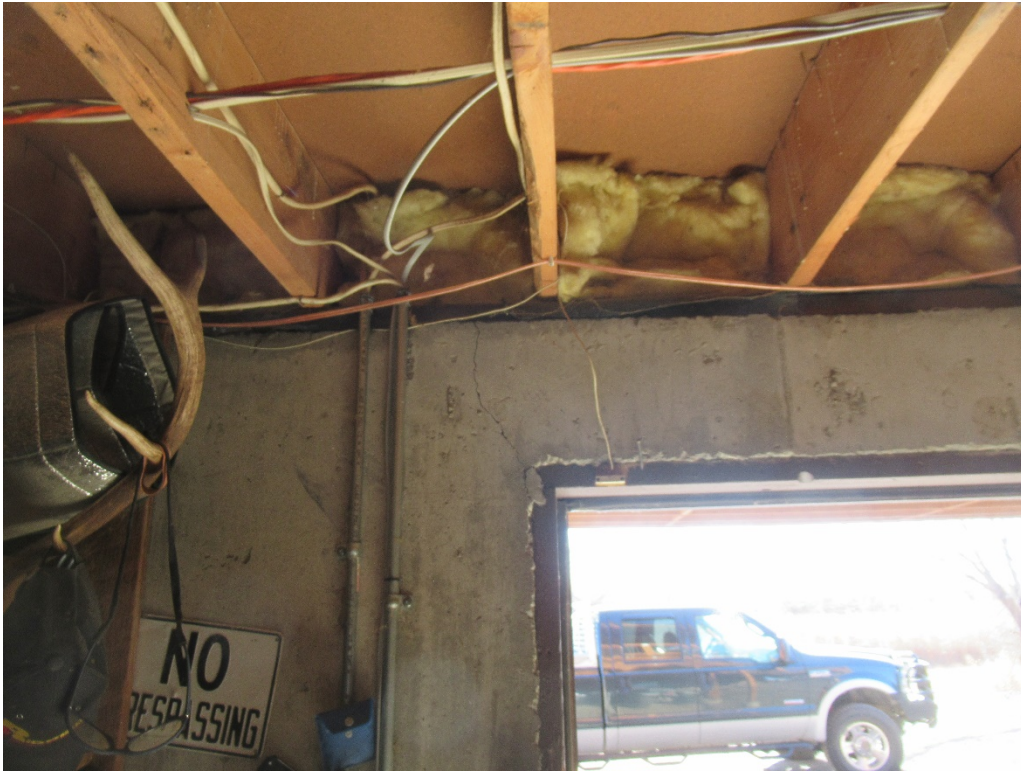
View of foundation crack above basement door

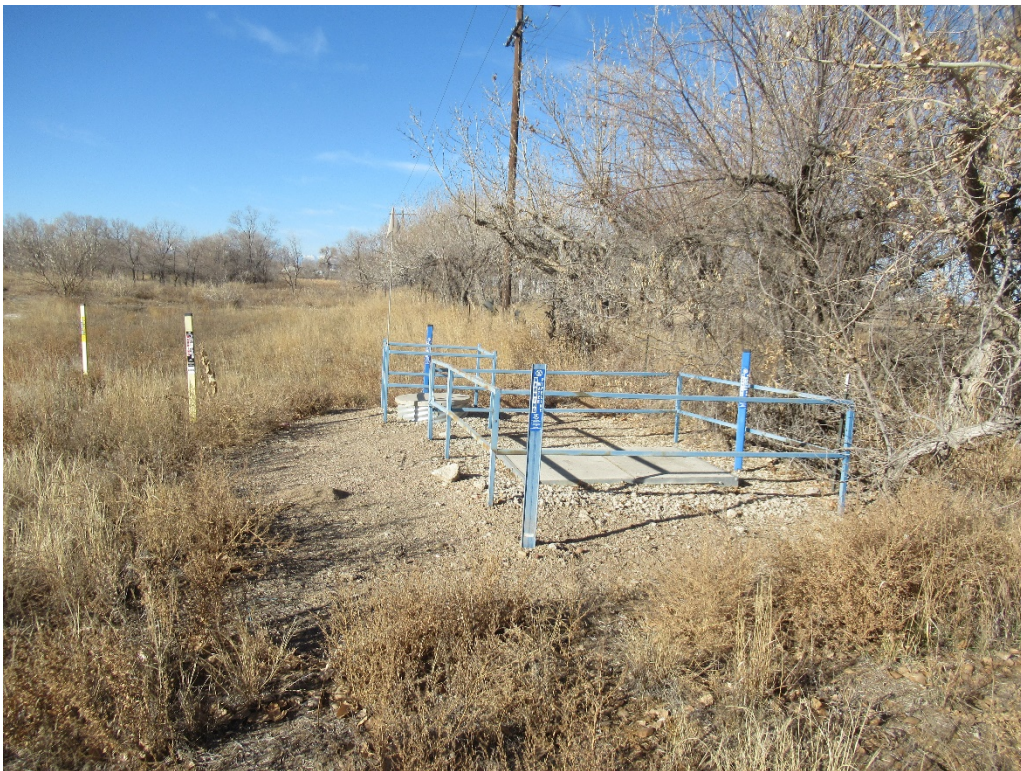
A fracking water pipeline is located south of CR 22.5 on the northern boundary of the Karlik property. Mr. Karlik stated the pipeline was repaired several years ago due to a leak in the pipeline. The photographs submitted with the complaint were located near the vault box for the pipeline in the northeast corner of the Karlik property. The Division was unable to determine if the pipeline was active at the time of the inspection, however if the pipeline is leaking and was recently shutdown this could explain the water in the northwest corner of the property and the water receding recently. The Division believes the pipeline could be a possible cause of the water in the northwest corner of the Karlik property. The Division recommends Mr. Karlik contacts the pipeline owner to investigate a possible leak in the pipeline.

View of fracking water pipeline vault box located in the northeast corner of the Karlik property

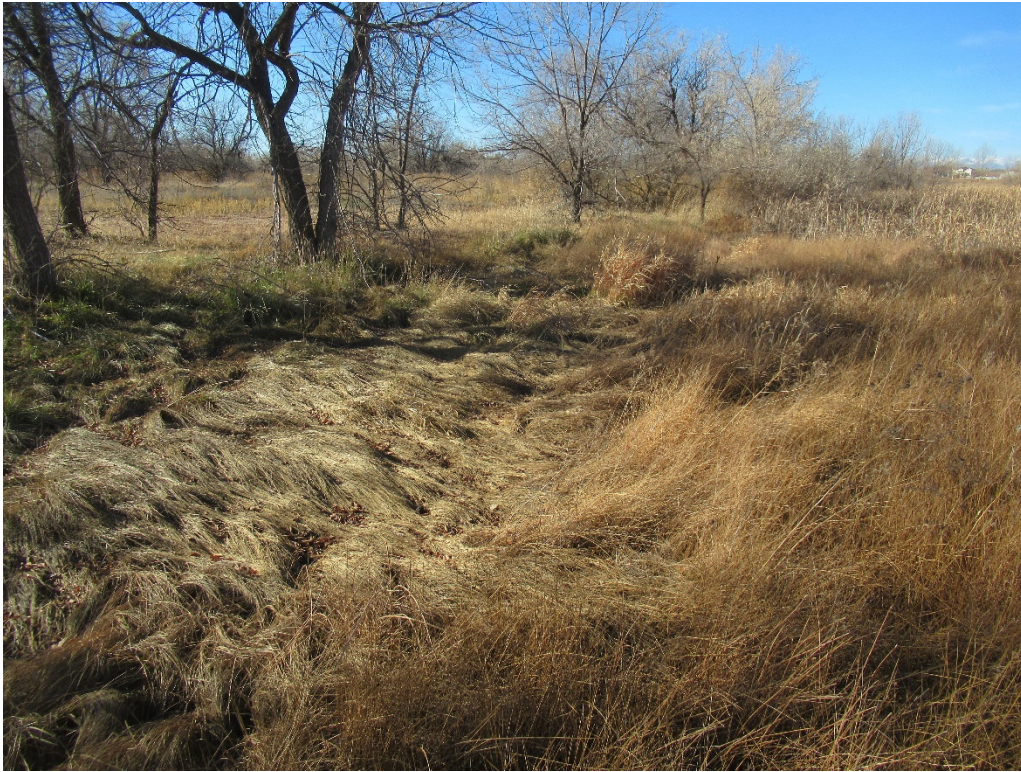
View of vegetation in the northeast corner of the Karlik property

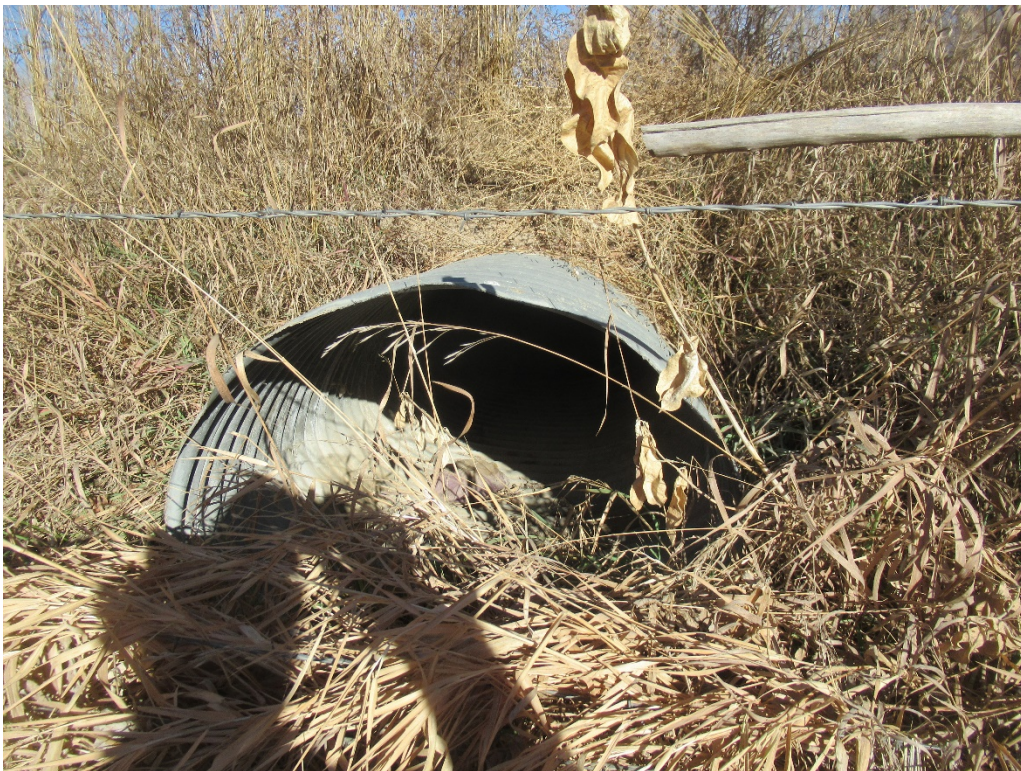
elevation (4842') than the Karlik property (4841'). The culvert under CR 22.5 from the Karlik to the Brugger properties was observed during the inspection. The culvert was clear and appeared to be functioning properly. No erosion features were observed at the inlet or outlet of the culvert.

View of the culvert inlet under CR 22.5 from the Karlik to Brugger properties

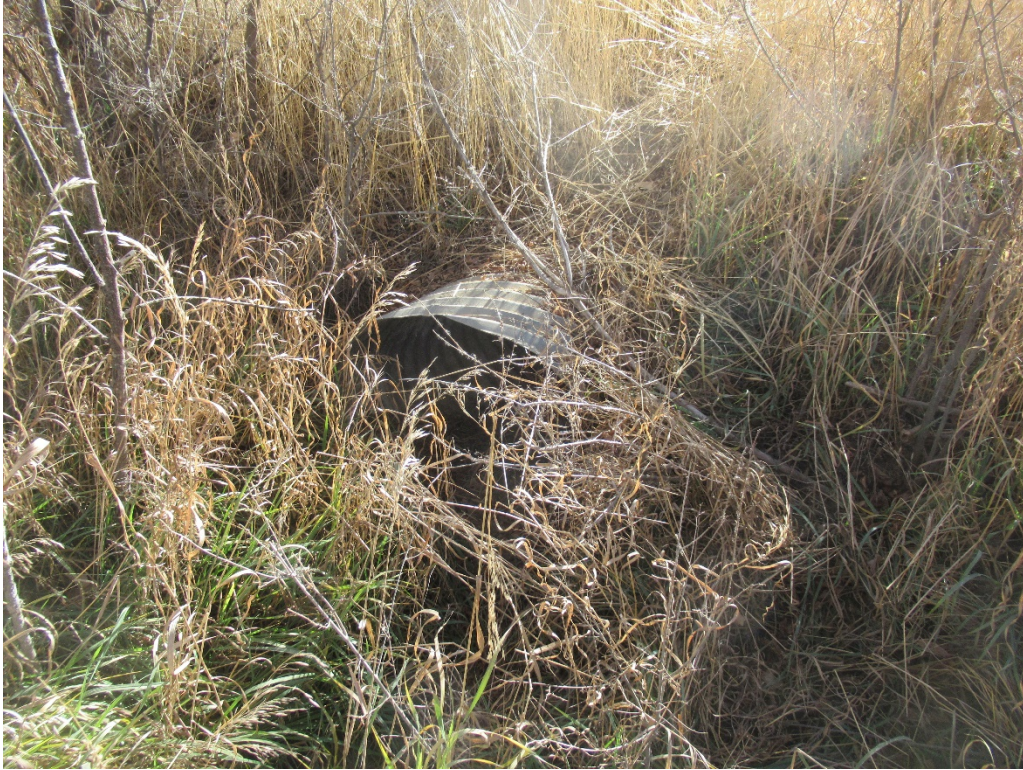
View of the culvert outlet under CR 22.5 from the Karlik to Brugger properties

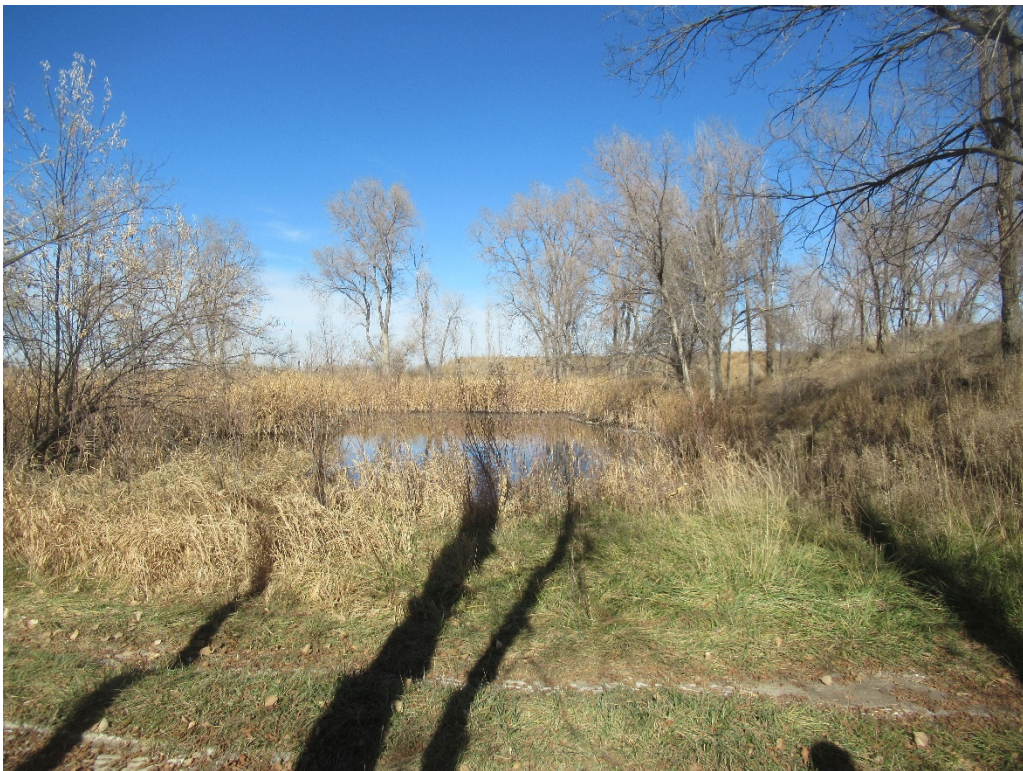
View of the pond on the Brugger property with water staining on the cattails

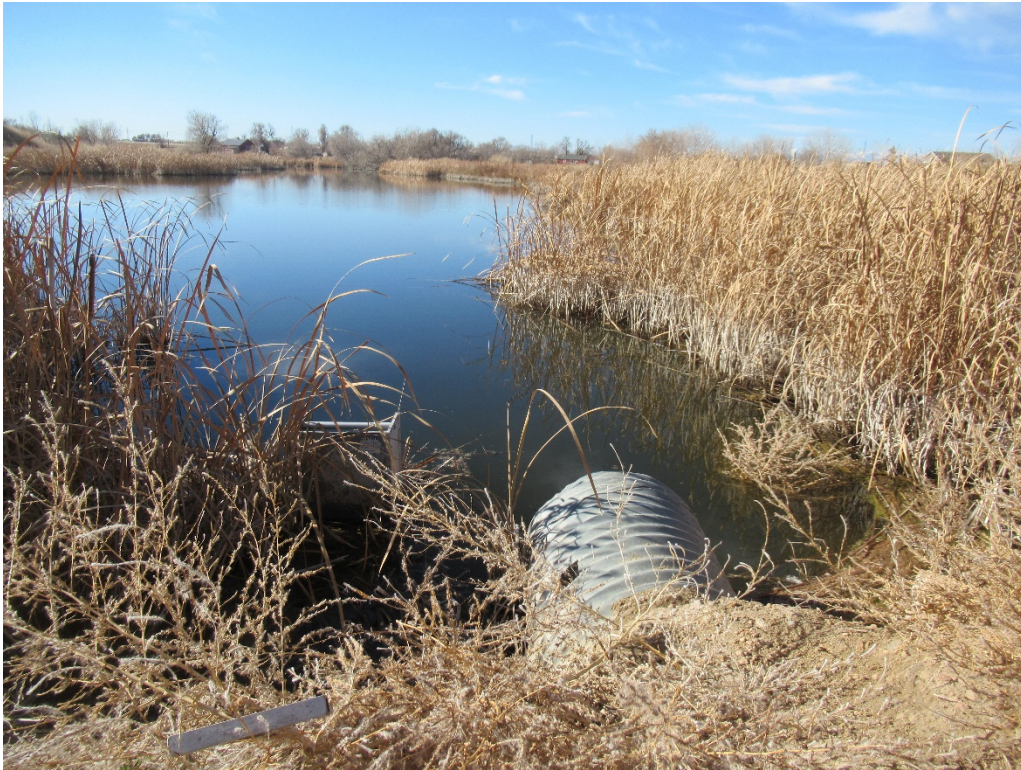
After the Division notified the Operator of the complaint, the Operator conducted an inspection of the culvert under the road to the oil and gas facility located west of the processing plant. The culvert was discovered to be plugged. The Operator unplugged the culvert and noticed a reduction if the water level upgradient of the culvert. During the inspection, water staining on cattails located in the pond upgradient of the culvert was observed. The Division was unable to determine if the staining was due to seasonal groundwater elevation fluctuation or due to the plugged culvert increasing the water elevation. Similar cattail staining was observed in the pond on the Brugger property which could indicate the staining was due to seasonal groundwater fluctuations and not the plugged culvert.

The diameter of the culvert was estimated at 24" in diameter. The culvert was clear and appeared to be working property at the time of the inspection. The plugged culvert was not related to the mining activities at the site, since the source of the water, sediment and any debris is from the slough which runs through the Karlik and Brugger properties and no mining activities occur in the slough. No evidence of the oil and gas road overtopping with water was observed during the inspection. The culvert is located 2,000 feet from the Karlik residence. The Division does not believe the plugged culvert could backup enough water to cause the flooding on the Karlik property.

View of the oil and gas road culvert inlet

The Division will continue to require the Operator to collect and report the groundwater elevation data to the Division with the annual reports. Additionally, the Division will require the Operator to conduct inspections of the culvert under the road to the oil and gas facility.

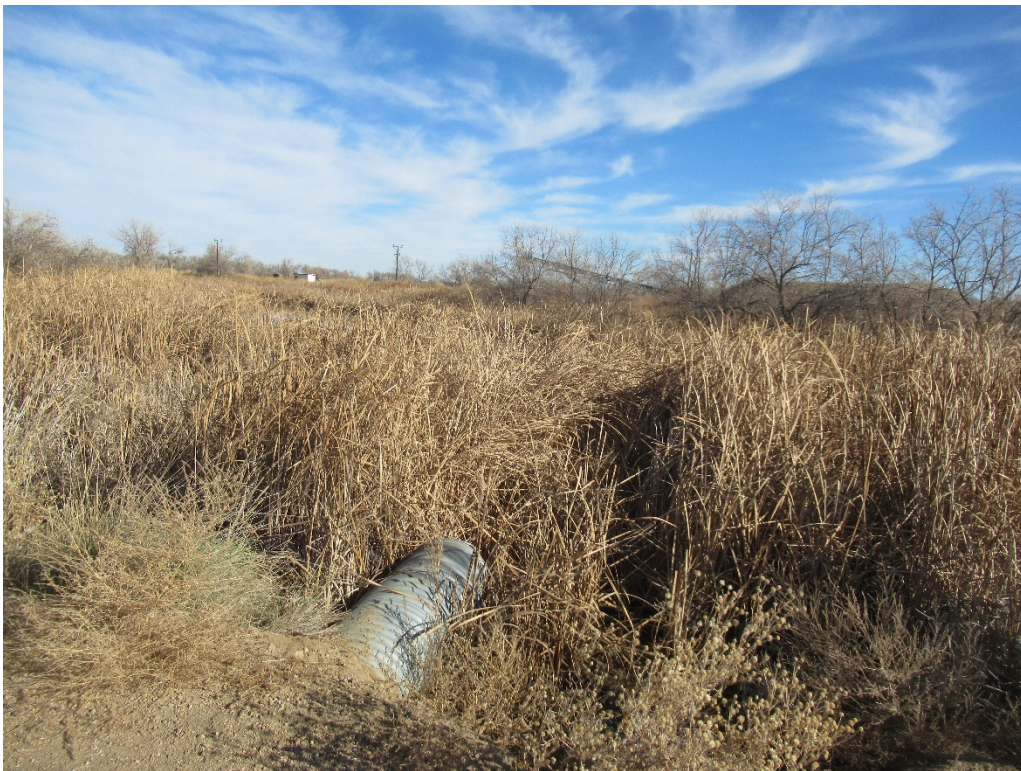
View of the oil and gas road culvert outlet
