Permit Number: C-1981-012 Mine Name: New Elk Mine Operator: New Elk Coal Company, LLC Operator Address: Mr. Mark Gray 12250 Highway 12 Weston, CO 81091	County: Las Animas Operation Type: Underground Permit Status: Active Ownership: Private
	Operator Representative Present: None
Operator Representative Signature: (Field Issuance Only)

Inspection Start Date: January 11, 2022 Inspection Start Time: 14:27 Inspection End Date: January 13, 2022 Inspection End Time: 14:00		Inspection Type: Aerial Inspection Inspection Reason: Normal I&E Program Weather: Clear	
Joint Inspection Agency: None		Joint Inspection Contacts: None	
Post Inspection Agency: None		Post Inspection Contacts: None	
Inspector(s): Jared Ebert Brock Bowles	Inspector's Signature:

This was an aerial inspection of the New Elk Mine, Colorado Division of Reclamation, Mining and Safety (DRMS/Division) permit number C-1981-012, operated by New Elk Coal Company, LLC (NECC). Brock Bowles with DRMS conducted the aerial inspection on January 11, 2022. I, Jared Ebert with DRMS reviewed the photographs taken by Mr. Bowles on January 13, 2022 and prepared this inspection report.

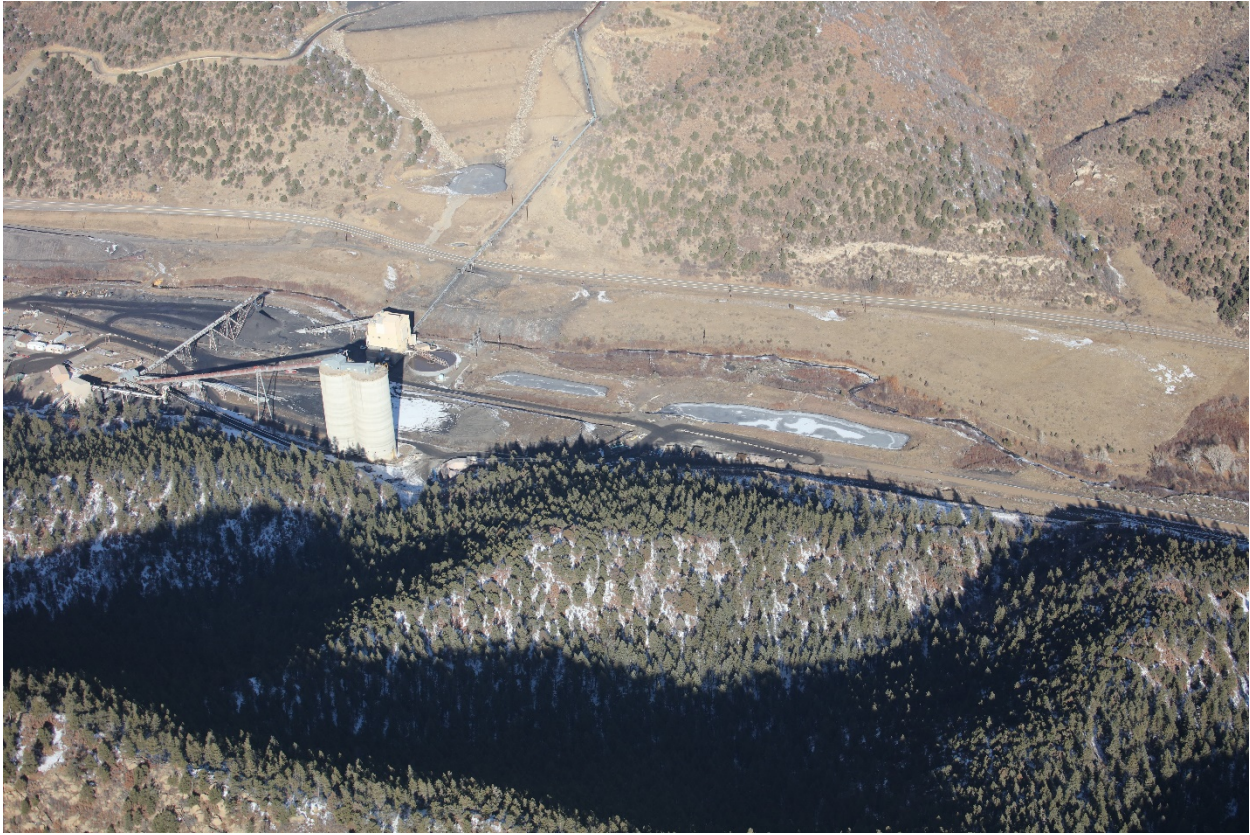
It appears coal was being stockpiled in the Raw Coal pile at the time of the aerial inspection.

Figure 1. New Elk Mine, from the southeast, looking northwest.

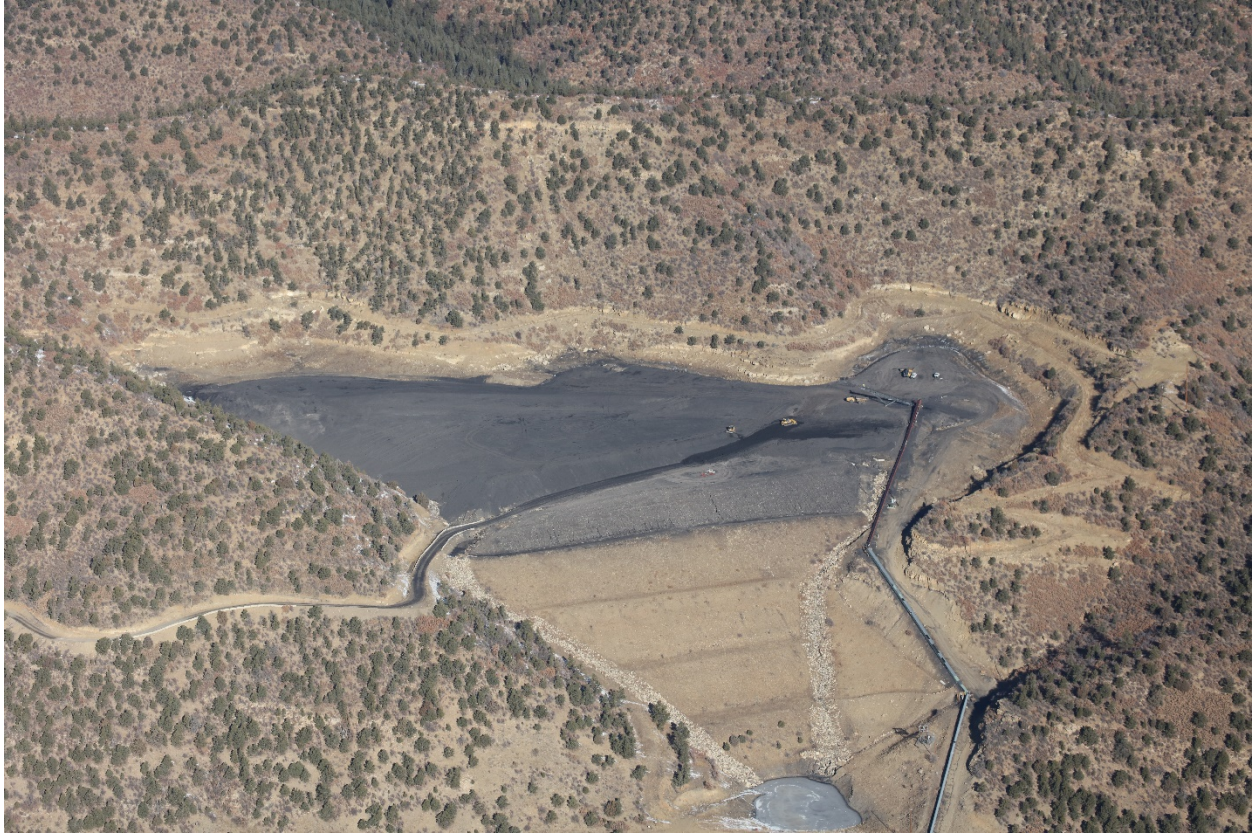
Pond 001, 004, 006, 007 and 008 were observed. Each of these ponds with the exception of Pond 004, appears to be holding water but do not appear to be discharging. The pond embankments appear to be stable and no signs of instability is observed.

Waste appear to have been recently placed on the Refuse Disposal Area (RDA). The recently placed waste appears to have been graded out and a line of piles was observed on the top bench.

Figure 2. Refuse Disposal Area and Pond 008

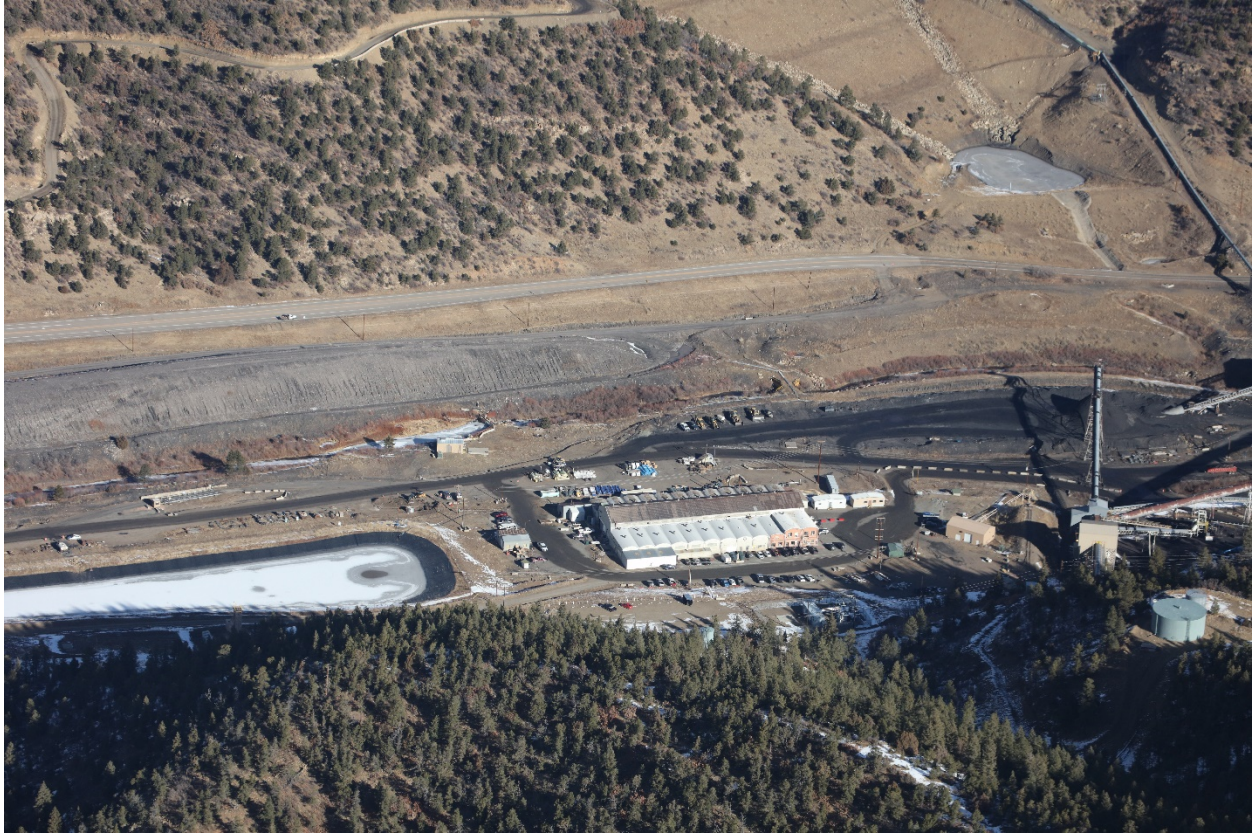
Development Waste Disposal Areas (DWDA) #1 and #2 was observed. DWDA #1 appears stable and vegetated. DWDA #2 appears stable, the rills commonly observed on this non-reclaimed pile seem consistent with previous DRMS inspection observations.

Figure 3. East Portal Facilities, Pond 001, DWDA#2

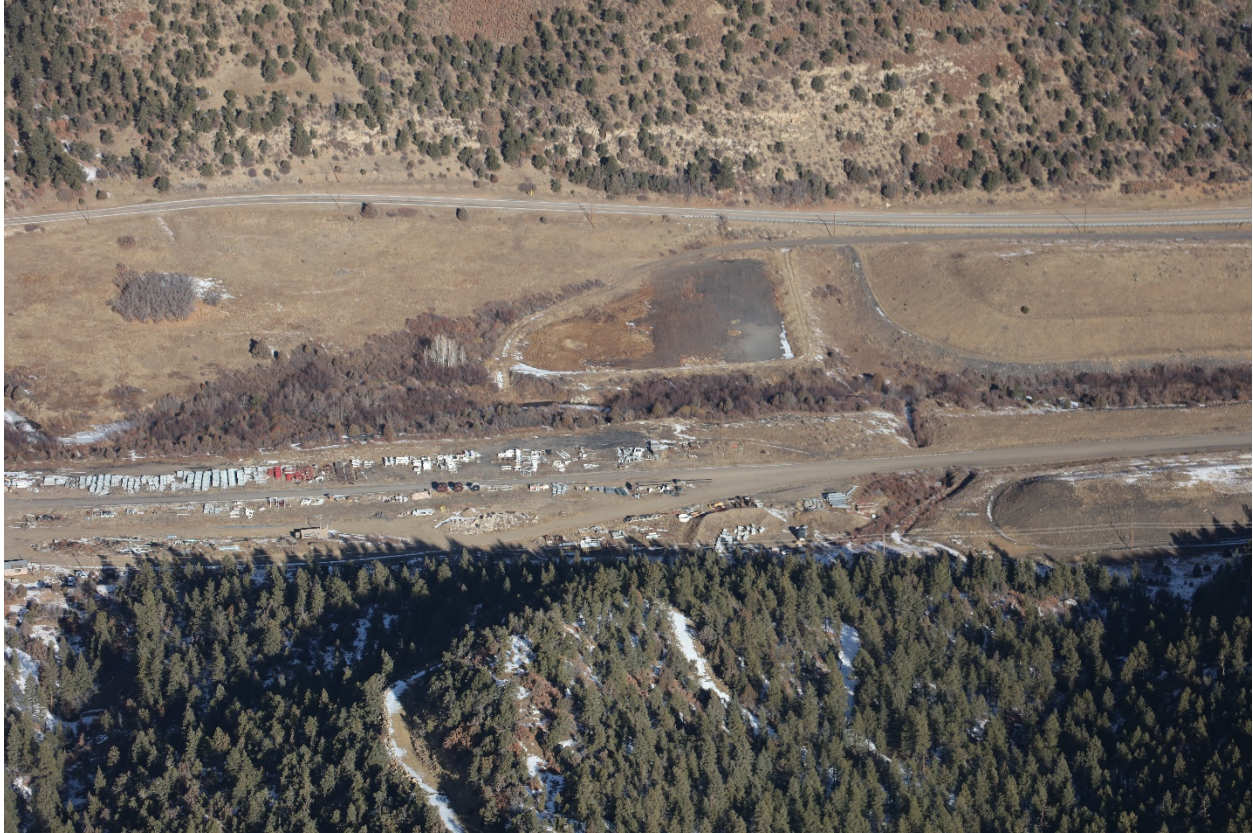
Figure 4. Equipment storage area, Pond 004, and DWDA#1 (west end)

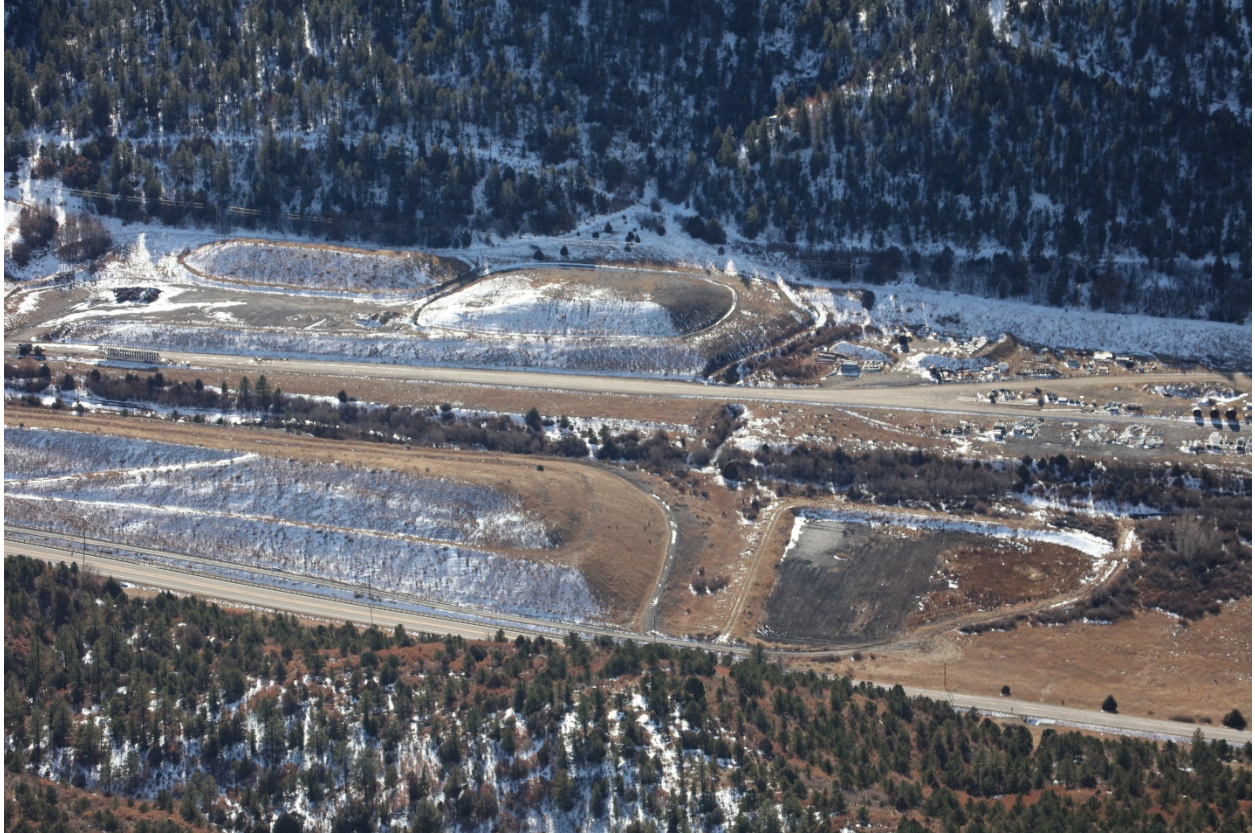
The topsoil and subsoil stockpiles appear stable. No problems were observed.

Figure 5. Topsoil and Subsoil Storage Area, Pond 004, DWDA #1
