## Lorencito Canyon Mine, C-1996-084

**PERMIT INFORMATION**

<b>Inspection Start Date:</b> January 11, 2022 <b>Inspection Start Time:</b> 14:00 <b>Inspection End Date:</b> January 13, 2022 <b>Inspection End Time:</b> 16:00		<b>Inspection Type:</b> Aerial Inspection <b>Inspection Reason:</b> Normal I&E Program <b>Weather:</b> Clear	
<b>Joint Inspection Agency:</b>  None		<b>Joint Inspection Contacts:</b>  None	
<b>Post Inspection Agency:</b>  None		<b>Post Inspection Contacts:</b>  None	
<b>Inspector(s):</b>  Jared Ebert  Brock Bowles		<b>Inspector's Signature:</b>

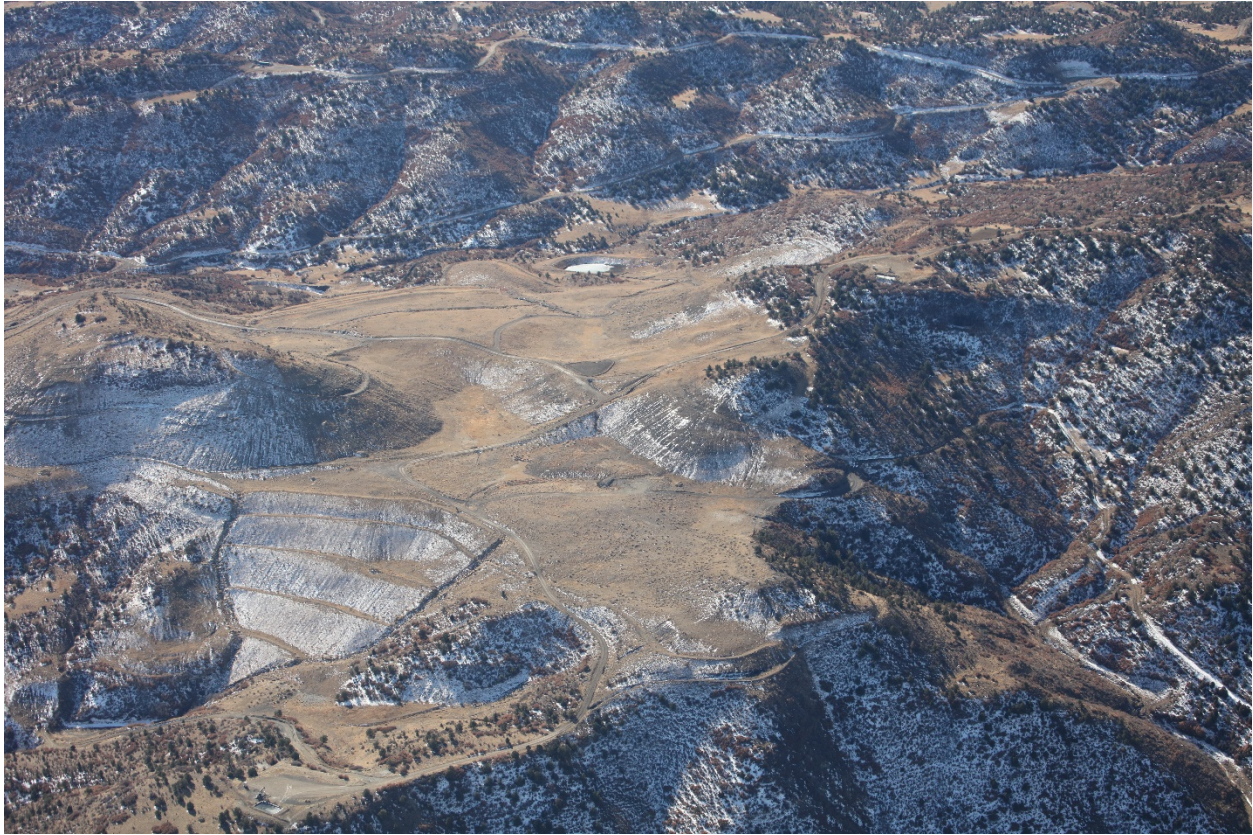
Fills 8, 9 and 7 were observed. Fill 8 was partially snow covered but appeared stable. Fill 7 and 9 were clear of snow, the vegetation on these piles appeared well established and the face of the fill appeared stable.

The reclaimed area above the fills appeared stable. The rills observed in previous DRMS inspections are present.

*Figure 1. Fill 8, and top of the reclaimed area from the north looking south.*

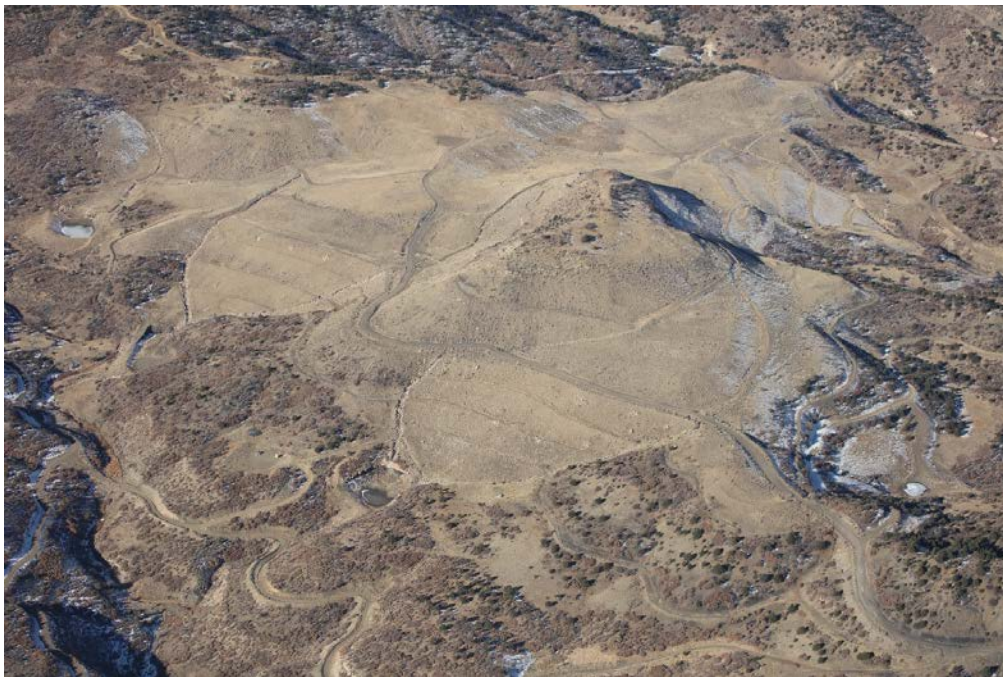
Pond 009a was holding water but did not appear to be discharging. The embankment of the pond was stable and vegetated.

Pond 007 appeared to be dry. The embankment was stable and vegetated.

Pond 006 was holding water but did not appear to be discharging. The embankment of the pond was stable and vegetated.

*Figure 3. Fill 9, Fill 7, Ponds 006, 007 and 009a*
