**MINERALS PROGRAM INSPECTION REPORT**  
**PHONE: (303) 866-3567**

<b>MINE NAME:</b> Climax Mine	<b>MINE/PROSPECTING ID#:</b> M-1977-493	<b>MINERAL:</b> Molybdenum	<b>COUNTY:</b> Lake, Summit
<b>INSPECTION TYPE:</b> Monitoring	<b>INSPECTOR(S):</b> Dustin Czaplá	<b>INSP. DATE:</b> January 7, 2022	<b>INSP. TIME:</b> 10:00
<b>OPERATOR:</b> Climax Molybdenum Company	<b>OPERATOR REPRESENTATIVE:</b> Diana Kelts	<b>TYPE OF OPERATION:</b> 112d-3 - Designated Mining Operation	
<b>REASON FOR INSPECTION:</b> Normal I&E Program	<b>BOND CALCULATION TYPE:</b> Complete Bond	<b>BOND AMOUNT:</b> \$91,011,850.00	
<b>DATE OF COMPLAINT:</b> NA	<b>POST INSP. CONTACTS:</b> None	<b>JOINT INSP. AGENCY:</b> None	
<b>WEATHER:</b> Clear	<b>INSPECTOR'S SIGNATURE:</b>

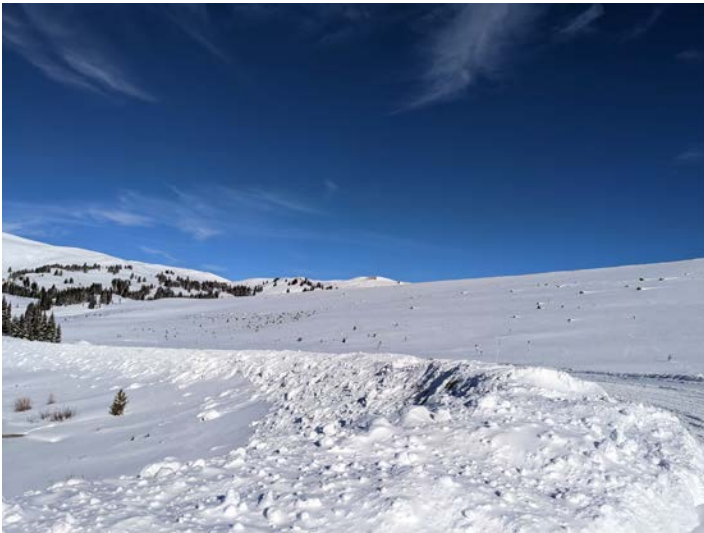
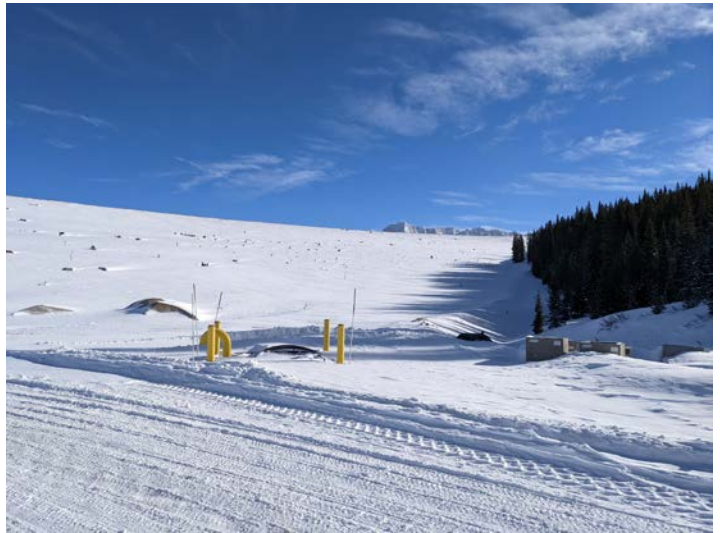
1 Dam

1 Dam, 3 Dam and 5 Dam were observed. The dams were under snow cover, up to approximately one foot depth. No staining or discoloration was noted at any of the TSF dams. No abnormal conditions were noted.

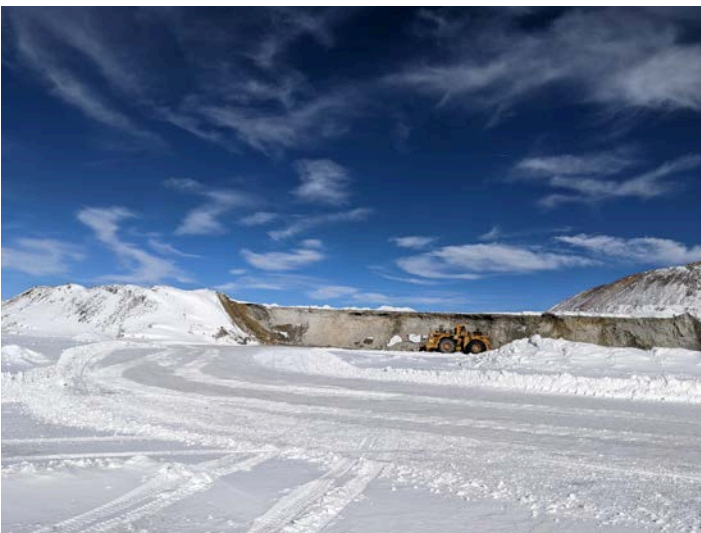
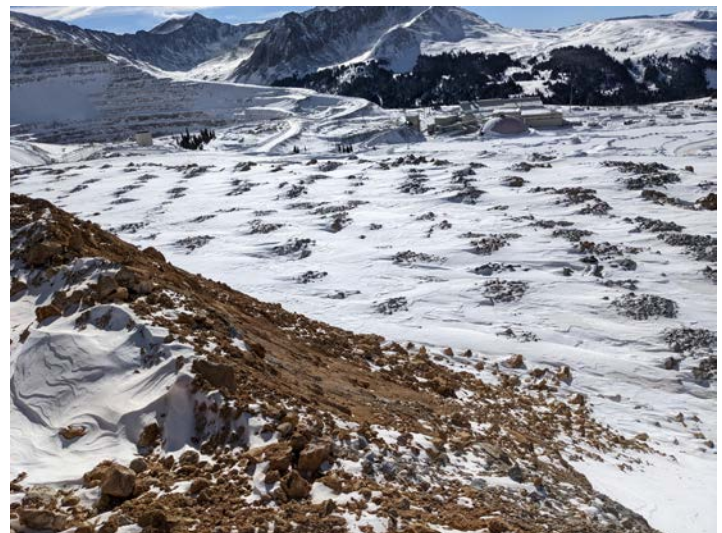
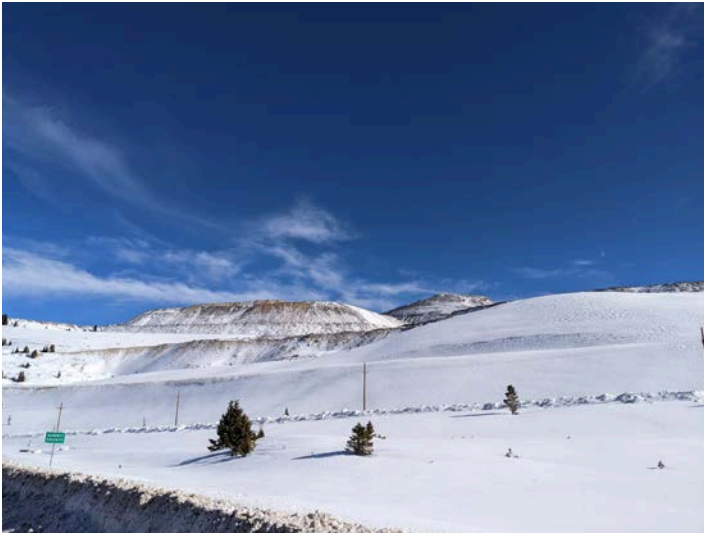
North 40 OSF

The McNulty and North 40 OSF's were observed. There was snow cover on most of the OSF area, up to approximately one foot depth. The current OSF operating plan was drafted by Golder Associates in December 2016. The plan was submitted to the Division as part of TR-25. Golder states that snow accumulations of up to 2-3 feet on OSF faces do not significantly impact operation of large OSFs, however larger accumulations greater than 3 feet can become trapped as a continuous layer and form a weak layer or saturate finer grained layers as melting occurs. Therefore Golder recommended that waste rock only be deposited on slopes with less than 3 feet of snow accumulation. This inspection confirmed that Climax is limiting waste rock deposition to slopes with little to no snow accumulation, and therefore appears to be in compliance with Golder recommendations for winter time OSF operations.

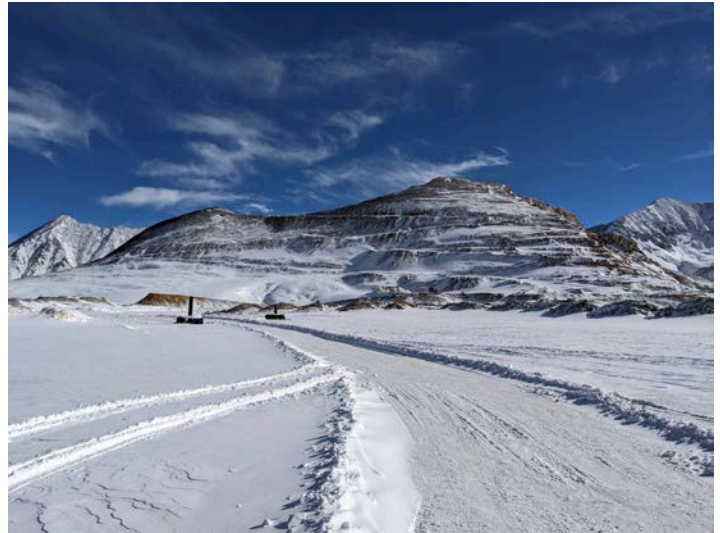
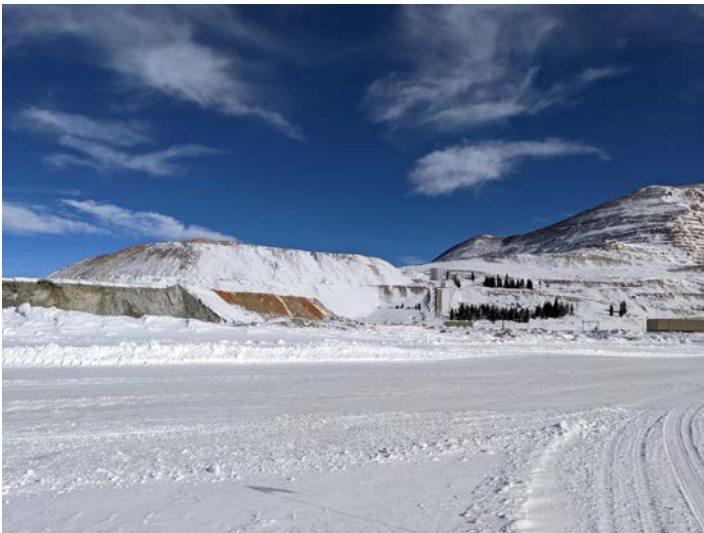
McNulty OSF viewed from North 40 OSF
