MINERALS PROGRAM INSPECTION REPORT
PHONE: (303) 866-3567

MINE NAME: Climax Mine	MINE/PROSPECTING ID#: M-1977-493	MINERAL: Molybdenum	COUNTY: Lake, Summit
INSPECTION TYPE: Aerial Inspection	INSPECTOR(S): Dustin Czapla	INSP. DATE: January 10, 2022	INSP. TIME: 13:00
OPERATOR: Climax Molybdenum Company	OPERATOR REPRESENTATIVE:	TYPE OF OPERATION: 112d-3 - Designated Mining Operation	
REASON FOR INSPECTION: Normal I&E Program	BOND CALCULATION TYPE:	BOND AMOUNT: \$91,011,850.00	
DATE OF COMPLAINT: NA	POST INSP. CONTACTS: None	JOINT INSP. AGENCY: None	
WEATHER: Clear	INSPECTOR'S SIGNATURE:

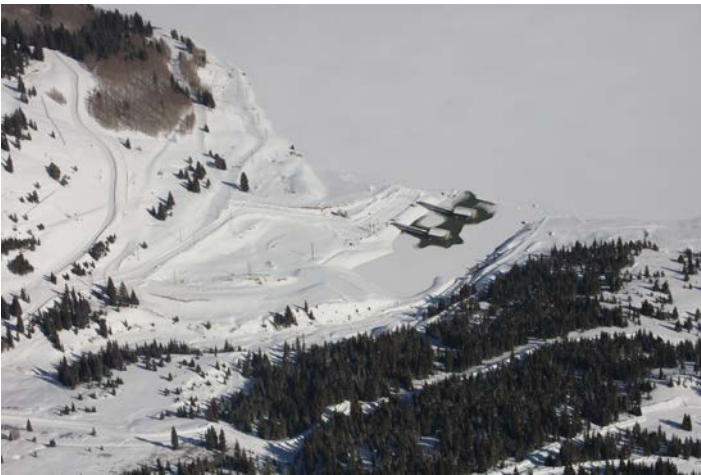
The Mayflower TSF and 5 Dam, Tenmile TSF and 3 Dam, Robinson TSF and 1 and 2 Dams, Robinson Lake, Eagle Park Reservoir and 4 Dam were observed. The area was under snow cover, up to approximately one foot depth. No staining or discoloration were noted at any of the TSF dams. No abnormal conditions were noted. TSF's appear to be functioning within the established design criteria.

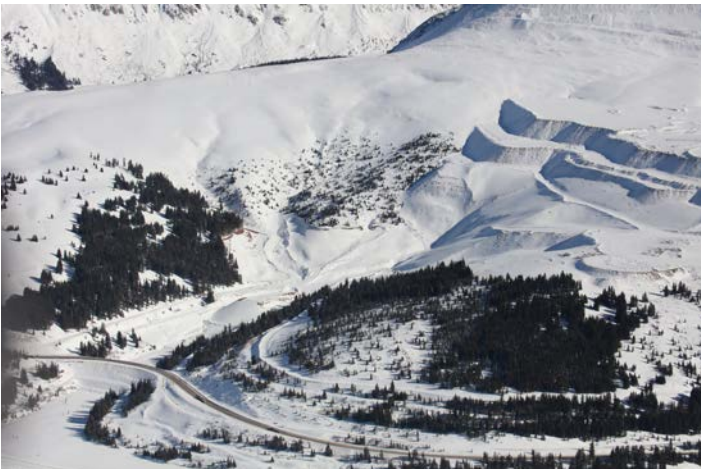
McNulty OSF

The McNulty and North 40 OSF's were observed. Snow cover on the OSF's appeared to be about one foot depth. The current OSF operating plan was drafted by Golder Associates in December 2016. The plan was submitted to the Division as part of TR-25. Climax appears to be in compliance with Golder recommendations for OSF operations. No problems were noted with the OSF's.
