MINERALS PROGRAM INSPECTION REPORT
PHONE: (303) 866-3567

MINE NAME: Carol Ann Pit	MINE/PROSPECTING ID#: M-1997-026	MINERAL: Sand and gravel	COUNTY: Eagle
INSPECTION TYPE: Preoperation Inspection	INSPECTOR(S): Dustin Czapla	INSP. DATE: January 7, 2022	INSP. TIME: 13:00
OPERATOR: Carol Ann Pit LLC	OPERATOR REPRESENTATIVE:	TYPE OF OPERATION: 112c - Construction Regular Operation	
REASON FOR INSPECTION: Preoperation Inspection	BOND CALCULATION TYPE: Complete Bond	BOND AMOUNT: \$77,900.00	
DATE OF COMPLAINT: NA	POST INSP. CONTACTS: None	JOINT INSP. AGENCY: None	
WEATHER: Clear	INSPECTOR'S SIGNATURE:

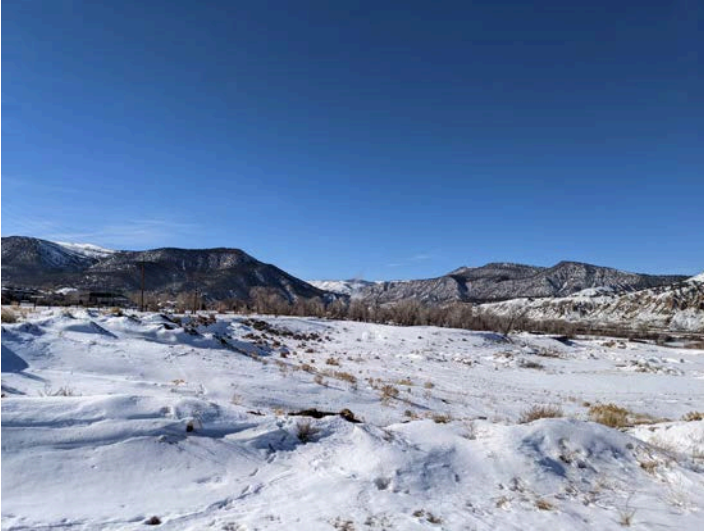
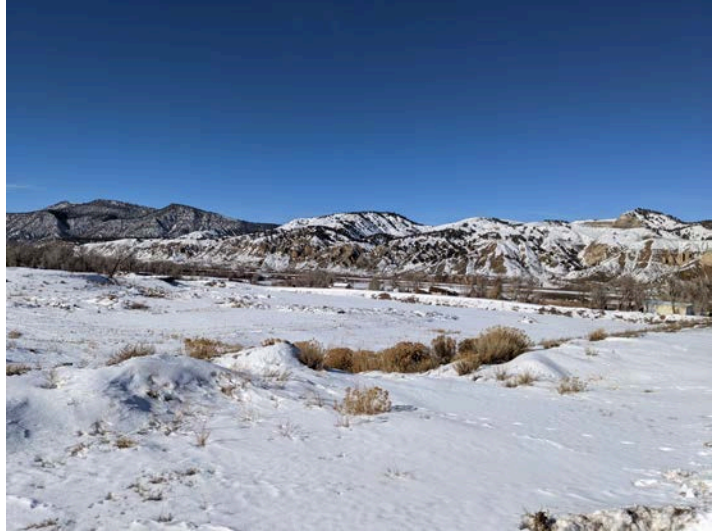
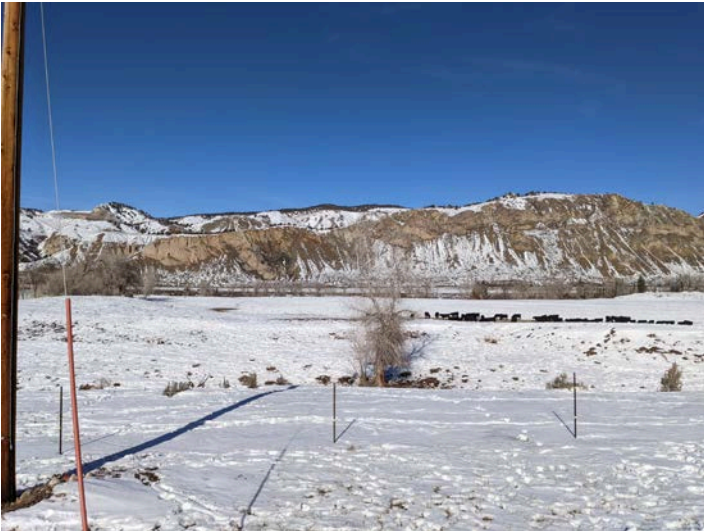
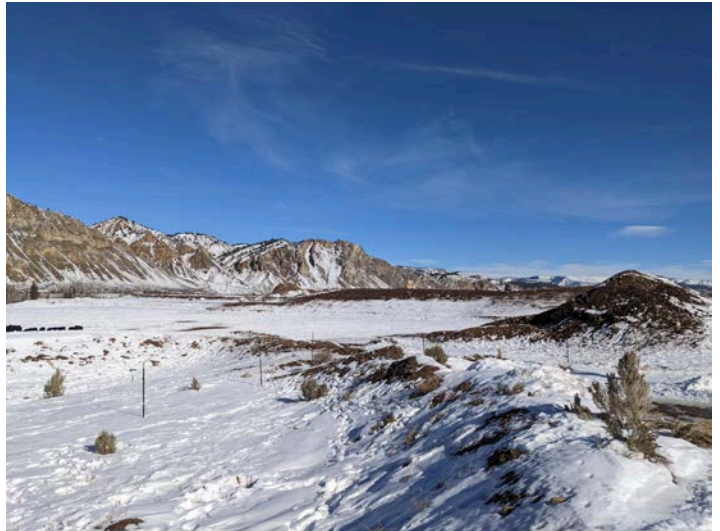
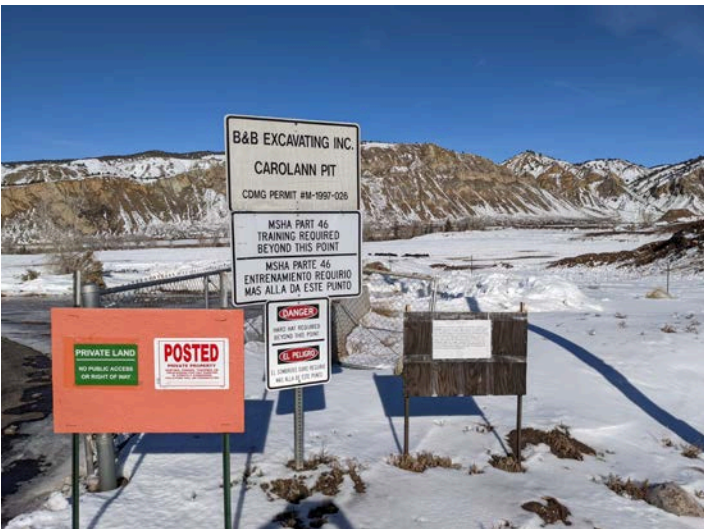
Adequate mine identification signage was noted at the entrance to the site.

The east part of the permit area has been reclaimed to pastureland. There were cattle in this area during the inspection. Reclaimed slopes around the pit area appear to be 3H:1V and stable.

Partial reclamation has been completed in the west part of the permit area. The pit slopes have mostly been reduced to 3H:1V and appear stable, but final grading is not quite complete. Stockpiles of construction materials were not noted in the pit area.
