Fwd: Mica White Quarries Mining Continuation Recommendations

From: Darin Duran <DDuran@cesareinc.com>
Date: January 11, 2022 at 4:46:35 PM MST
To: Bill Tezak <Bill@coloradoquarries.com>
Cc: Aaron Tezak <Aaron@coloradoquarries.com>
Subject: Mica White Quarries Mining Continuation Recommendations

At your request, Cesare, Inc. (Cesare) visited the Mica White Quarry on December 21, 2021 to observe the condition of the slope in the area of current mining activity at the quarry. It is our understanding that during excavation of the northwest highwall, a crack form above the excavation face. The location of the northwest highwall (arrows) and the crack (red line) are shown below in Exhibit 1. It is also our understanding that the crack formed during excavation of Bench 2 of the northwest highwall (Photo 1).

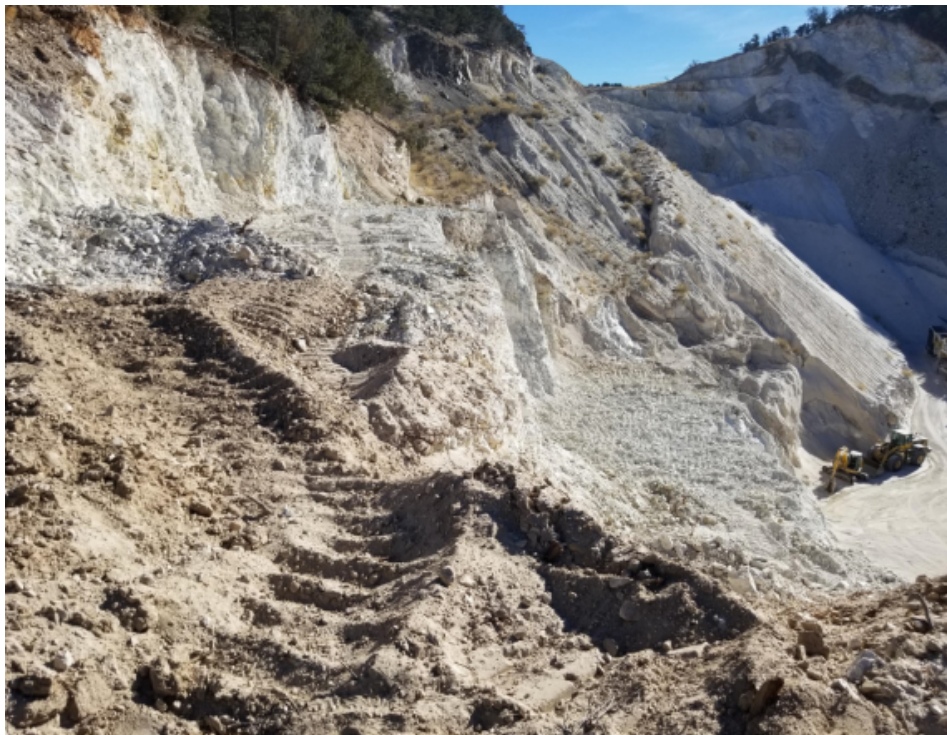
Photo 1. View of Benches 1 (right) and 2 (left) on the northwest highwall.

The crack at the time of our visit did not show any signs of vertical displacement. The dip of the crack as observed in a cut face of an access road was about 75 degrees. We did not observe any signs of toe bulging in any of the benches in the northwest highwall. Cracking also occurred during mining of the NE/E highwall. The cracks in the NE/E highwall did not appear to extend to the cut face but terminated after 10's of feet (estimated as the area could not be safely accessed).

The cracking is likely associated with stress relief along predominant jointing orientation. The stress relief occurred during excavation of Bench 2. The likely instability will be toppling, where blocks rotate off the top, or high angle planar sliding. This is consistent with the description of the behavior of the NE/E highwall face. If this crack remains consistent in behavior, the risk of a large catastrophic failure of the northwest highwall is low.

Cesare recommends to conduct the excavation from the top down. The purpose is to reduce the driving forces in the slope. Additional excavation of Bench 2 into the slope should be avoided at this time as this can reduce the resisting forces. Blocks may topple or slide effecting individual benches, especially near the top. These blocks can cause debris to slide down to lower benches. The occurrence of these blocks should be monitored, especially above the upper bench. If the cracking increases in width or instability is noted, the unstable blocks can be scaled back. It is our understanding that the crack in the access road has been covered. The subgrade of the road should be monitored for the crack reappearing. If the crack reappears, then the stability should be re-evaluated.
