Re: GCC Energy, LLC, King II Mine
CDRMS Permit # C-1981-035
Stoner Engineering: Quarterly Inspection: Water Quality Improvements
4th Quarter 2021

Date: December 17, 2021

Re: King Coal I – Quarterly Water Quality Improvements Inspection

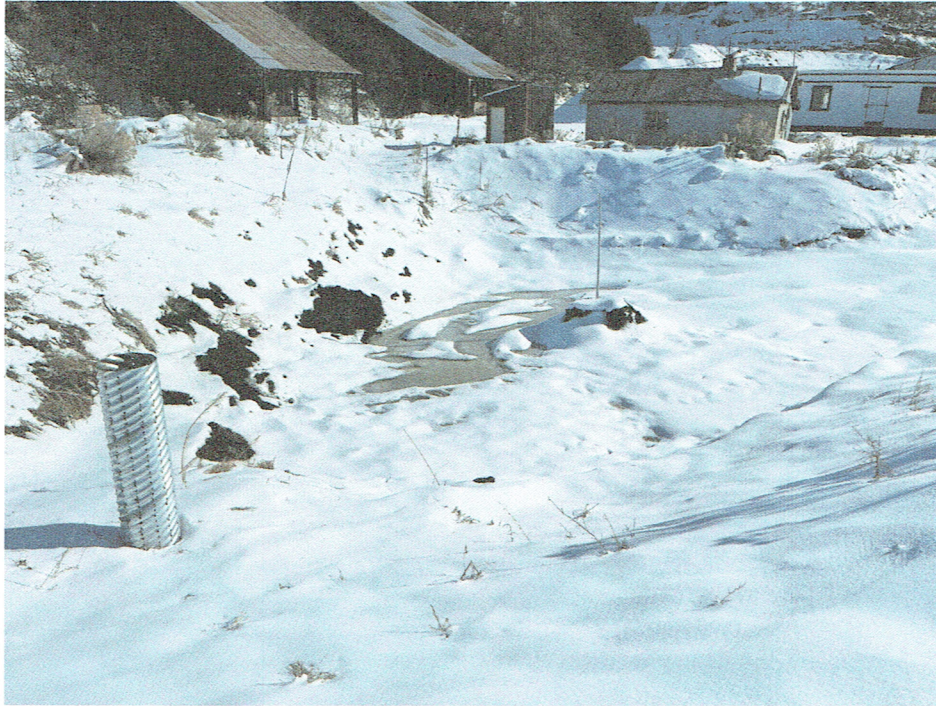
There was snow present at the time of the inspection making a visual inspection of the drainage features difficult. There was water noted in the east pond in the form of ice (see Pic. 1). The west pond had no ice visible but was covered in drifted snow. The pond maintenance does not appear to have been completed. The east pond appears to have had the excess material removed; however, the west pond appears to have been partially completed due to the visible change in the depth of the pond near the sediment gage (see Pic. 2). The stockpiled material removed from the ponds has been installed most likely in the lower waste pile. While the maintenance was not completed, the capacity of the ponds has been improved. The ponds should continue to be monitored after storm events to ensure that excess sediment does not reduce the required storage capacity available for storm water runoff.

Pic. 1 –East pond covered with snow, some ice present.

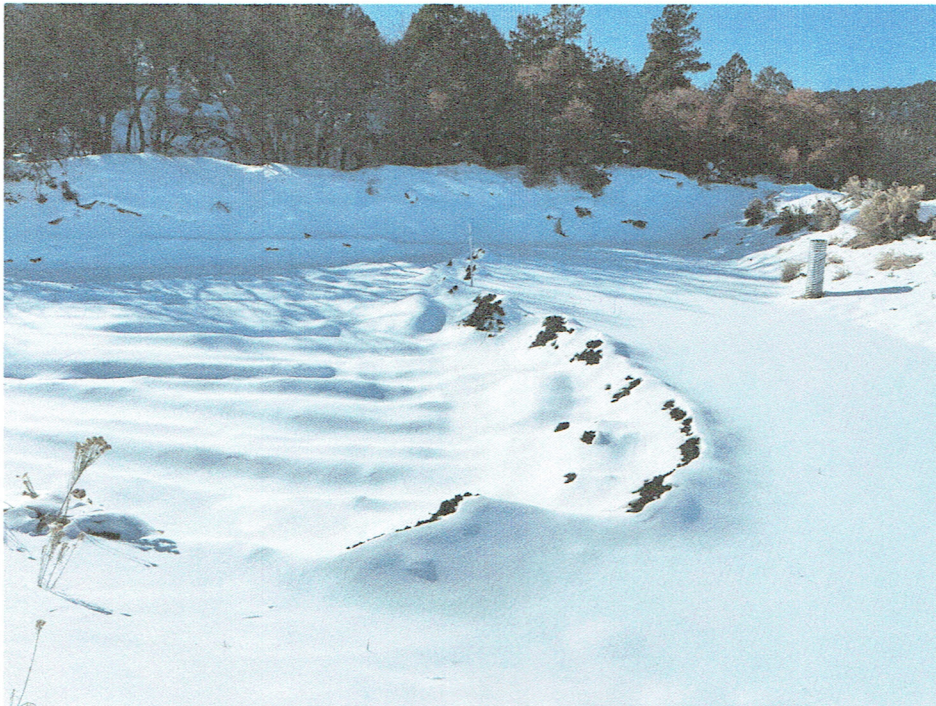
Pic. 2 – West pond covered in snow, excess sediment removal progress to date.

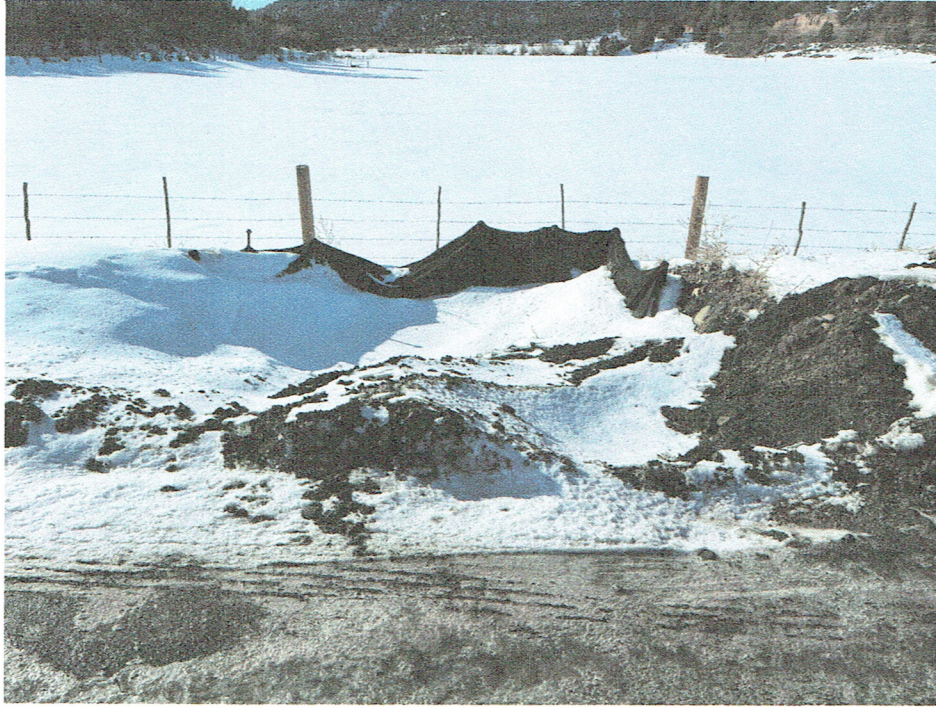
The sedimentation traps at the entrance to the site are generally in good condition. The ongoing snow removal operations have created berms in front of the sediment traps (see Pic. 3). The culvert leading into the east detention pond also has snow piled in front of its opening (see Pic. 4). These piles may limit the ability of runoff to flow through these drainage features which could result in additional maintenance of other areas within the site as well as creating a saturated area in and around the detention ponds. The inlets to these areas should be cleared to prevent runoff from bypassing these features. A portion of the lower site, south of the storm water detention ponds, is currently being utilized by a contractor (Weeminuche Construction Authority) as a field office.

Pic. 3 – Snow removal bermed/built up in front of sediment traps.

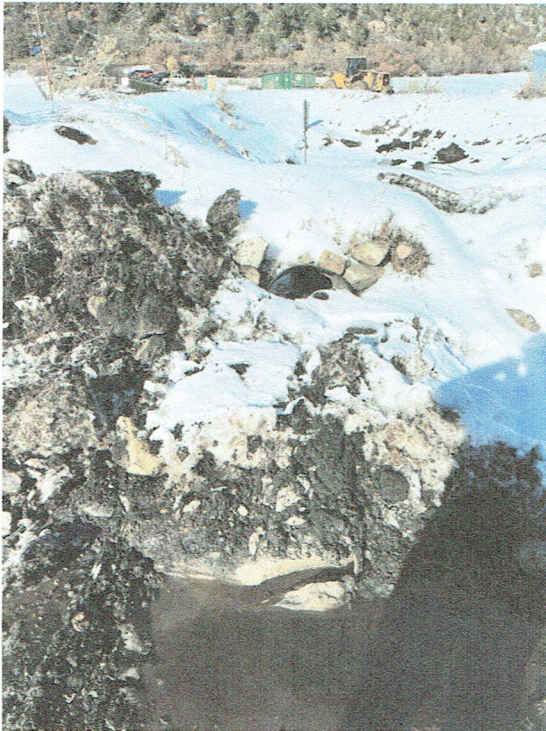
Pic. 4 – Culvert pipe to east detention pond blocked by snow removal operations.
