Re: GCC Energy, LLC, King II Mine CDRMS Permit # C-1981-035

Stoner Engineering: Quarterly Inspection: Refuse Pile

4th Quarter 2021

Re: King Coal I – Quarterly Waste Pile/Embankment Inspection

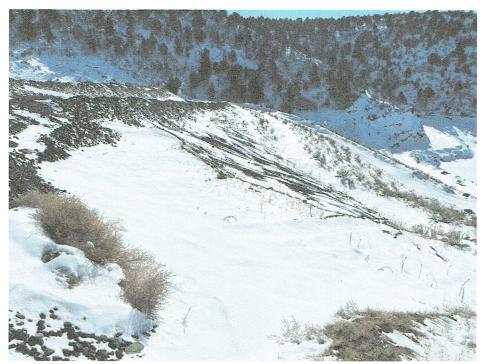
There was little to observe of the existing ditches and drainage features for the embankment waste pile due to the existing snow cover at the time of the inspection (see Pic. 1). The existing ditches were filled in with wind blown snow and most culverts were barely visible (see Pic. 2).

Pic. 1 – Upper embankment pile covered in snow.

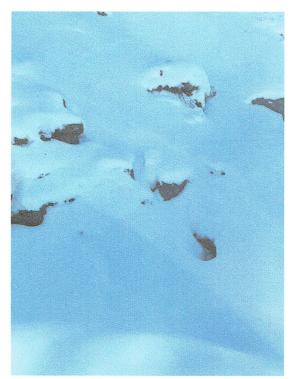
Pic. 2 – Reach 10 treated water channel covered in snow.

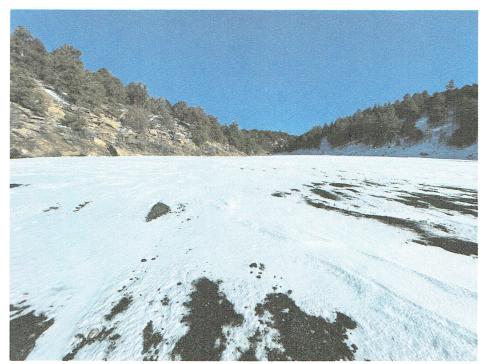
There has been minimal placement of additional waste material at the top of the main waste embankment pile since the previous inspection. There does not appear to be significant additional material installed on the lower pile either. There was no stockpiled material located on neither upper waste pile nor the lower waste embankment pile at the time of the inspection (see Pic. 3). The slope of the top of the existing pile is now closer to that defined in the Waste Bank Design produced by Don May, 1997.

Pic. 3 – Main waste pile no stockpiled materials.

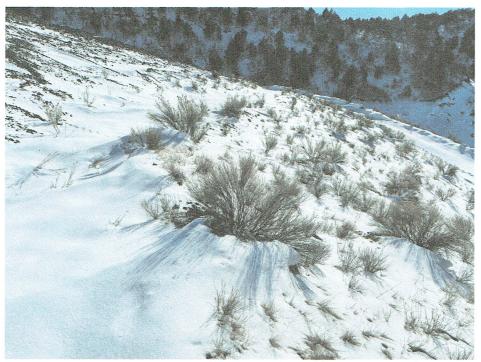
The face of the embankment was not visible due to snow cover though there were no signs of excessive erosion, instability, sloughing or weakness observed on the face of the embankment of either of the waste embankment piles at the time of the inspection (see Pic. 4).

Pic 4 – Face of the main waste pile covered in snow. No sign of slides.
