## Slope Stability Monitoring Report

Permit: M1973007SG  
ePermit Number: 615298  
Operation Name: Daniels Sand Pit 2

January 13, 2022  
Project No.: 19125

Regarding: Daniels Sand Pit 2, Permit No. M-1973-007-SG  
Slope Stability Monthly Monitoring Report

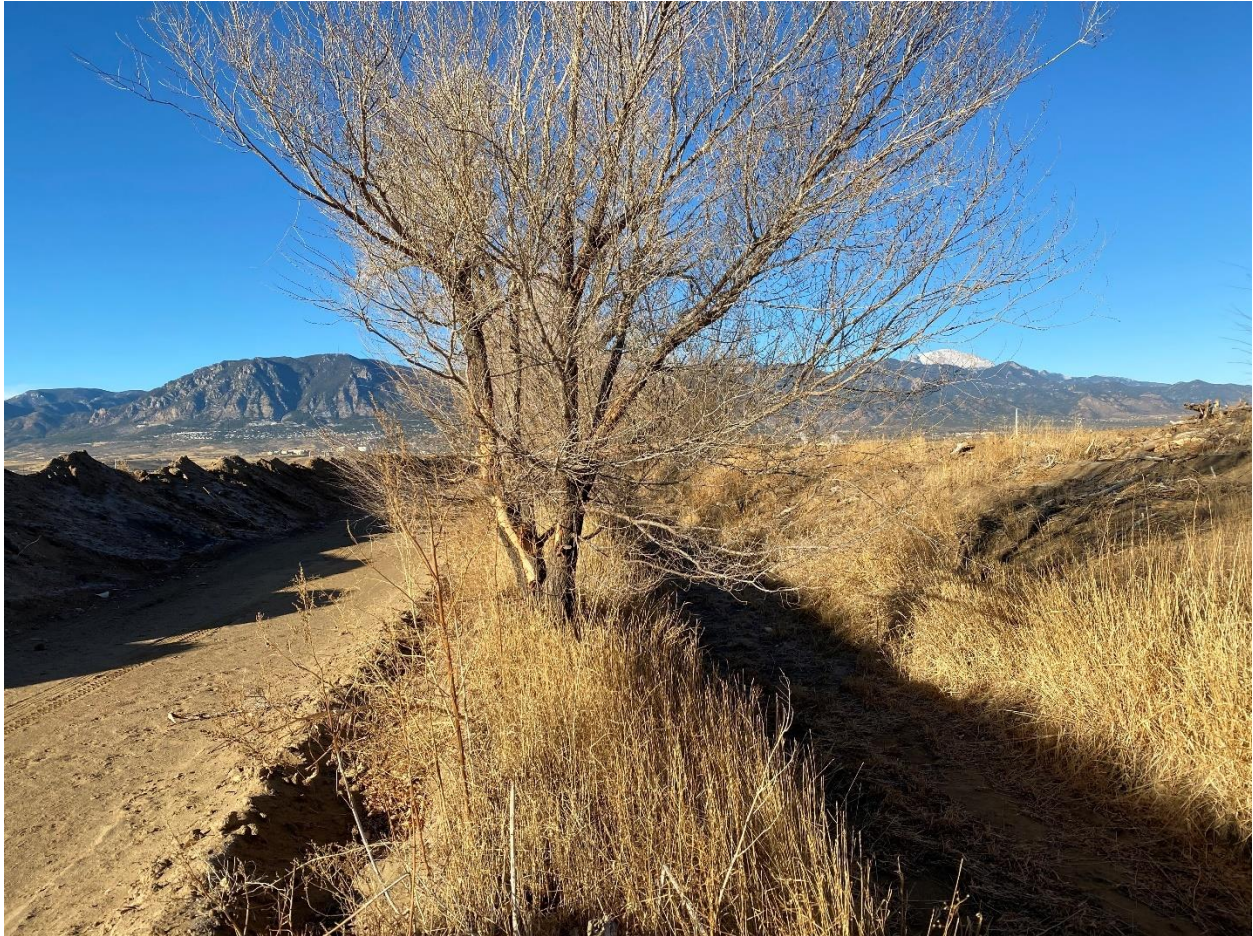
- Weather: 28°, sunny
- Visual observation of the Fountain Mutual Ditch:
  - No tension cracks
  - No toe erosion
  - No moisture changes, ditch is dry
  - No sloughed slope surfaces
  - Several broken branches near crest
  - The condition of the ditch is stable

Photo 1. Fountain Mutual Ditch looking west

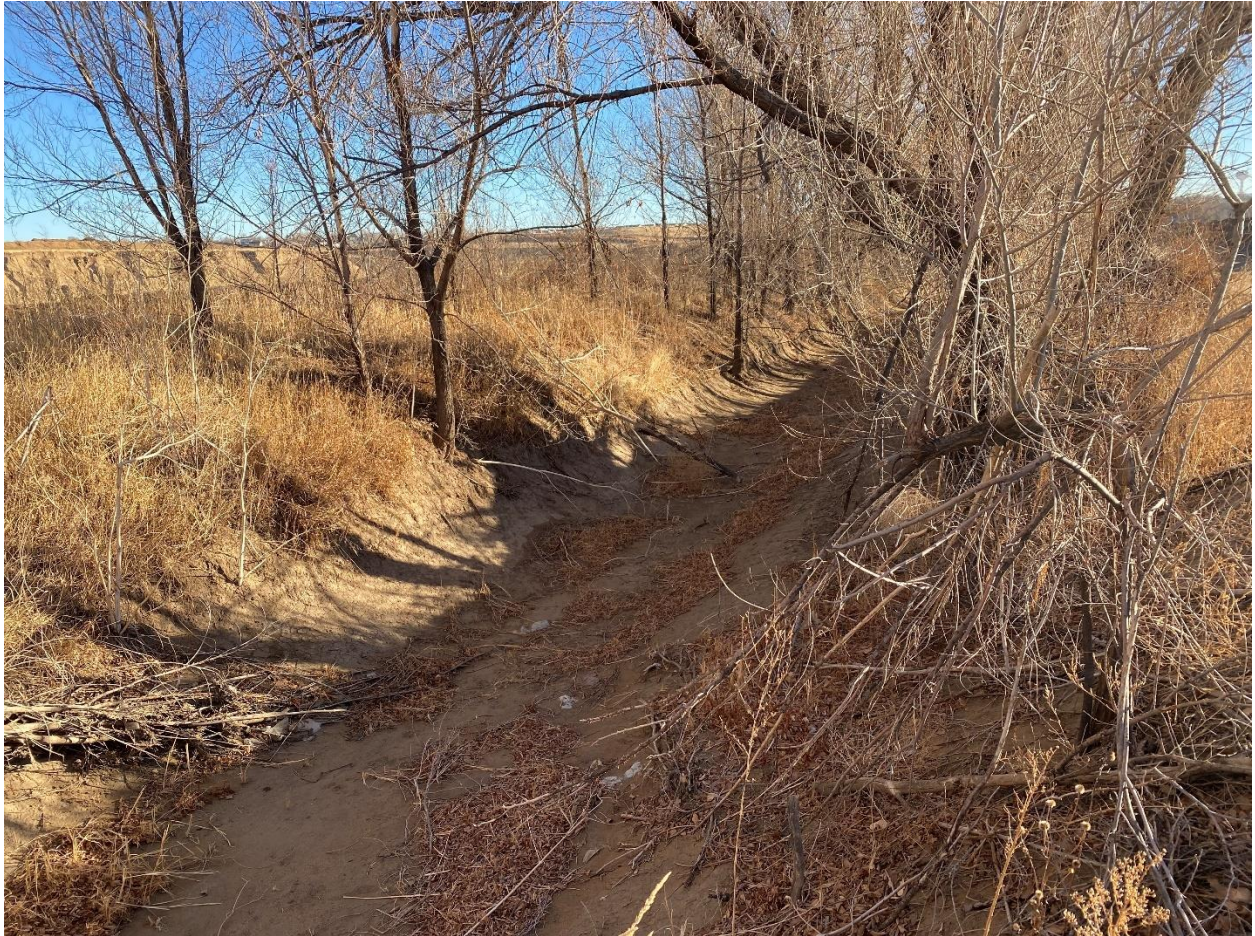
Photo 2. Fountain Mutual Ditch looking east

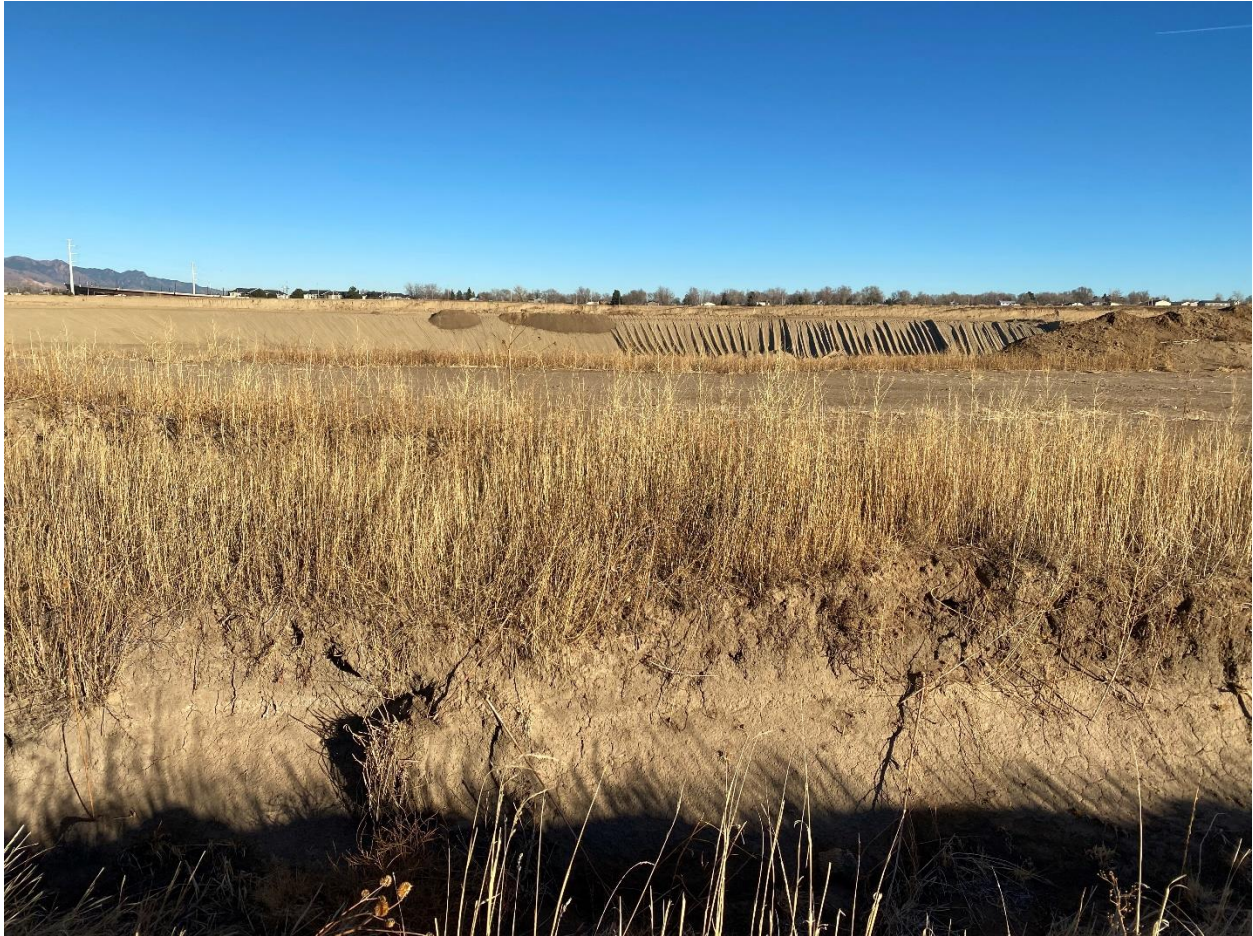
Photo 3. Fountain Mutual Ditch looking north

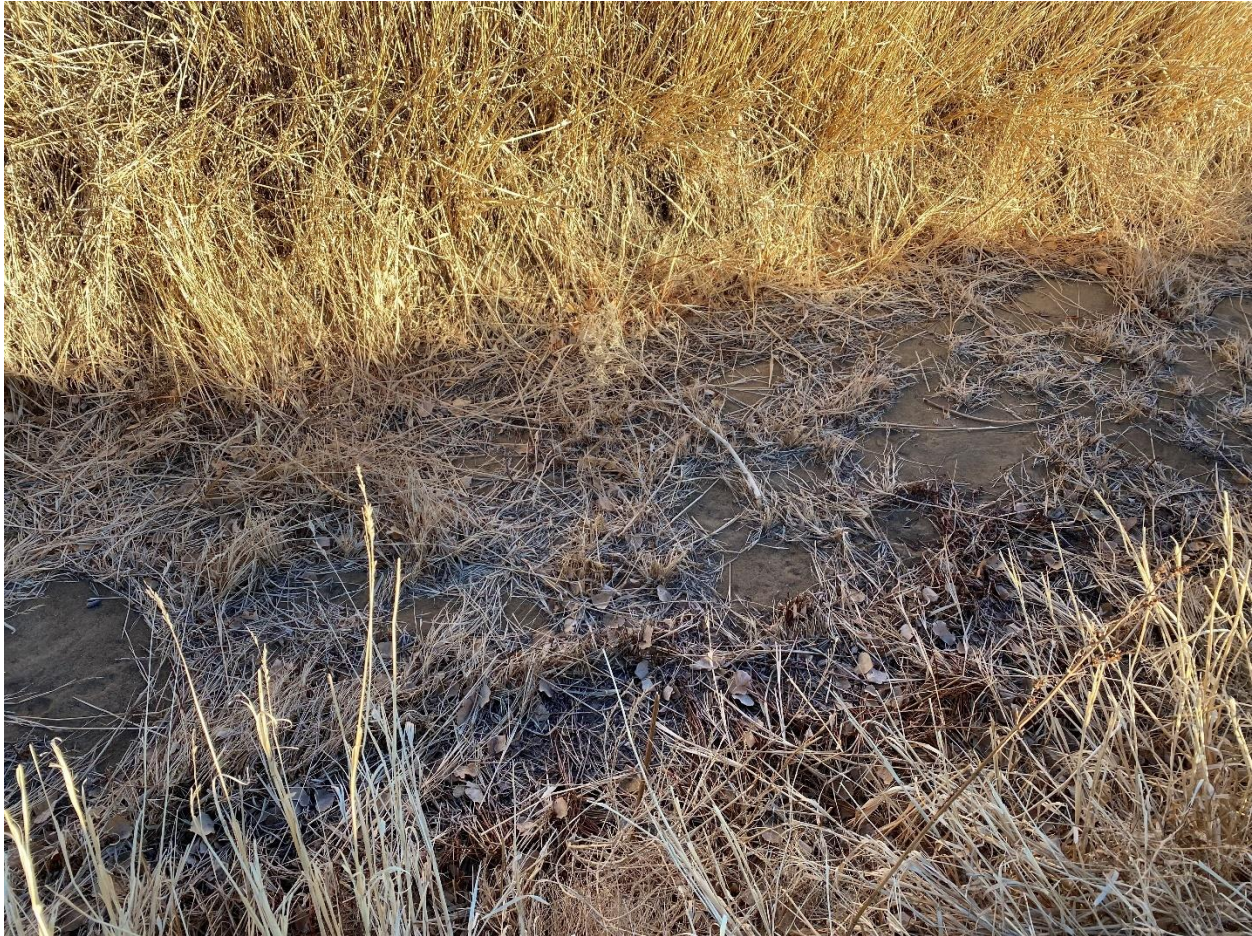
Photo 4. Fountain Mutual Ditch invert

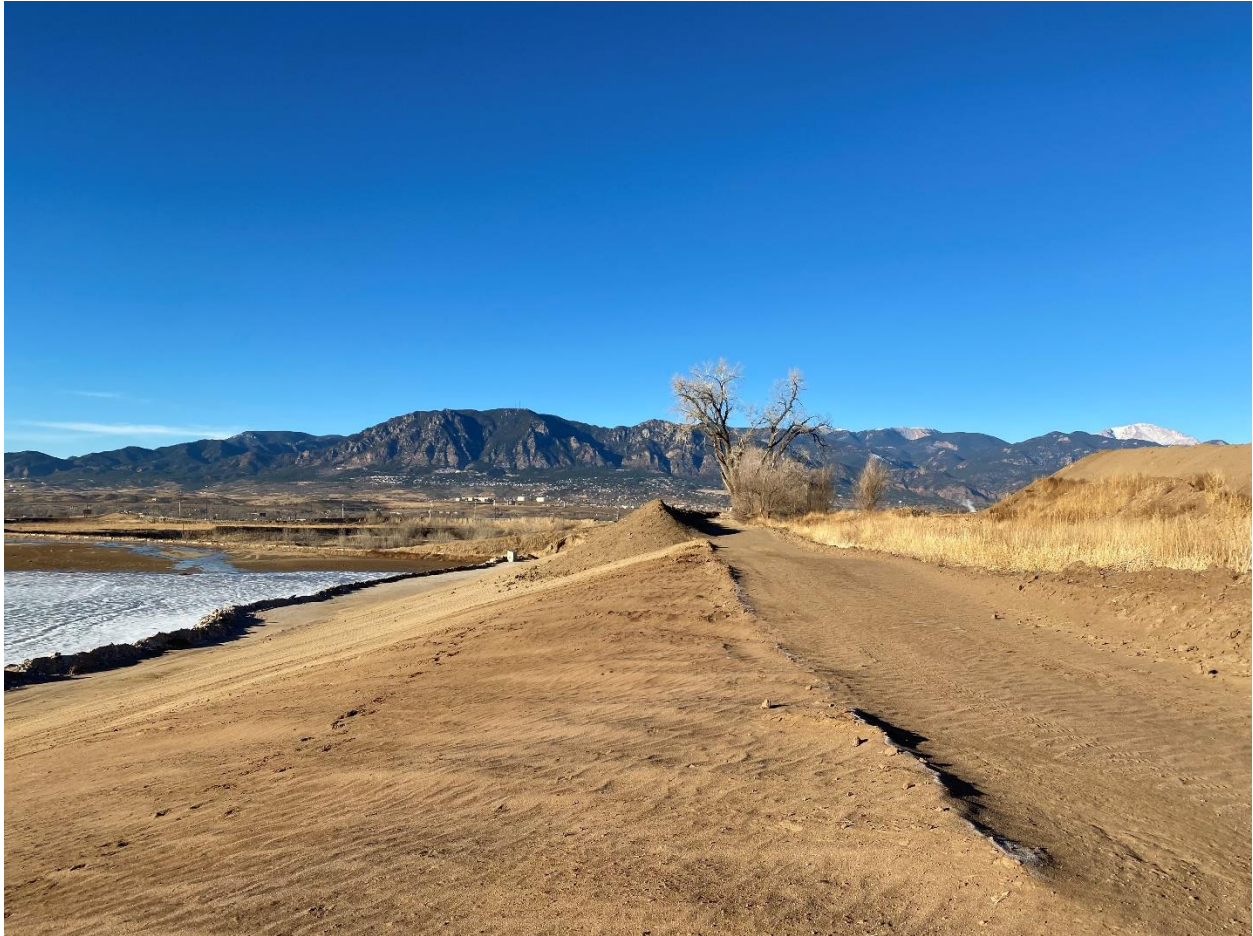
- Construction sequence
  - At this time, the buttress slope varies from 3H:1V to 4H:1V
  - Preparation for final lift
    - Stockpiled sand located at crest of embankment for the whole length

Photo 5. Stockpiled sand for final lift, access road and ditch (looking west)

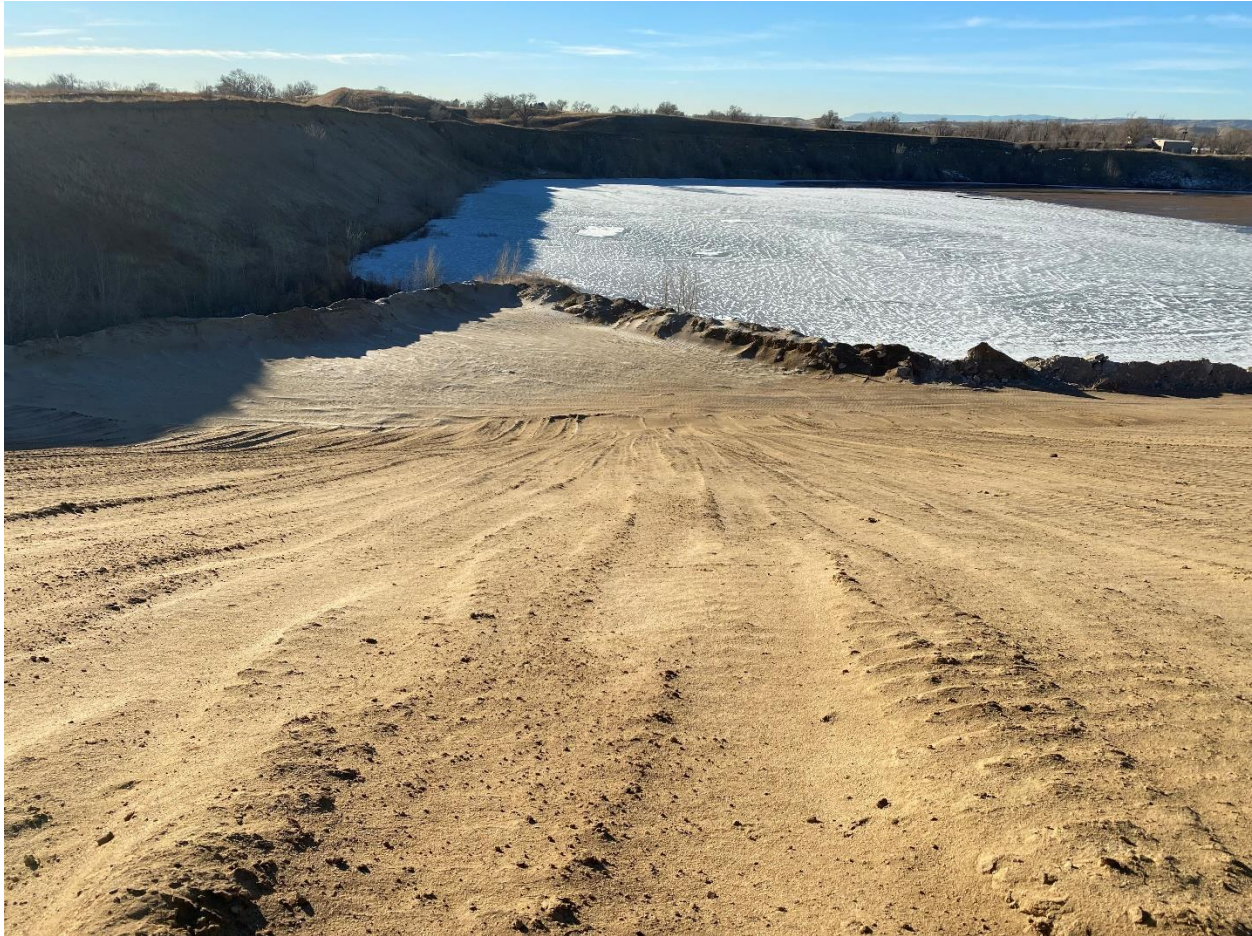
Photo 6. Buttress slope
