COLORADO
Division of Reclamation,
Mining and Safety
Department of Natural Resources

Permit Number: C-1981-041 Mine Name: Roadside Portals Operator: Snowcap Coal Company, Inc. Operator Address: MS Tonya Hammond P.O. Box 1430 Palisade, CO 81526	County: Mesa Operation Type: Underground Permit Status: Active Ownership: Private
	Operator Representative Present: Tonya Hammond
Operator Representative Signature: (Field Issuance Only)

Inspection Start Date: January 18, 2022 Inspection Start Time: 09:15 Inspection End Date: January 18, 2022 Inspection End Time: 09:50		Inspection Type: Coal Partial Inspection Inspection Reason: Normal I&E Program Weather: Cloudy	
Joint Inspection Agency: None		Joint Inspection Contacts: None	
Post Inspection Agency: None		Post Inspection Contacts: None	
Inspector(s): Clayton Wein	Inspector's Signature: <i>Clayton Wein</i>		Signature Date: 1/18/2022

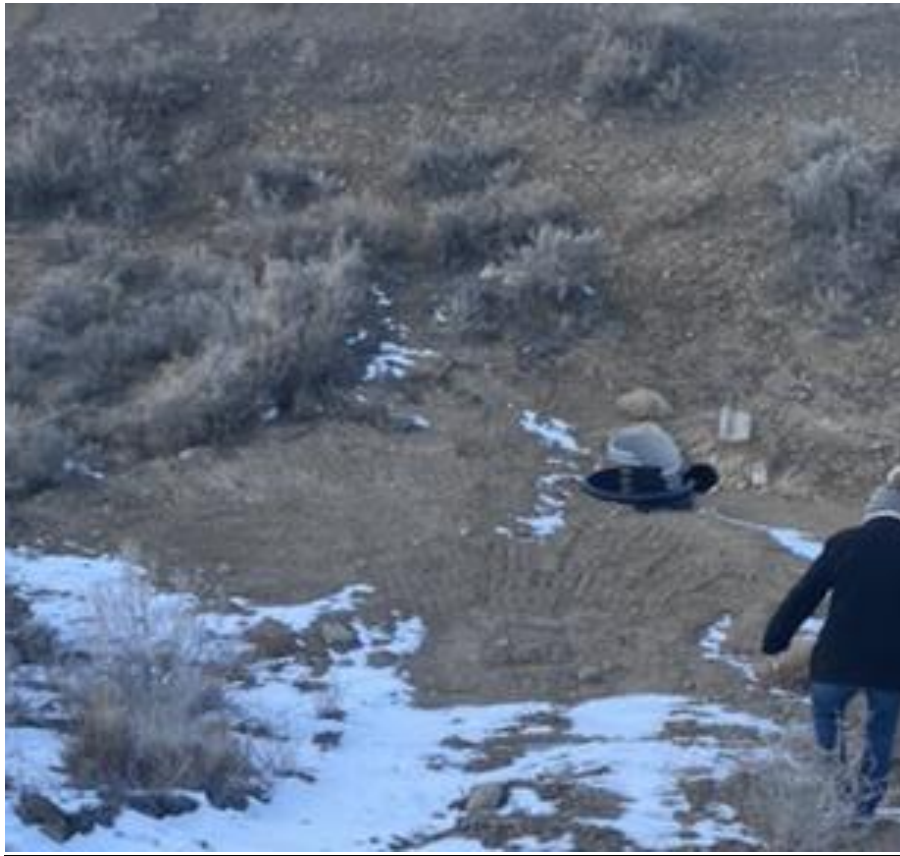
The discharge point 016 was visited during the inspection. The maintenance work at the site had been completed (Photo 1). The small amount of disturbance made had been ripped and reseeded (Photo 2). There was snow covering some of the north-facing slope. The site was stable and there were no off site impacts observed. There are two stations at the discharge point to access 016. The first is an access point for the valve, the second is for the discharge meter and sampling point. The discharge rate at the time of the inspection was recorded to be 125.1 gpm.

Photo 1: The completed maintenance at the site of the 016 Discharge Point. 016 is located in the gray upturned culvert. The Valve for 016 is located in the upturned black culvert.

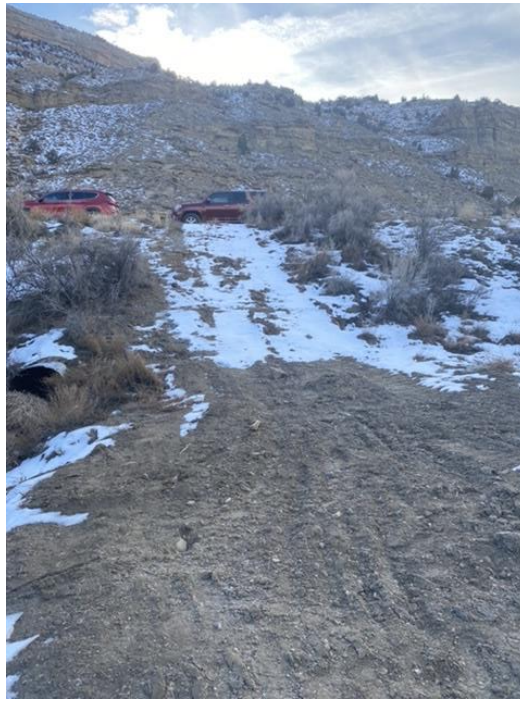
Photo 2: The ripped and reseeded portion of the access used to perform the 016 maintenance.

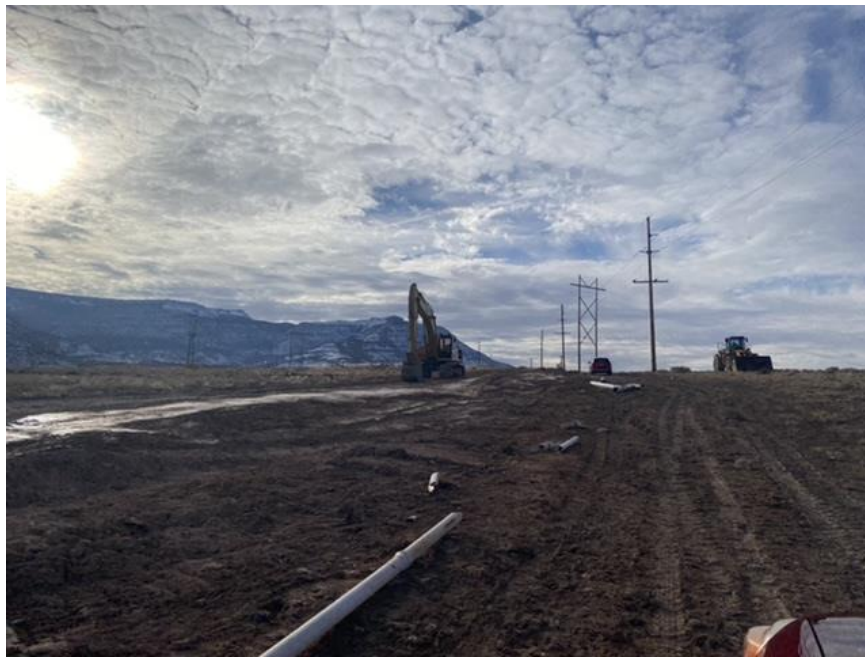
Work conducted on top of the Tract 70 Mesa was observed during the inspection. The landowner had a few pieces of equipment on site and a large portion of the landowner's pipeline was observed to be removed and laying on the side of the access road. Much of where the pipe was buried was observed to be re-covered with soil (Photo 3). None of the work conducted on the Tract 70 Mesa was created by SCC; therefore, SCC is not liable for the disturbance created at the site.

Photo 3: The landowner's work being conducted on top of the Tract 70 Mesa.

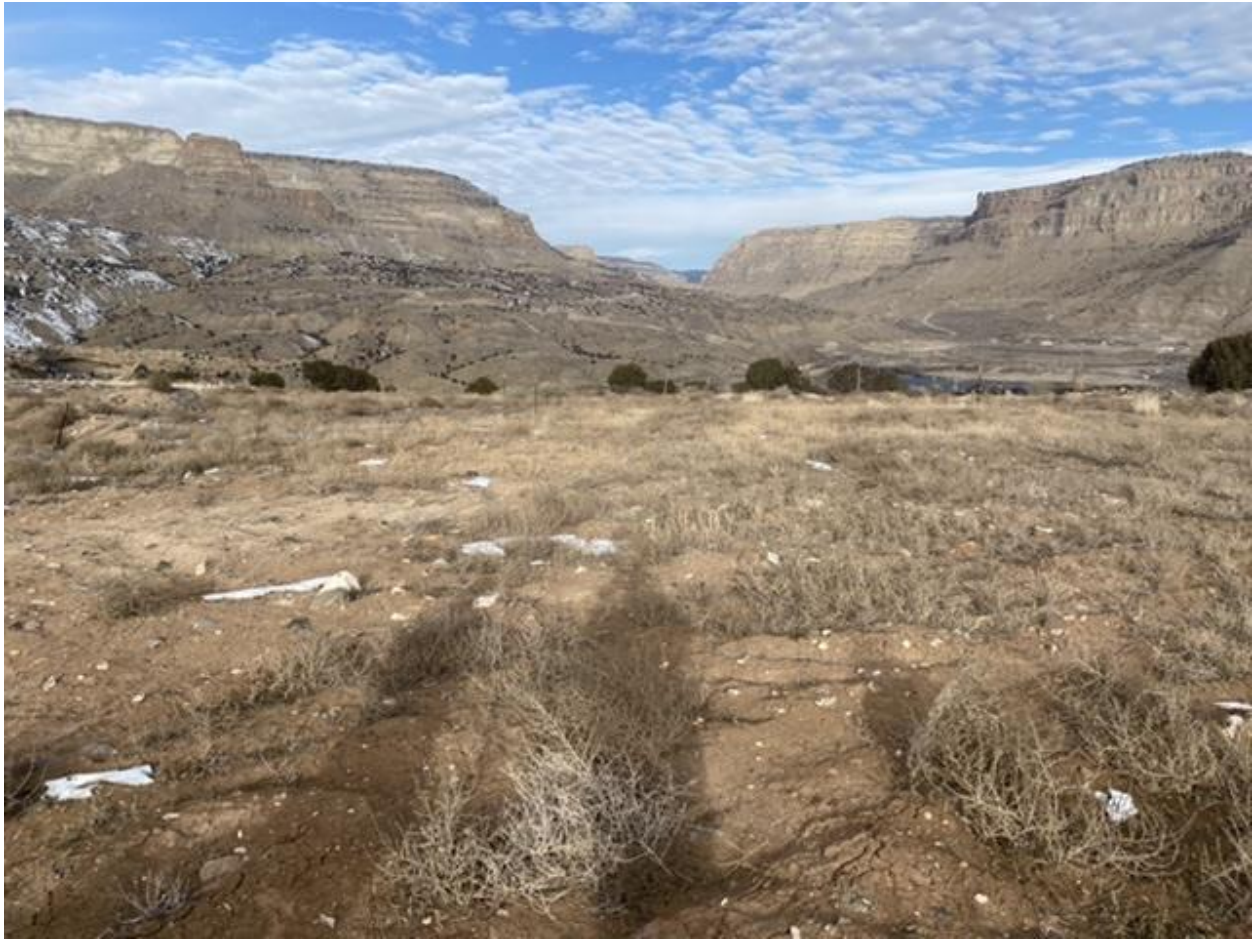
The TR-69 Repair area, located in the southwest portion of the permitted area, was observed to be stable with vegetative cover (Photo 4). There was hardly any snow left at the site. The disturbed area markers were observed to be in place. The sediment logs were intact and in good condition. No indications of surface settling or erosion were identified. No off site impacts were observed.

Photo 4: The TR-69 Repair area. Photo was taken looking to the northwest.
