MINERALS PROGRAM INSPECTION REPORT

MINE NAME: Cross Gold Mine	MINE/PROSPECTING ID#: M-1977-410	MINERAL: Gold, copper, silver, zinc and lead	COUNTY: Boulder
INSPECTION TYPE: Monitoring	INSPECTOR(S): Amy Eschberger, Michael Cunningham, Russ Means	INSP. DATE: January 11, 2022	INSP. TIME: 09:45
OPERATOR: Grand Island Resources LLC	OPERATOR REPRESENTATIVE(S): Richard Mittasch, Daniel Pollock, Daniel Takami	TYPE OF OPERATION: 110(2) - Hard Rock Limited Impact

M-1977-410 / Cross Gold Mine / Grand Island Resources LLC / 110(2) Permit

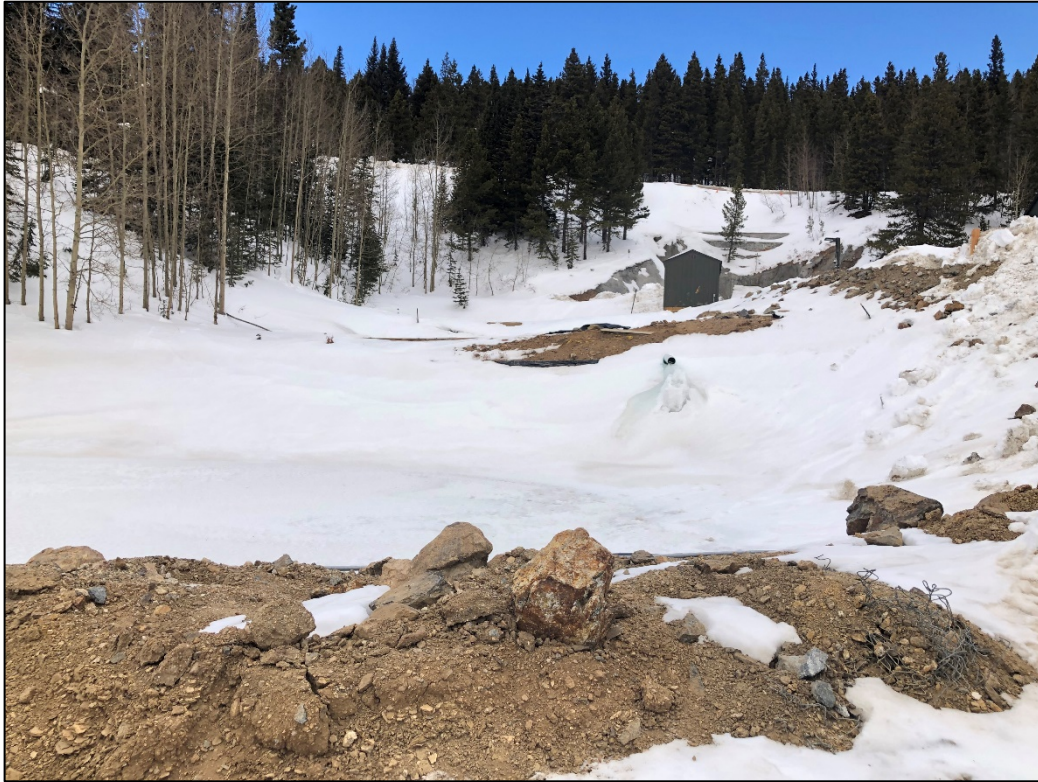
Photo 1. View looking northwest across Ponds 3A-C (covered with snow) at the Caribou Mine. Discharge from the Caribou Mine is currently routed to Pond 1 to combine with Cross Mine water prior to entering the new water treatment system.

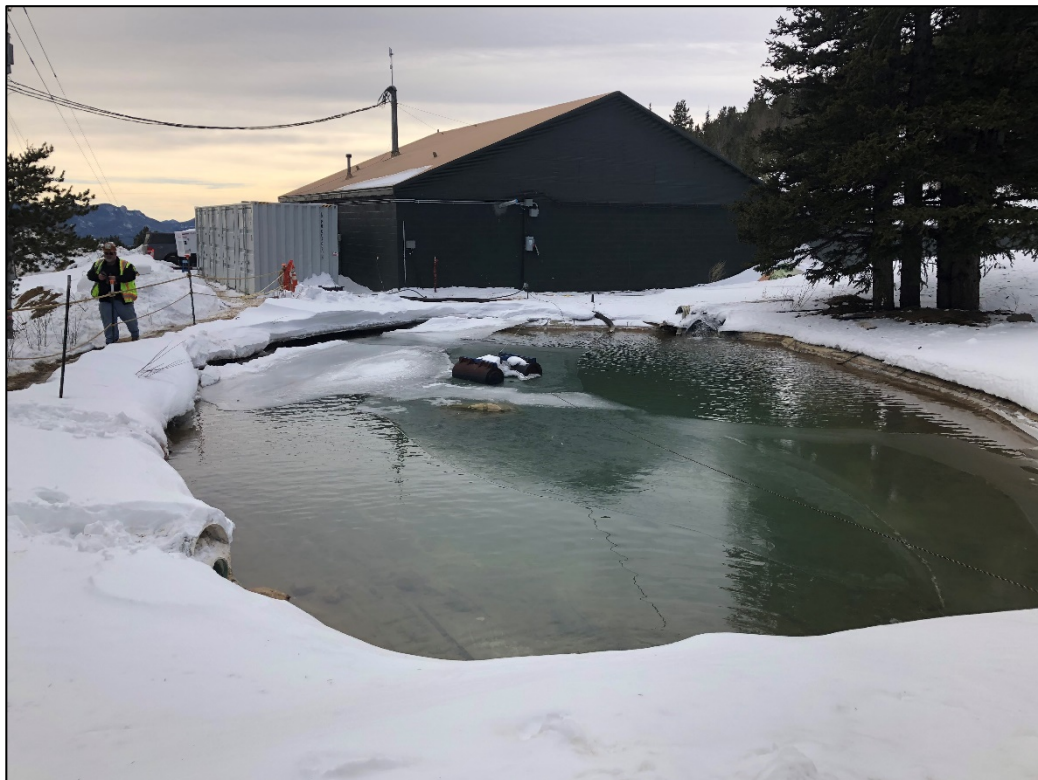
Photo 2. View looking southeast across Pond 1 at the Cross Mine. Discharge from both the Caribou and Cross mines is currently routed to this pond, from which, it is pumped to the new treatment system (inside insulated Conex box visible in background).

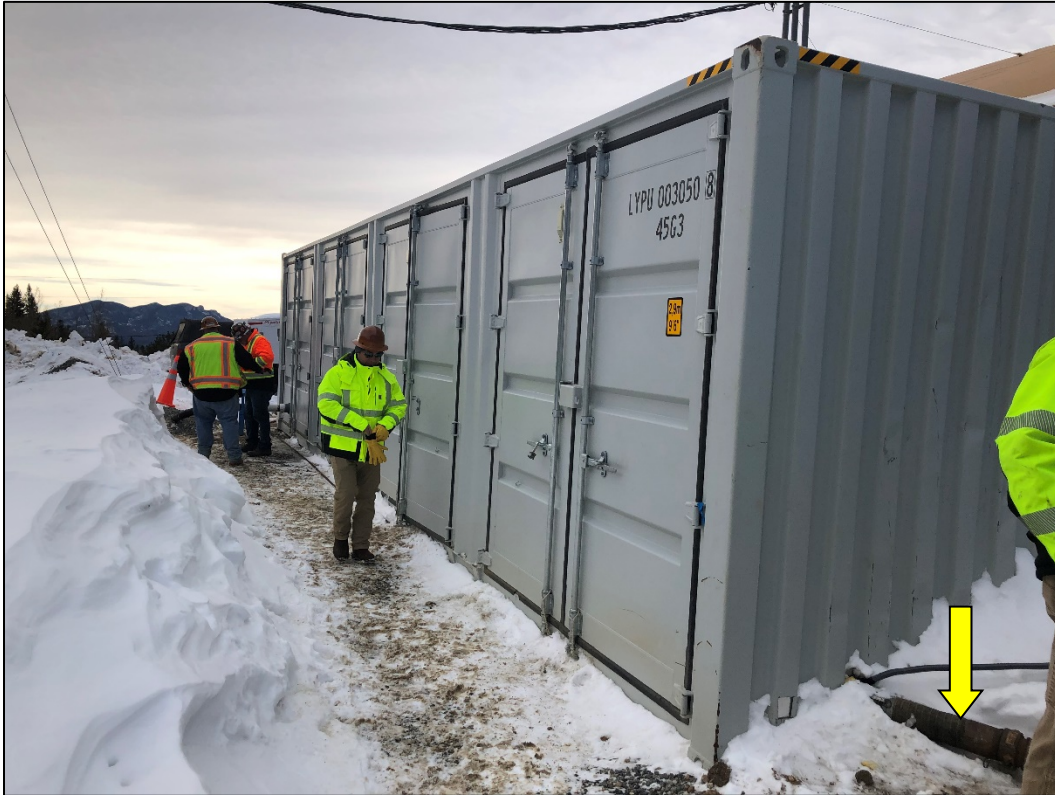
Photo 3. Closer view of insulated Conex box stored at Cross Mine, which houses new water treatment system. Note water inlet pipe (at bottom right, indicated) which transports mine water (from Pond 1) into treatment system.

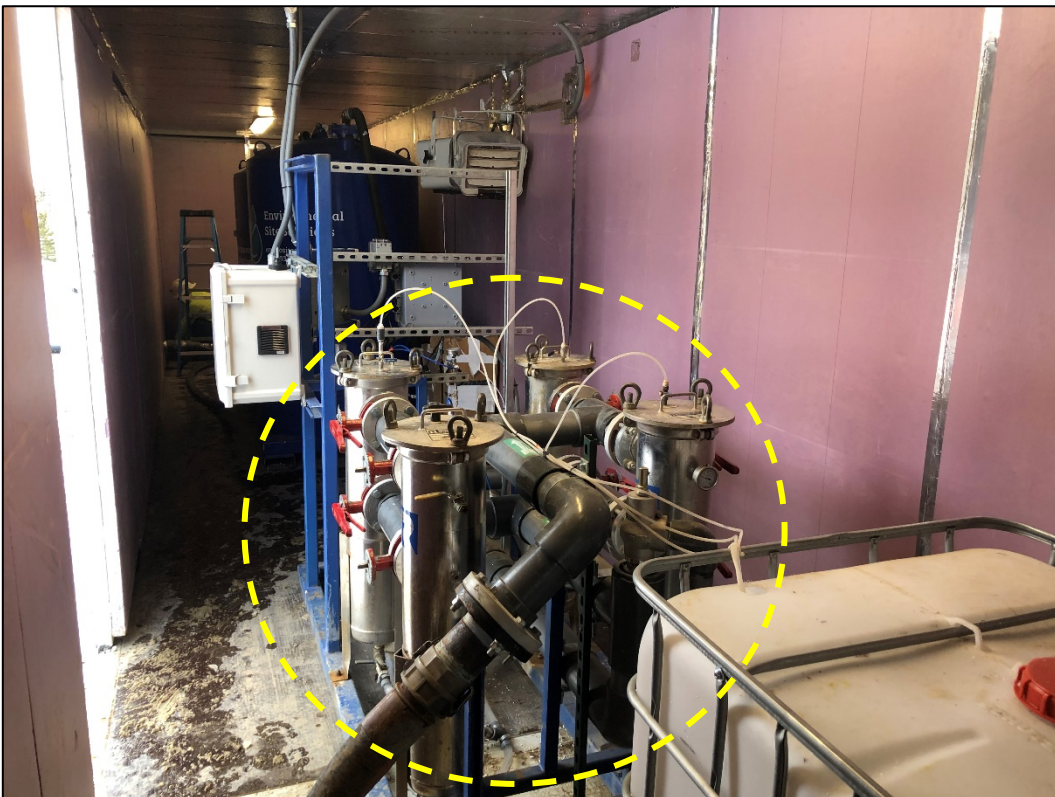
Photo 4. View inside insulated Conex box stored at Cross Mine, which houses new water treatment system. Note filtration system in foreground (circled) consisting of four bag filters, through which, mine water is first run.

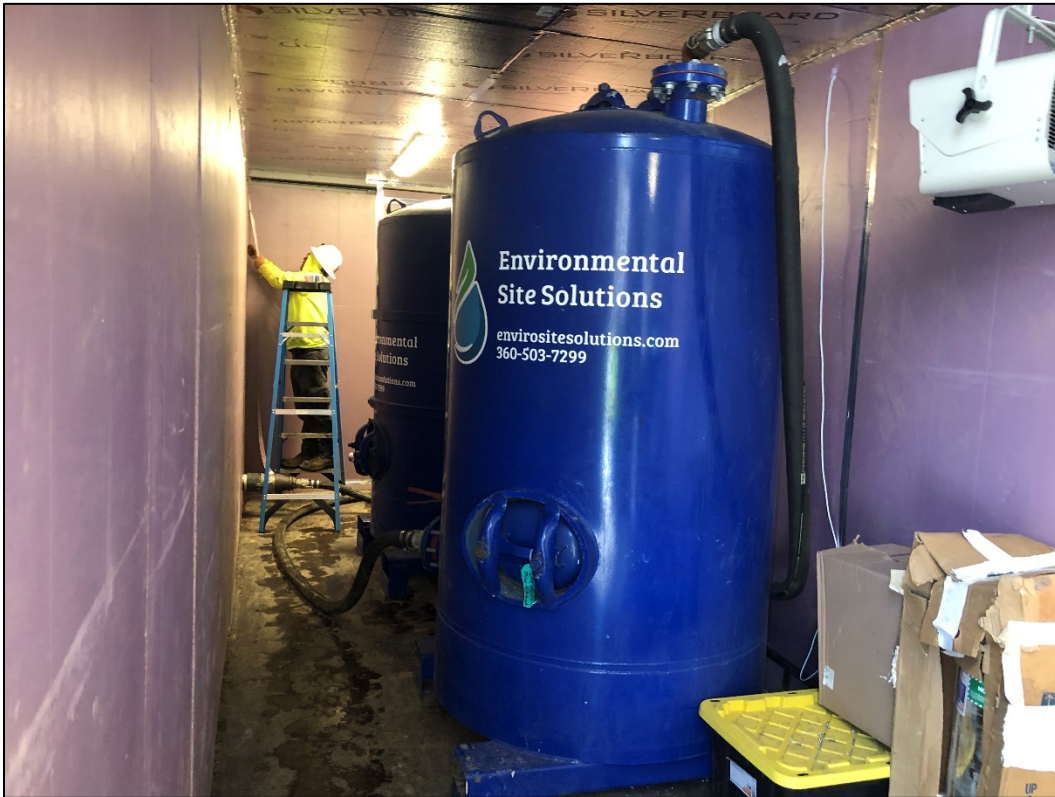
Photo 5. View inside insulated Conex box stored at Cross Mine, which houses new water treatment system. Note polishing system consisting of two blue vessels, through which, mine water is run after passing through filtration system. As mentioned above, only one of these vessels is in use at this time.

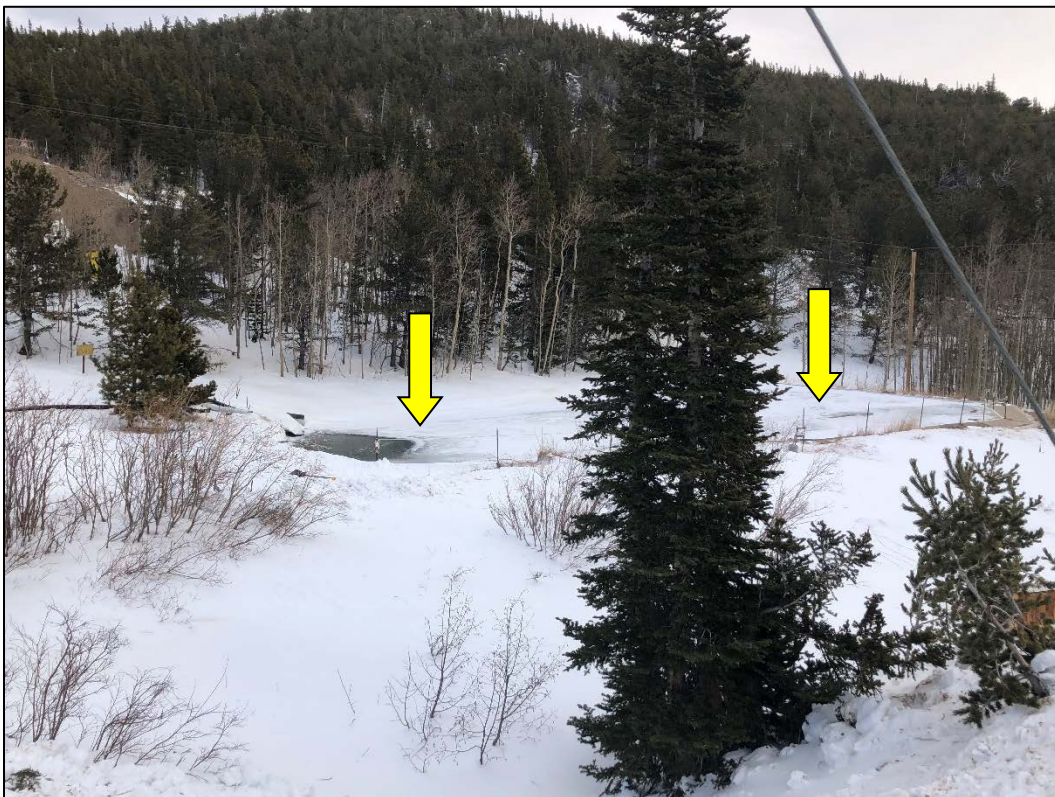
Photo 6. View looking north/northeast at Pond 2 (covered with snow; indicated), not used by current water management/treatment system.

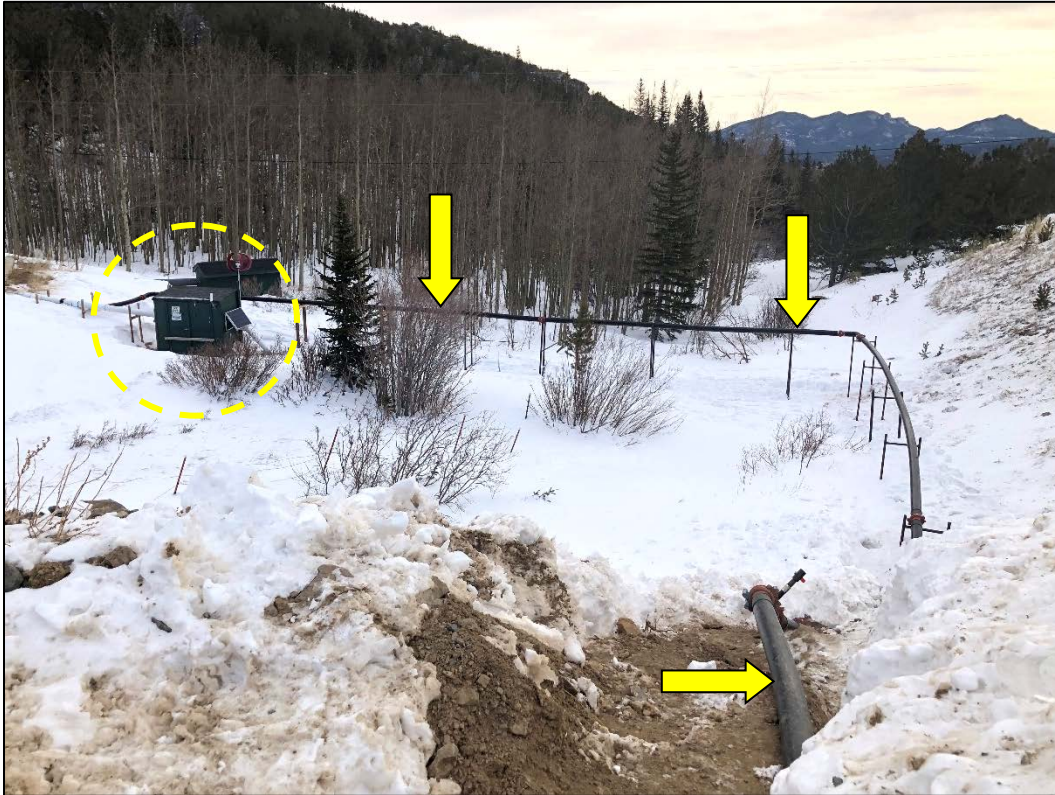
Photo 7. View looking east at new pipeline (indicated) installed to transport water from new treatment system to existing monitoring shed (circled) near Pond 2, where it joins with existing pipeline to discharge at permitted outfall on Coon Track Creek.
