**MINERALS PROGRAM INSPECTION REPORT**  
**PHONE: (303) 866-3567**

<b>MINE NAME:</b> LA Methodist Pit	<b>MINE/PROSPECTING ID#:</b> M-1995-008	<b>MINERAL:</b> Sand and gravel	<b>COUNTY:</b> Fremont
<b>INSPECTION TYPE:</b> Surety-Related Inspection	<b>INSPECTOR(S):</b> Timothy Cazier, P.E.	<b>INSP. DATE:</b> December 2, 2021	<b>INSP. TIME:</b> 13:40
<b>OPERATOR:</b> Fremont Paving & Redi-Mix, Inc.	<b>OPERATOR REPRESENTATIVE:</b> John Paul Ary & Jodi Schreiber	<b>TYPE OF OPERATION:</b> 112c - Construction Regular Operation	
<b>REASON FOR INSPECTION:</b> Surety Related	<b>BOND CALCULATION TYPE:</b> None	<b>BOND AMOUNT:</b> \$5,000.00	
<b>DATE OF COMPLAINT:</b> NA	<b>POST INSP. CONTACTS:</b> None	<b>JOINT INSP. AGENCY:</b> None	
<b>WEATHER:</b> Clear	<b>INSPECTOR'S SIGNATURE:</b>

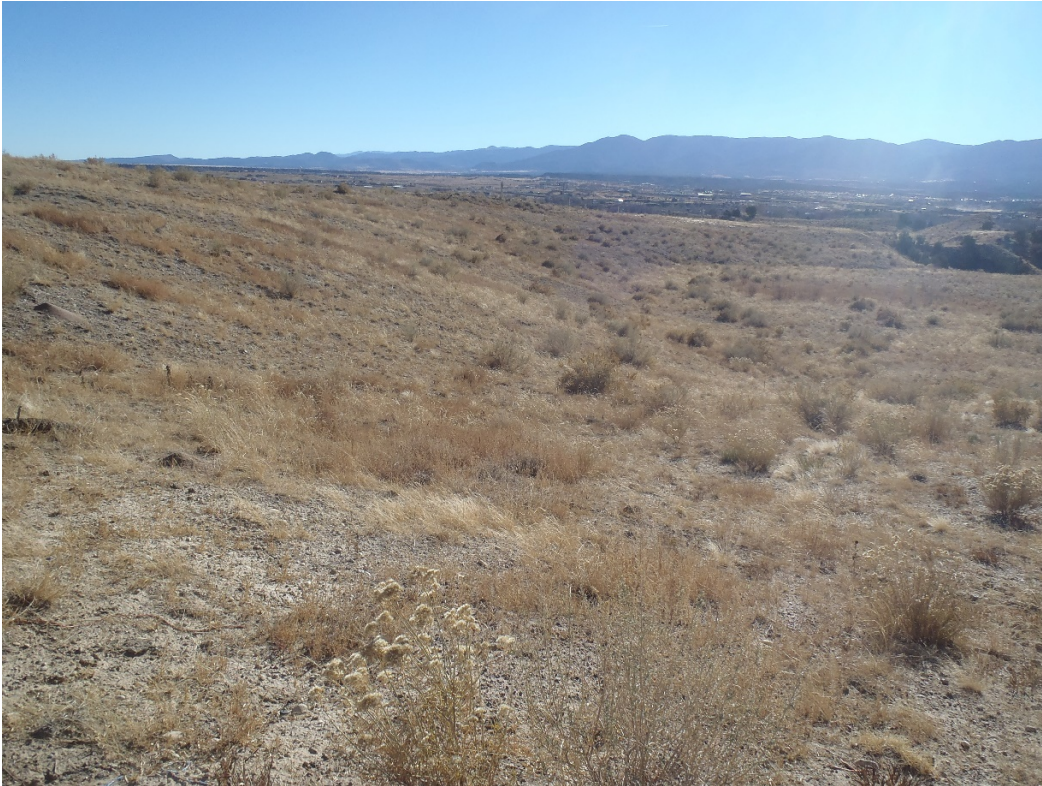
Backfilling and Grading: The erosion gullies cited in the previous inspection report were observed to have been repaired (see **Photos 1 and 2**).

Photo 1. West facing slope with repaired erosion gullies (looking south).

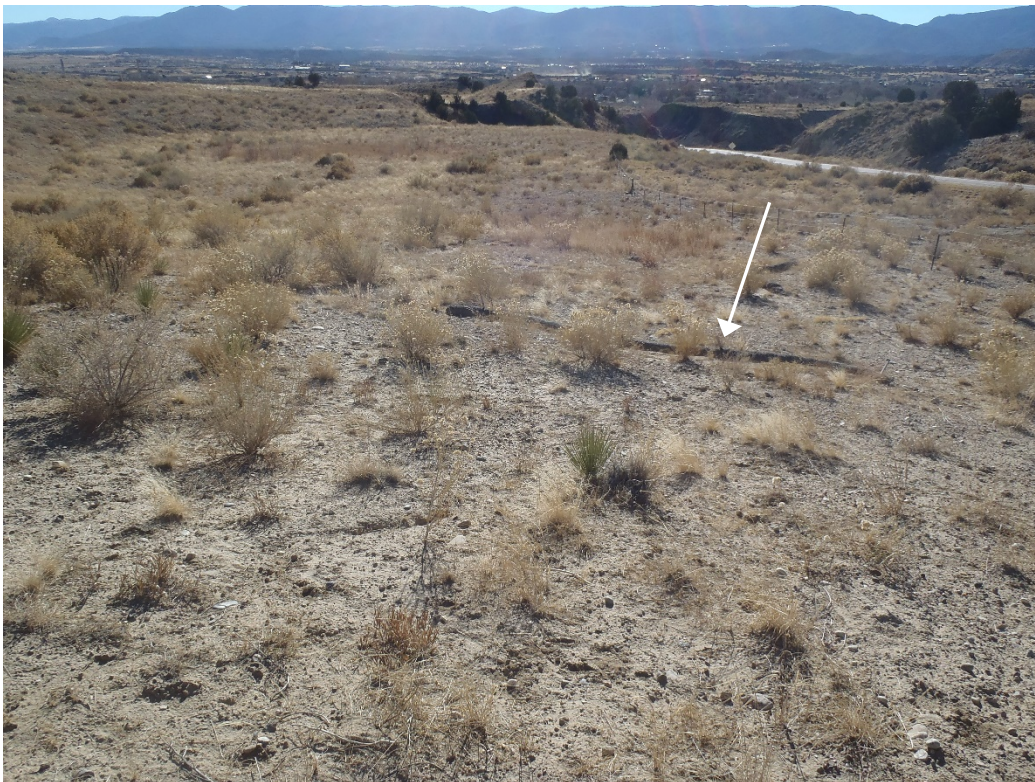
Photo 2. South facing slope with repaired erosion gullies (looking south, note straw wattle).

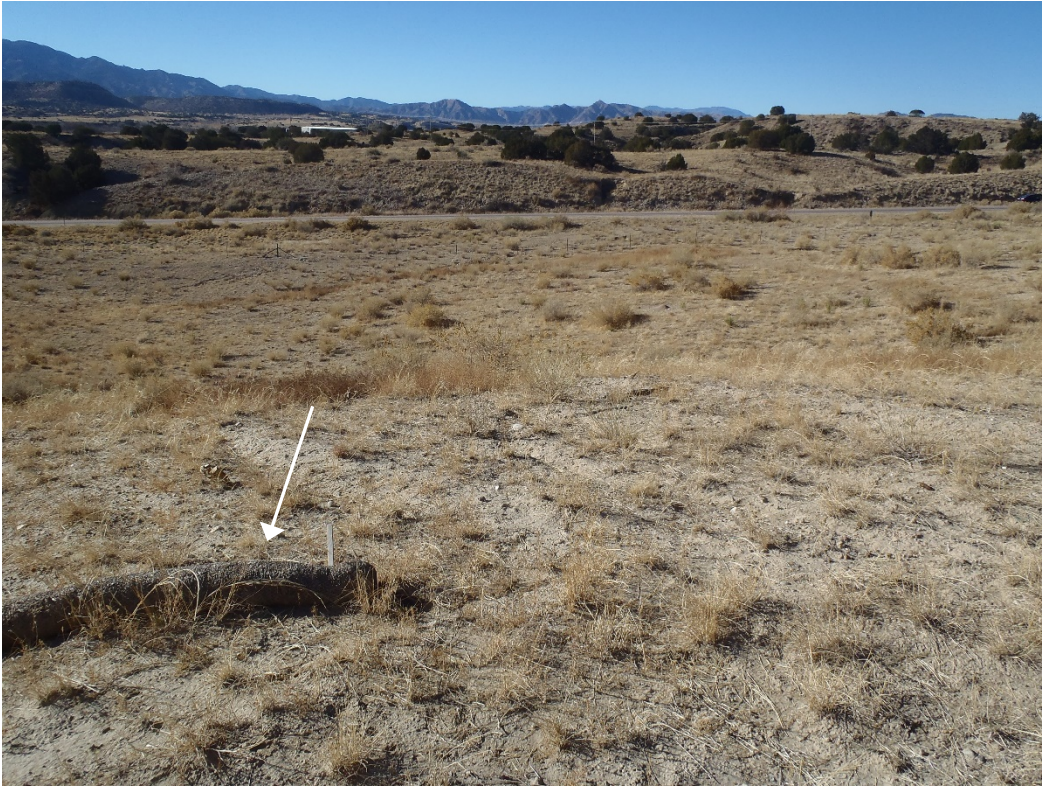
Revegetation: Revegetation was observed to be diverse and appeared well established (see **Photo 3**). No noxious weeds were observed.

Photo 3. Typical diverse, well established vegetation & straw wattle (east side, looking west).

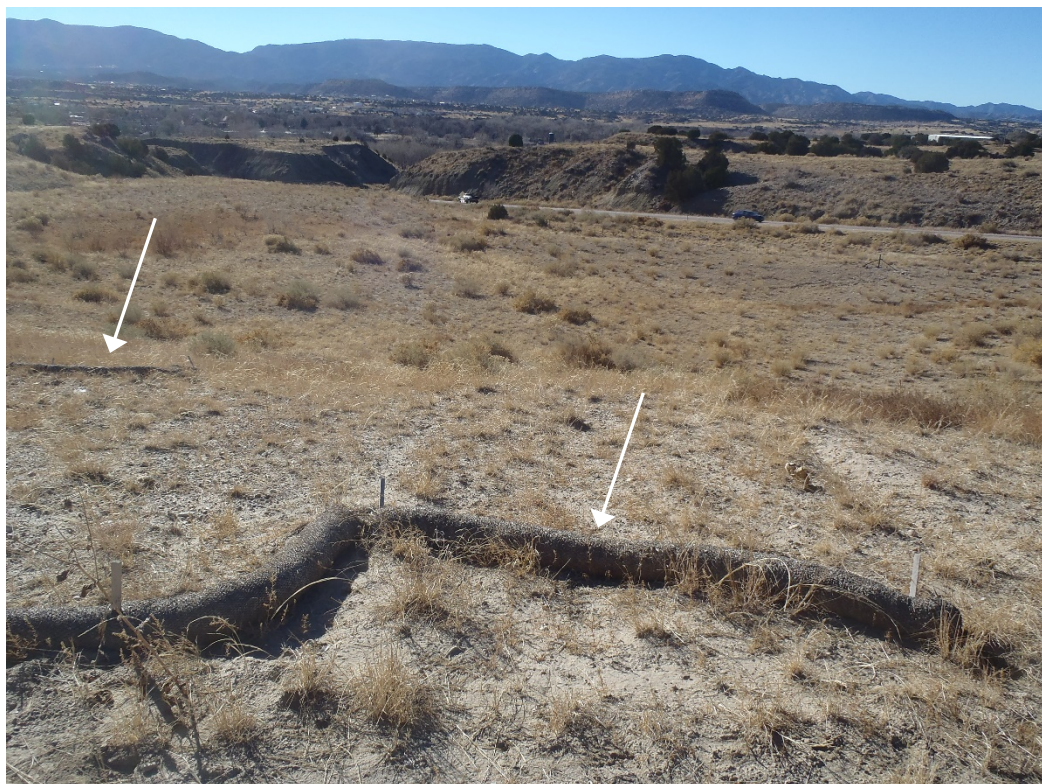
Sediment Control: No erosion problems were observed. Straw wattles were observed still in place (see **Photo 4**) from the repair of the erosion issues cited during the previous inspection. Fremont Paving provided photographic evidence on December 23<sup>rd</sup> that the wattles had been removed (see **Photo 5**).

Photo 4. Typical straw wattles needing removal (looking SW).

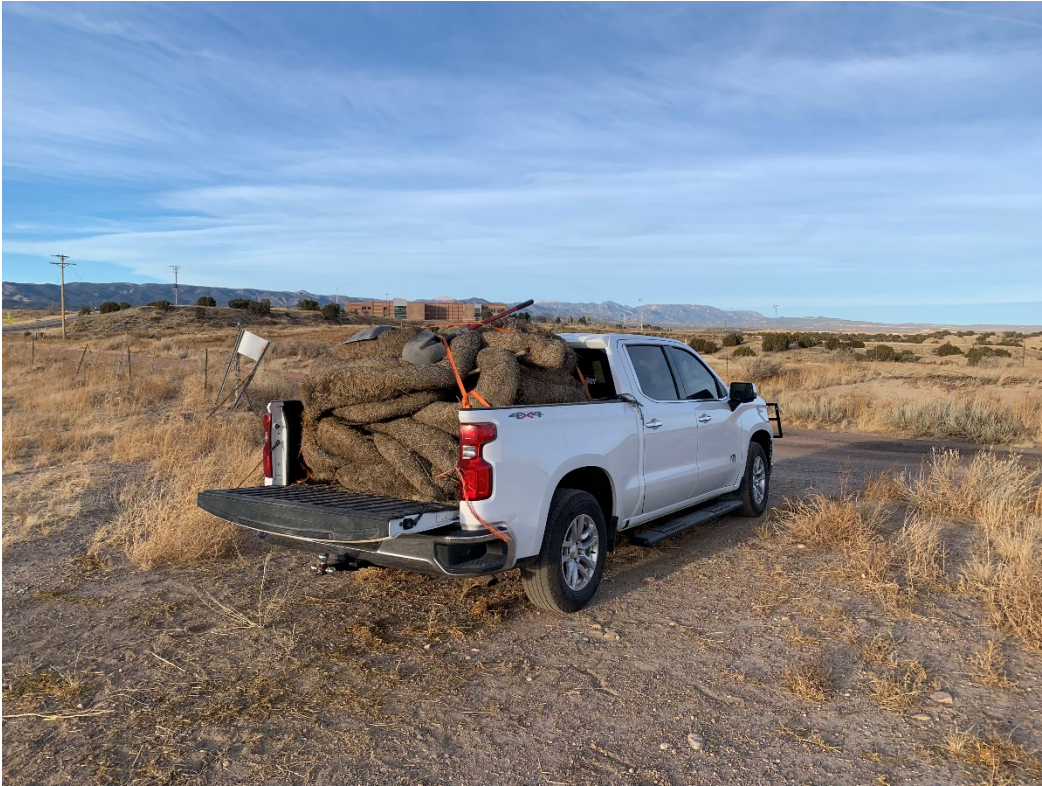
Photo 5. Used straw wattles loaded up for disposal (image provided by Fremont Paving 12/23/21).

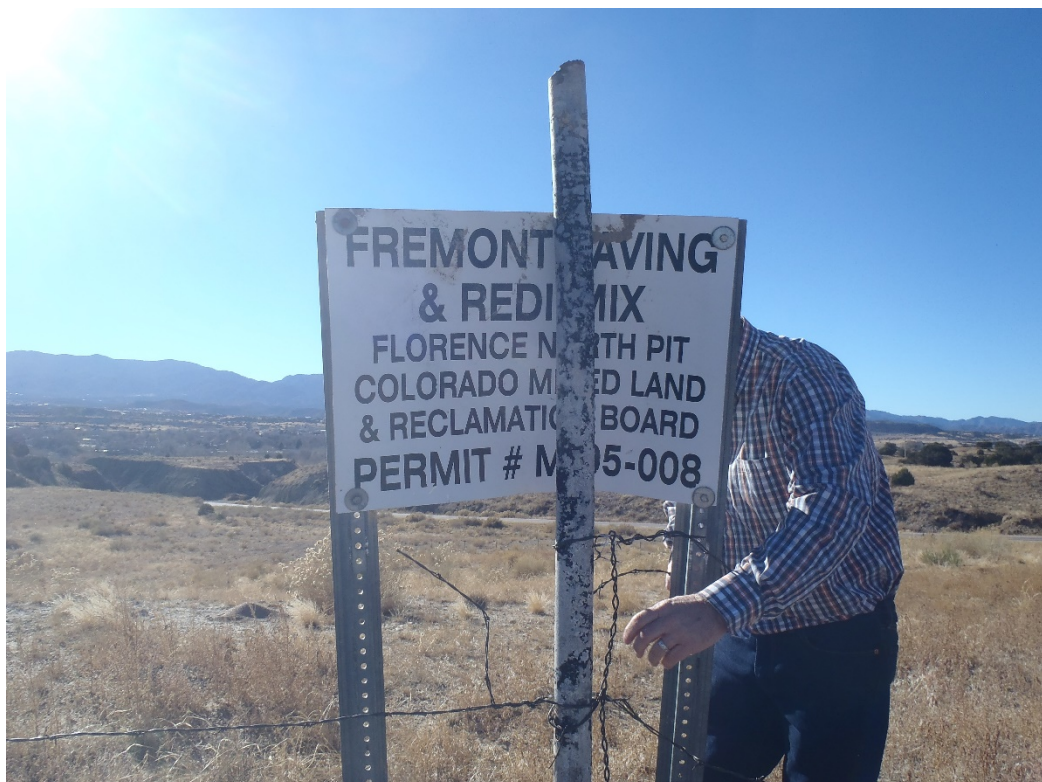
Signs and Markers: The permit sign was properly posted (see **Photo 6**).

Photo 6. Permit sign at entrance.
