**PERMIT INFORMATION**

<b>Permit Number:</b> C-1992-081 <b>Mine Name:</b> Hayden Gulch Loadout <b>Operator:</b> Hayden Gulch Terminal, LLC <b>Operator Address:</b> Ms Miranda Kawcak  P.O. Box 670 Hayden, CO 81639	<b>County:</b> Routt <b>Operation Type:</b> Loadout <b>Permit Status:</b> Active <b>Ownership:</b> Private  <b>Operator Representative Present:</b>  None
<b>Operator Representative Signature: (Field Issuance Only)</b>

**INSPECTION INFORMATION**

This was an aerial inspection of the Hayden Gulch Loadout; DRMS Permit No. C-1992-081, operated by Hayden Gulch Termnal, LLC. The photos were taken by Brock Bowles on 1/10/22 and evaluated by Tabettha Lynch with the Colorado Division of Reclamation, Mining, and Safety (Division) on 1/19/22. The weather was mostly clear and the site was snow covered during the inspection.

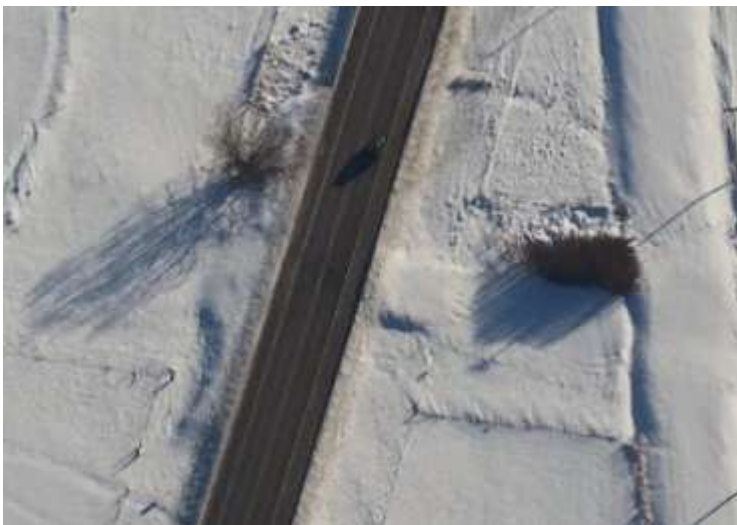
Reclamation of tracks on Hwy 40; Photo below shows the section of tracks that crossed Hwy 40 that were removed in 2021.

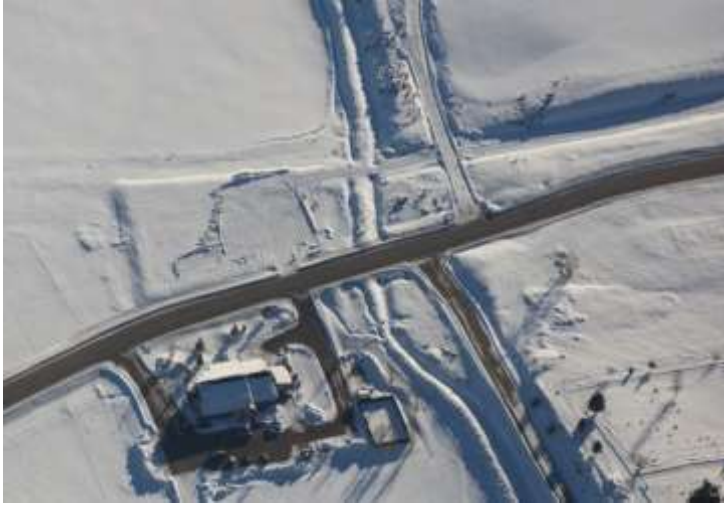
Former tie across haul road appears to be being plowed and maintained. Portions of the trail and the trail parking area appear to have been plowed (photo below).

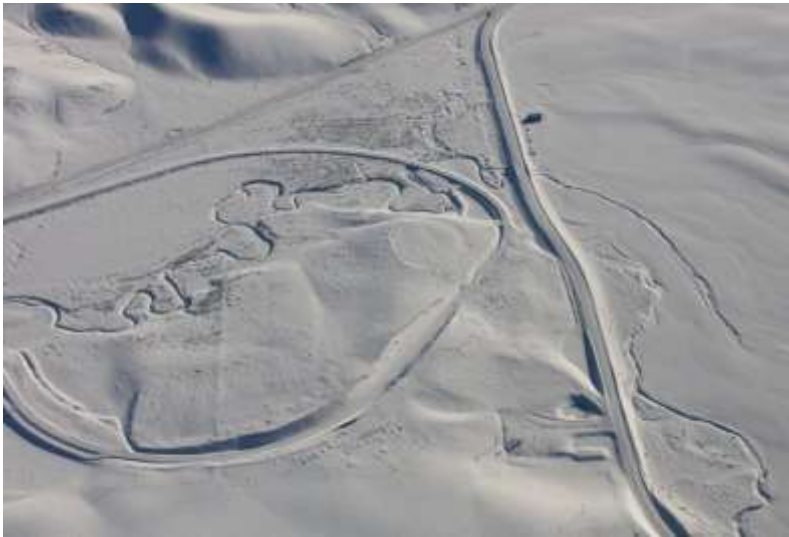
Train Loop shown below. Ponds appear snow covered and not likely holding additional water as vegetation is visible. The loop is currently being used by public as a walking trail. TAHR is plowed in the photo below.
