To: Jerald Schnabel From: Paul Kos
Continental Materials Corp. Denver, CO 80222
File: December 2021 Monitoring Summary Date: January 31, 2022

Reference: December 2021 Geotechnical Monitoring Summary Pikeview Quarry

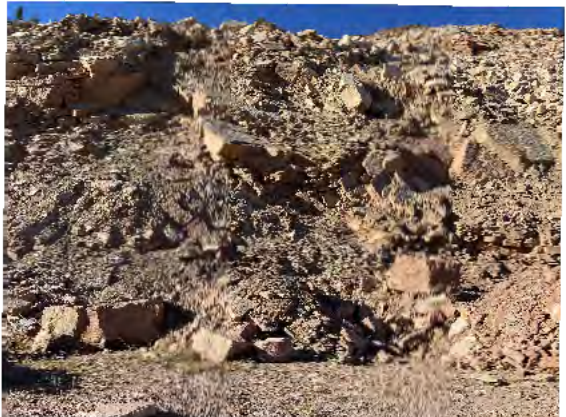
6. TOE OF THE SLIDE NEAR PRODUCTION FLOOR

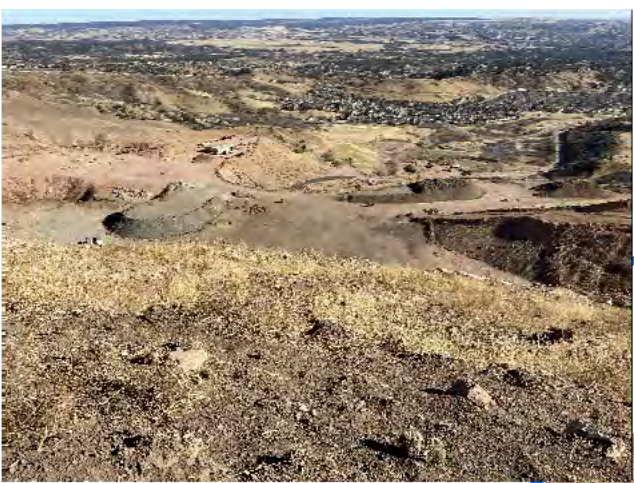
- Imported fill material and topsoil are being stockpiled in several areas on the production floor. (Photo 5)
- The culvert remains cleared but mostly blocked inside. CMC has partially cleared the debris, but access limitations and supports within the culvert inhibit clearing all the debris. CMC has procured a pump and will begin pumping operations if any water collects behind the culvert. CMC inspects the culvert for ponded water following rain events, and should any water be observed, it will be removed using pumps. To date, no ponding has been observed. (Photo 7)

5. VIEW OF STOCKPILES FROM WEST

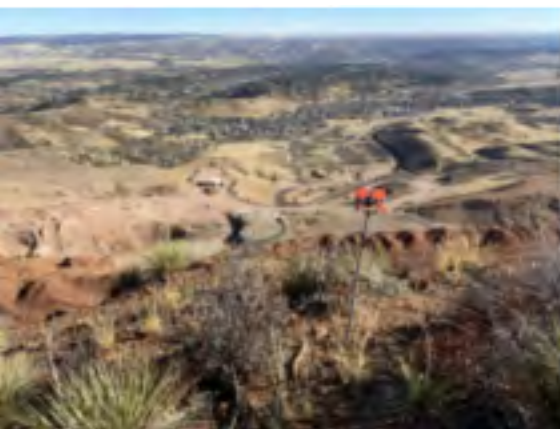
- Prisms: Several prisms were passed along the walking route and appeared to be in their original position and operating normally. Control points and most of the monitoring points are permanently cemented into the ground while some of the monitoring points are cemented into 5-gal buckets to be portable as needed. (Photo 4)

4. PRISM ON MIDDLE PEAK

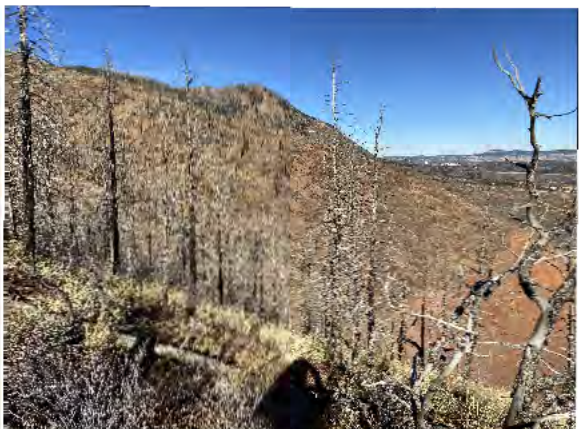
3. VIEW OF NORTH PEAK FROM MIDDLE PEAK

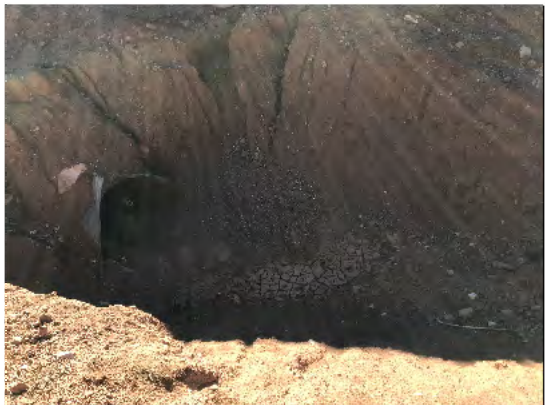
7. UPSTREAM END OF CULVERT

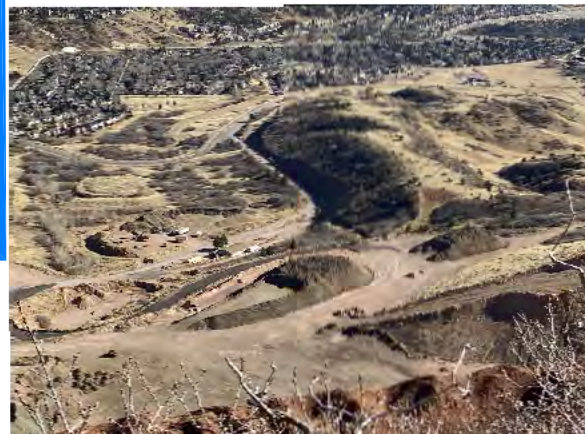
- Riprap continues to be produced on the production floor. (Photo 1)
- Growth Medium: Mulch and soil continue to be processed on the production floor to produce growth medium. The previous stockpiles of mulch and soil that were located in the buttress fill area have been processed and moved out of the fill area. (Photo 2)

2. VIEW OF GROWTH MEDIUM AND TOP SOIL

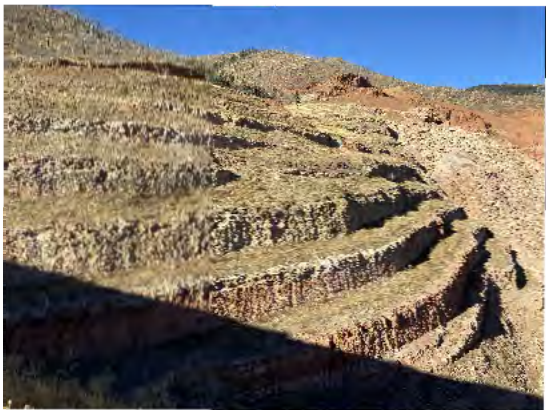
8. RECLAMATION BENCHES AT SOUTH END

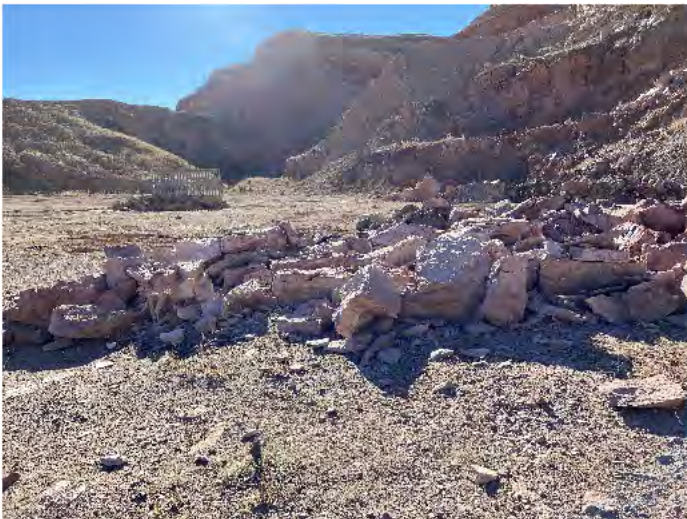
1. RIP RAP PROCESSING ON PRODUCTION FLOOR

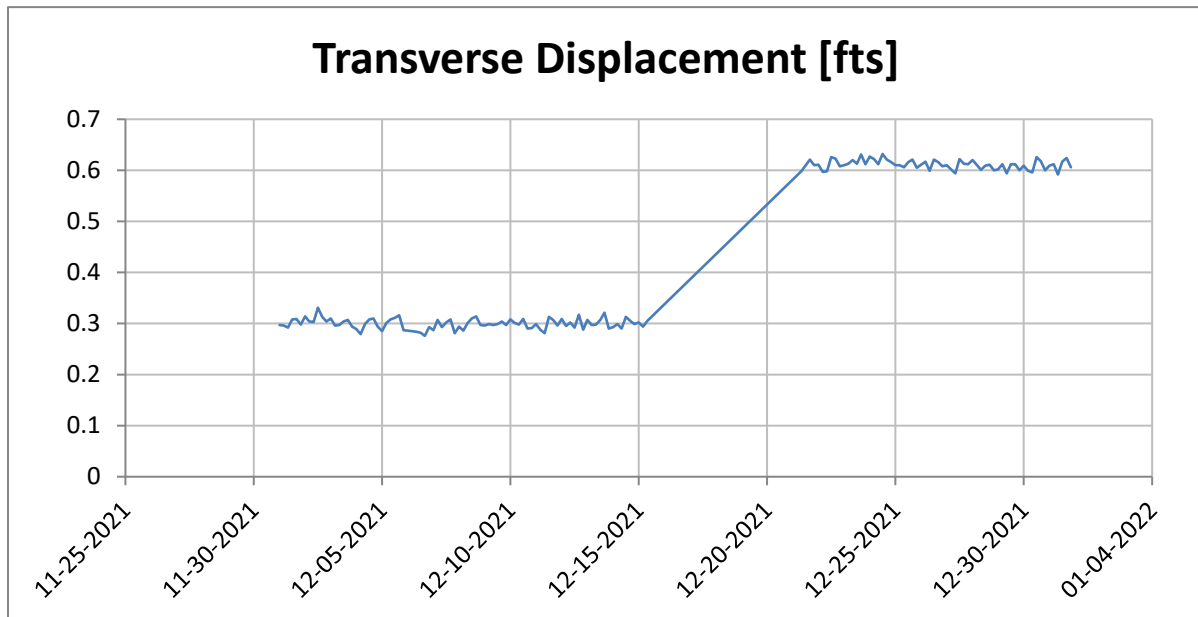
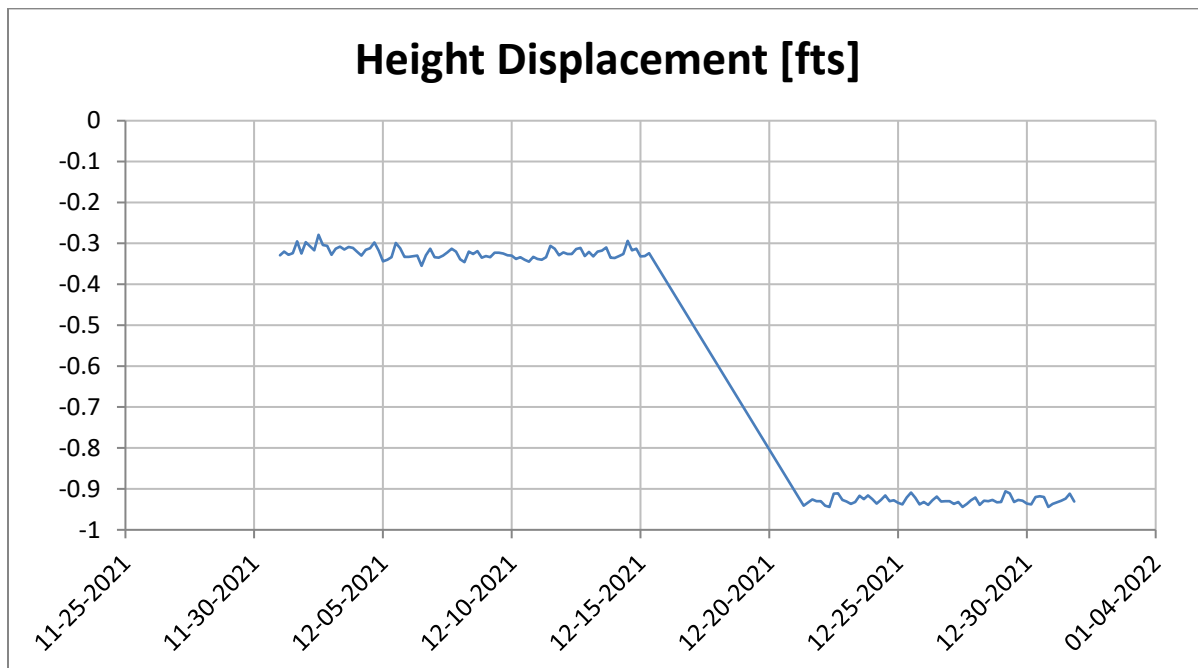
Prism NP1

The data show stable conditions with no movement for 15 of 20 prisms with recorded displacements limited to data scatter and not actual movements. Prisms NP1 and TOE3 were damaged or displaced by high winds on December 15, 2021, and movements were recorded when the prisms were replaced and repositioned. There were no signs of movement in the areas of these prisms, and the source of the movements recorded is likely the result of the wind damage. Prisms P63 and TOE3 are located at the toe of the landslide, and these locations showed slope creep movements at slow velocities. Prisms NP2 and NP66 are located above the landslide, and these prism also recorded slope creep movements at slow velocity. This settlement is likely related to the landslide material consolidating under its own weight. Plots of the transverse and height displacements for each prism are included in Appendix B.

1. Survey accuracy is ± 0.016 feet.
2. Alarm threshold is ± 0.35 feet.
3. Transverse displacement is in the horizontal direction. Positive direction means closer to the robotic station.
4. Height displacement is in the vertical direction. Positive direction means higher in elevation.
5. Prism damaged by wind and then repositioned on 12-22-2021. No signs of slope movement at prism location.

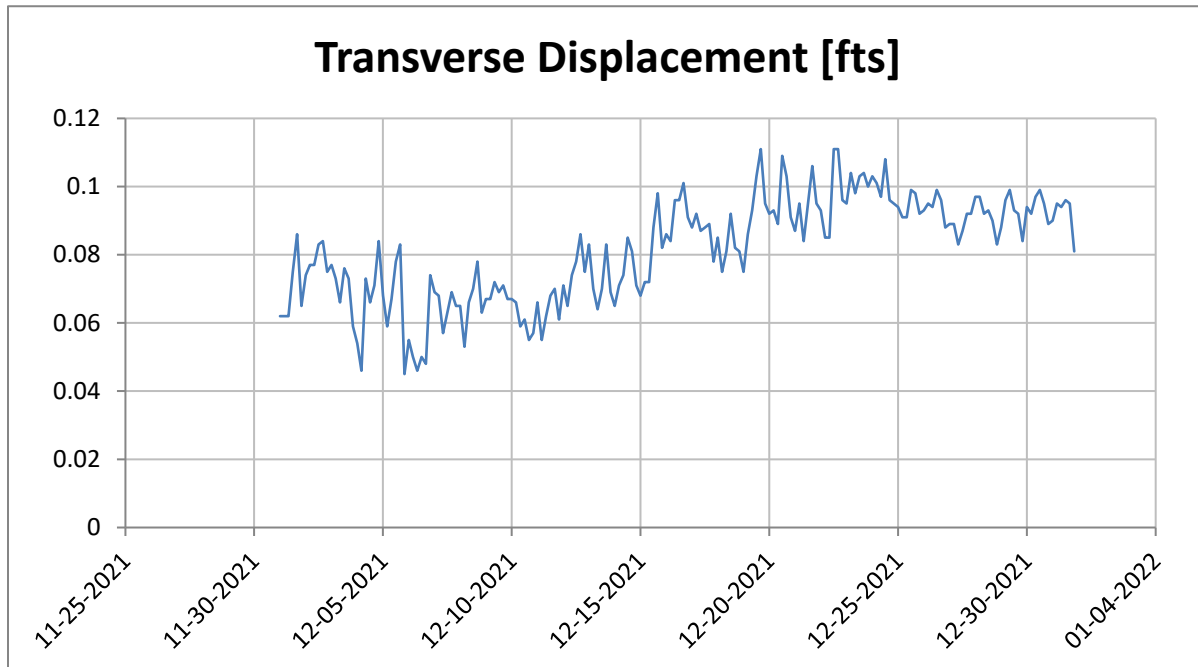
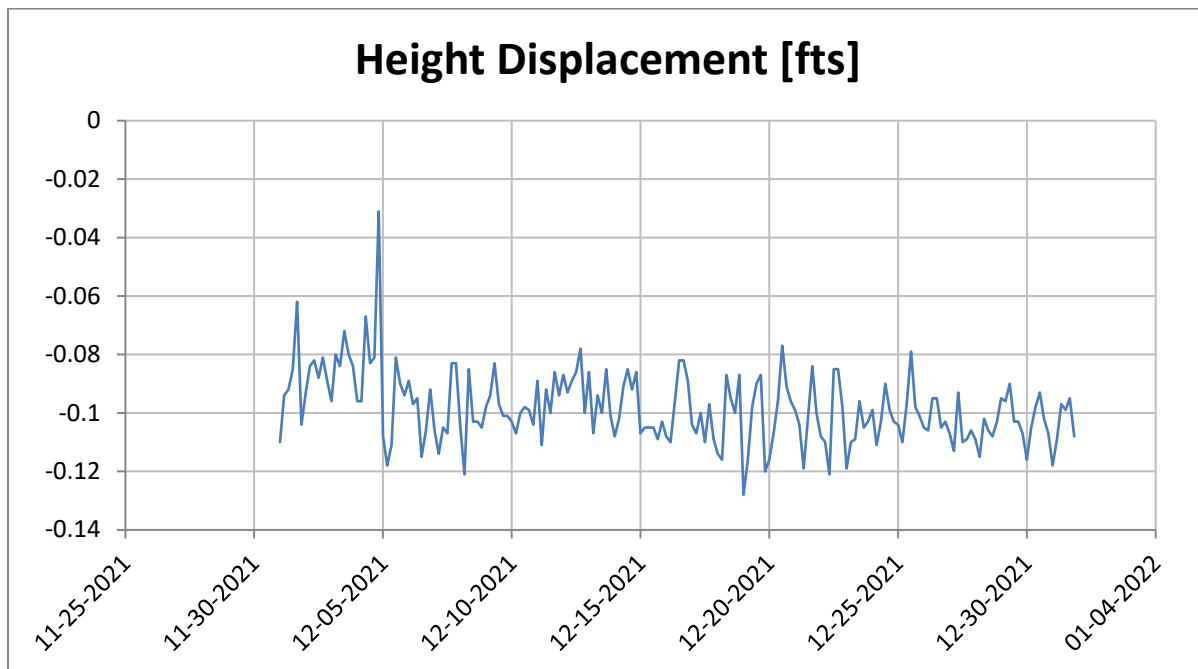
Prism NP2

1. Survey accuracy is ± 0.016 feet.
2. Alarm threshold is ± 0.35 feet.
3. Transverse displacement is in the horizontal direction. Positive direction means closer to the robotic station.
4. Height displacement is in the vertical direction. Positive direction means higher in elevation.
5. Prism records slope creep movements with slow velocity.

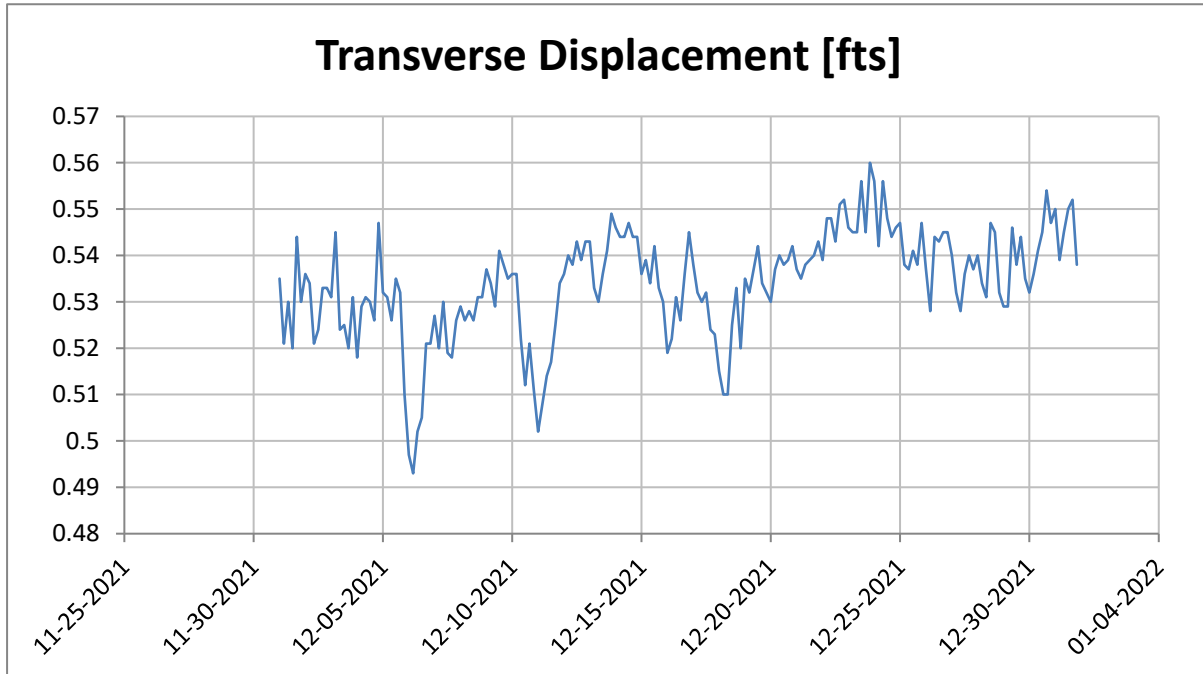
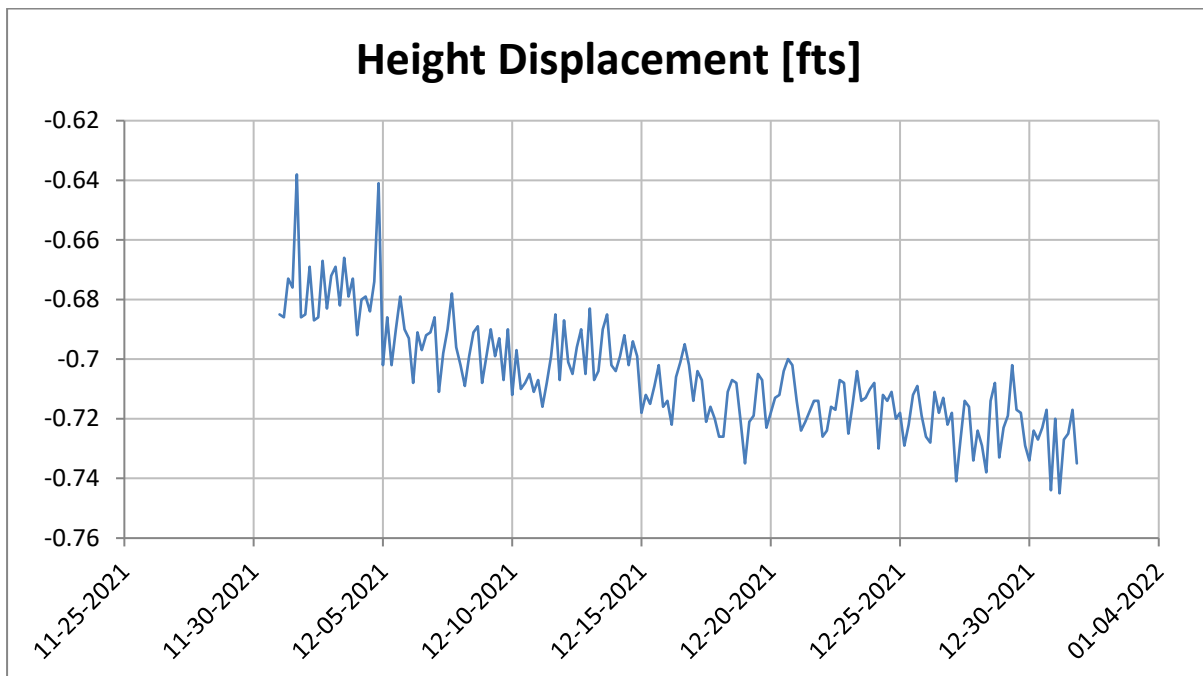
Prism NP66

1. Survey accuracy is ± 0.016 feet.
2. Alarm threshold is ± 0.35 feet.
3. Transverse displacement is in the horizontal direction. Positive direction means closer to the robotic station.
4. Height displacement is in the vertical direction. Positive direction means higher in elevation.
5. Prism records slope creep movements with slow velocity.

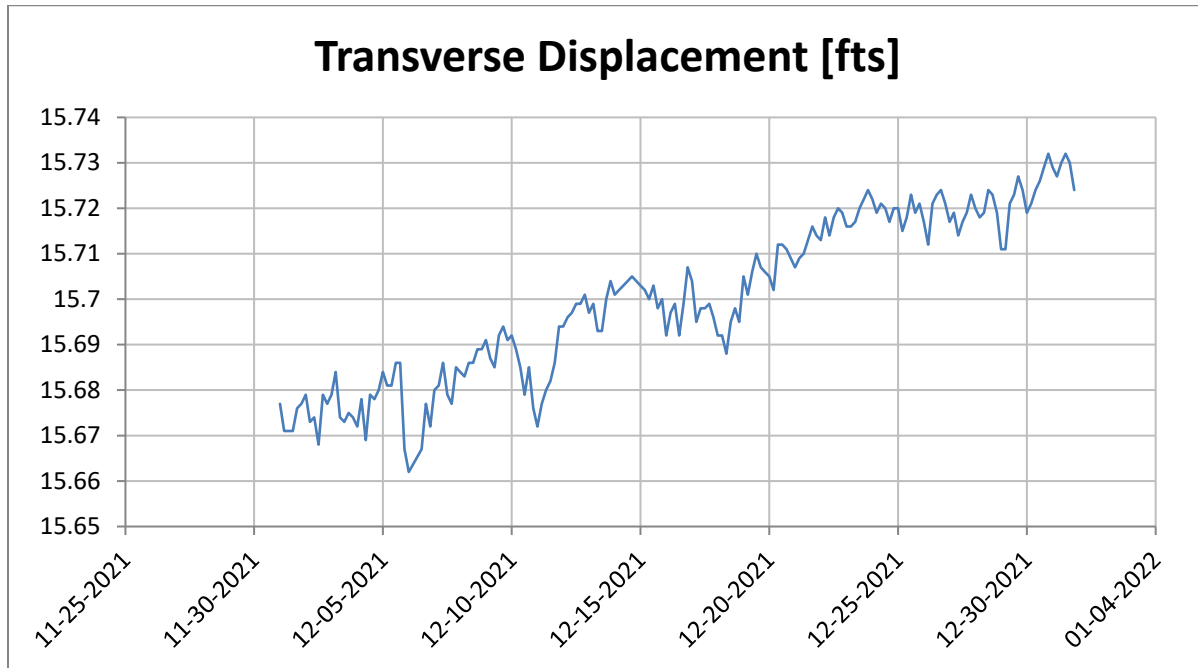
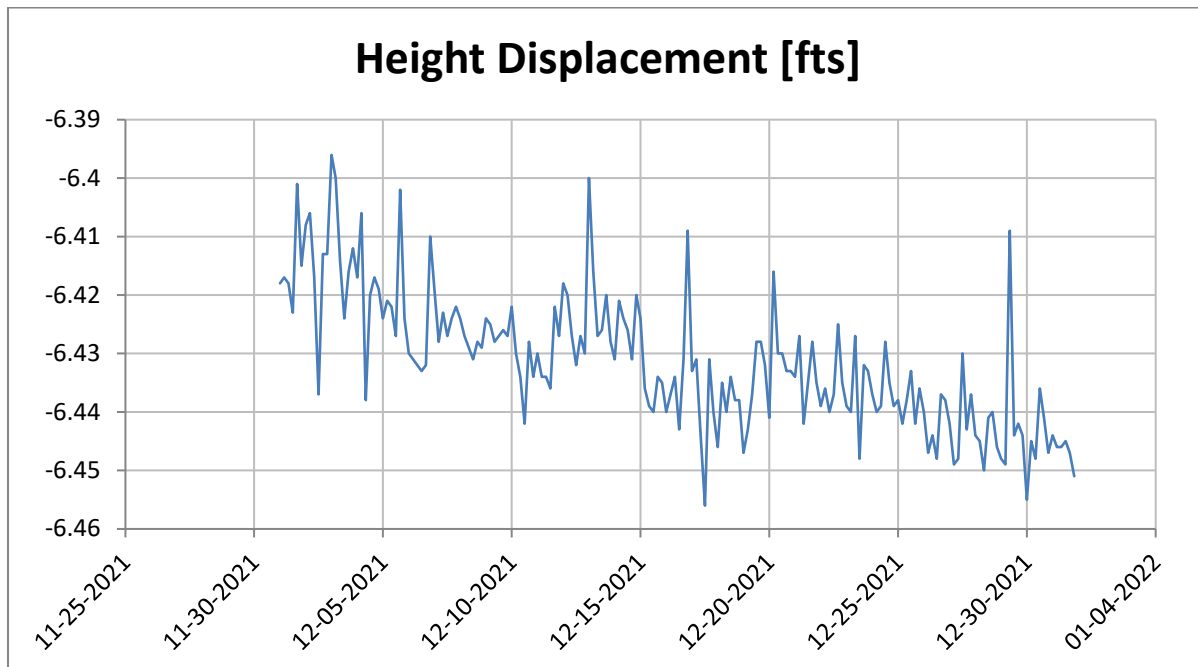
Prism P63

1. Survey accuracy is ± 0.016 feet.
2. Alarm threshold is ± 0.35 feet.
3. Transverse displacement is in the horizontal direction. Positive direction means closer to the robotic station.
4. Height displacement is in the vertical direction. Positive direction means higher in elevation.
5. Prism records slope creep movements with slow velocity.

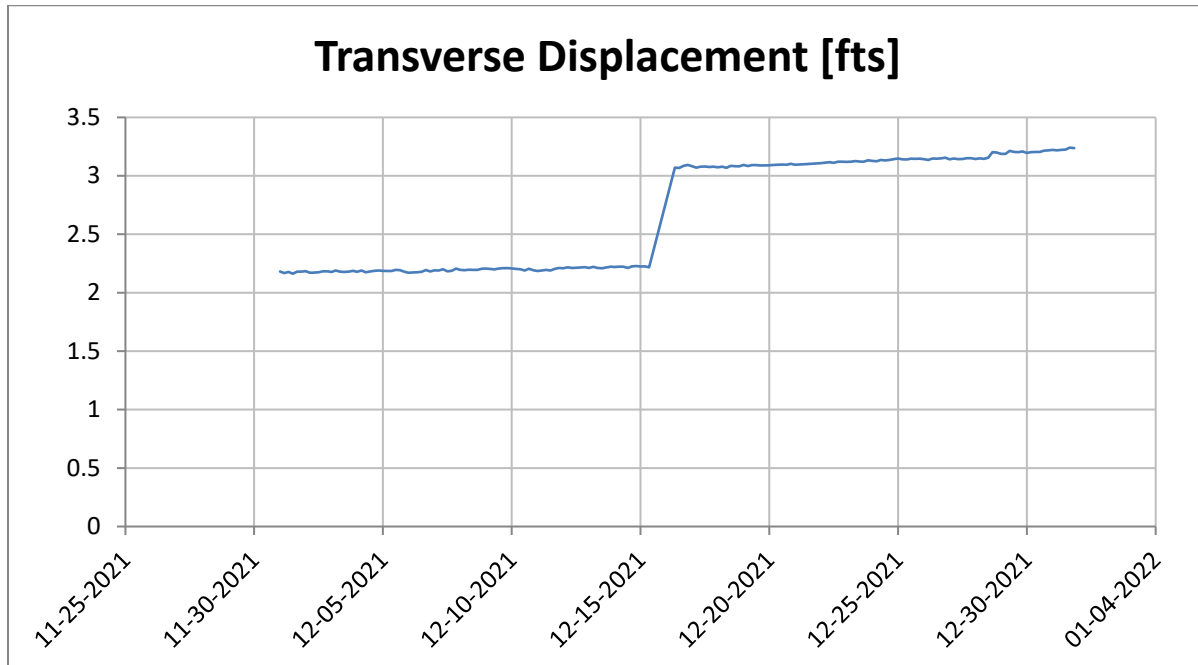
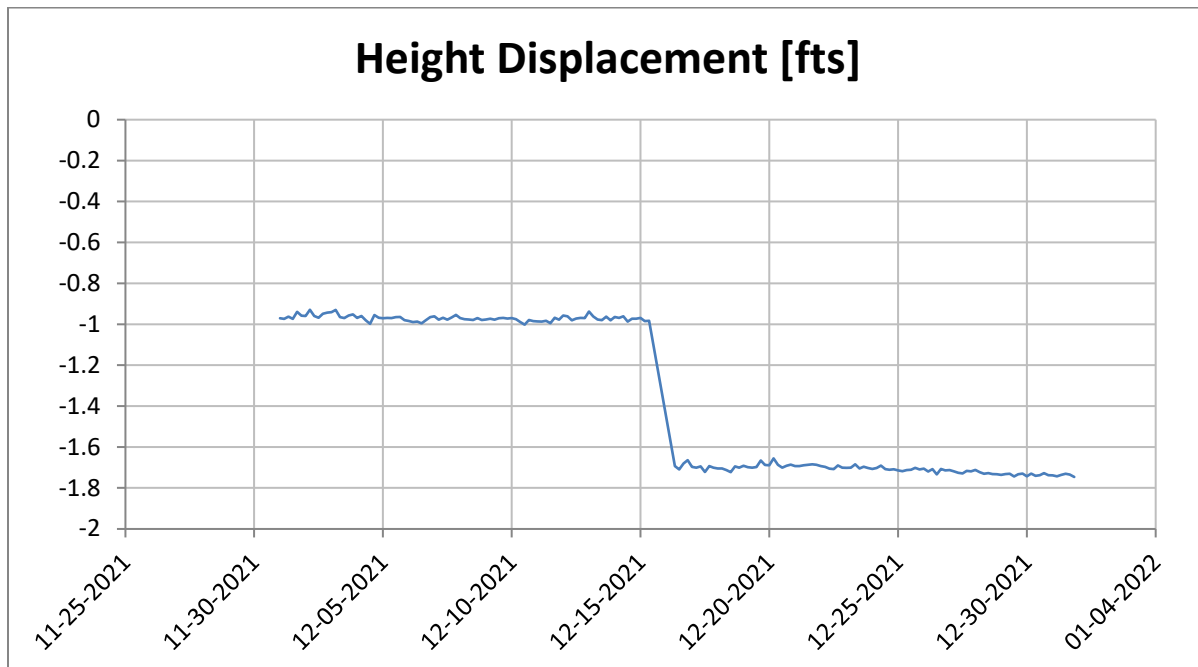
Prism TOE3

1. Survey accuracy is ± 0.016 feet.
2. Alarm threshold is ± 0.35 feet.
3. Transverse displacement is in the horizontal direction. Positive direction means closer to the robotic station.
4. Height displacement is in the vertical direction. Positive direction means higher in elevation.
5. Prism records slope creep movements with slow velocity.
6. Prism displaced by wind and then repositioned on 12-16-2021. No signs of slope movement at prism location.

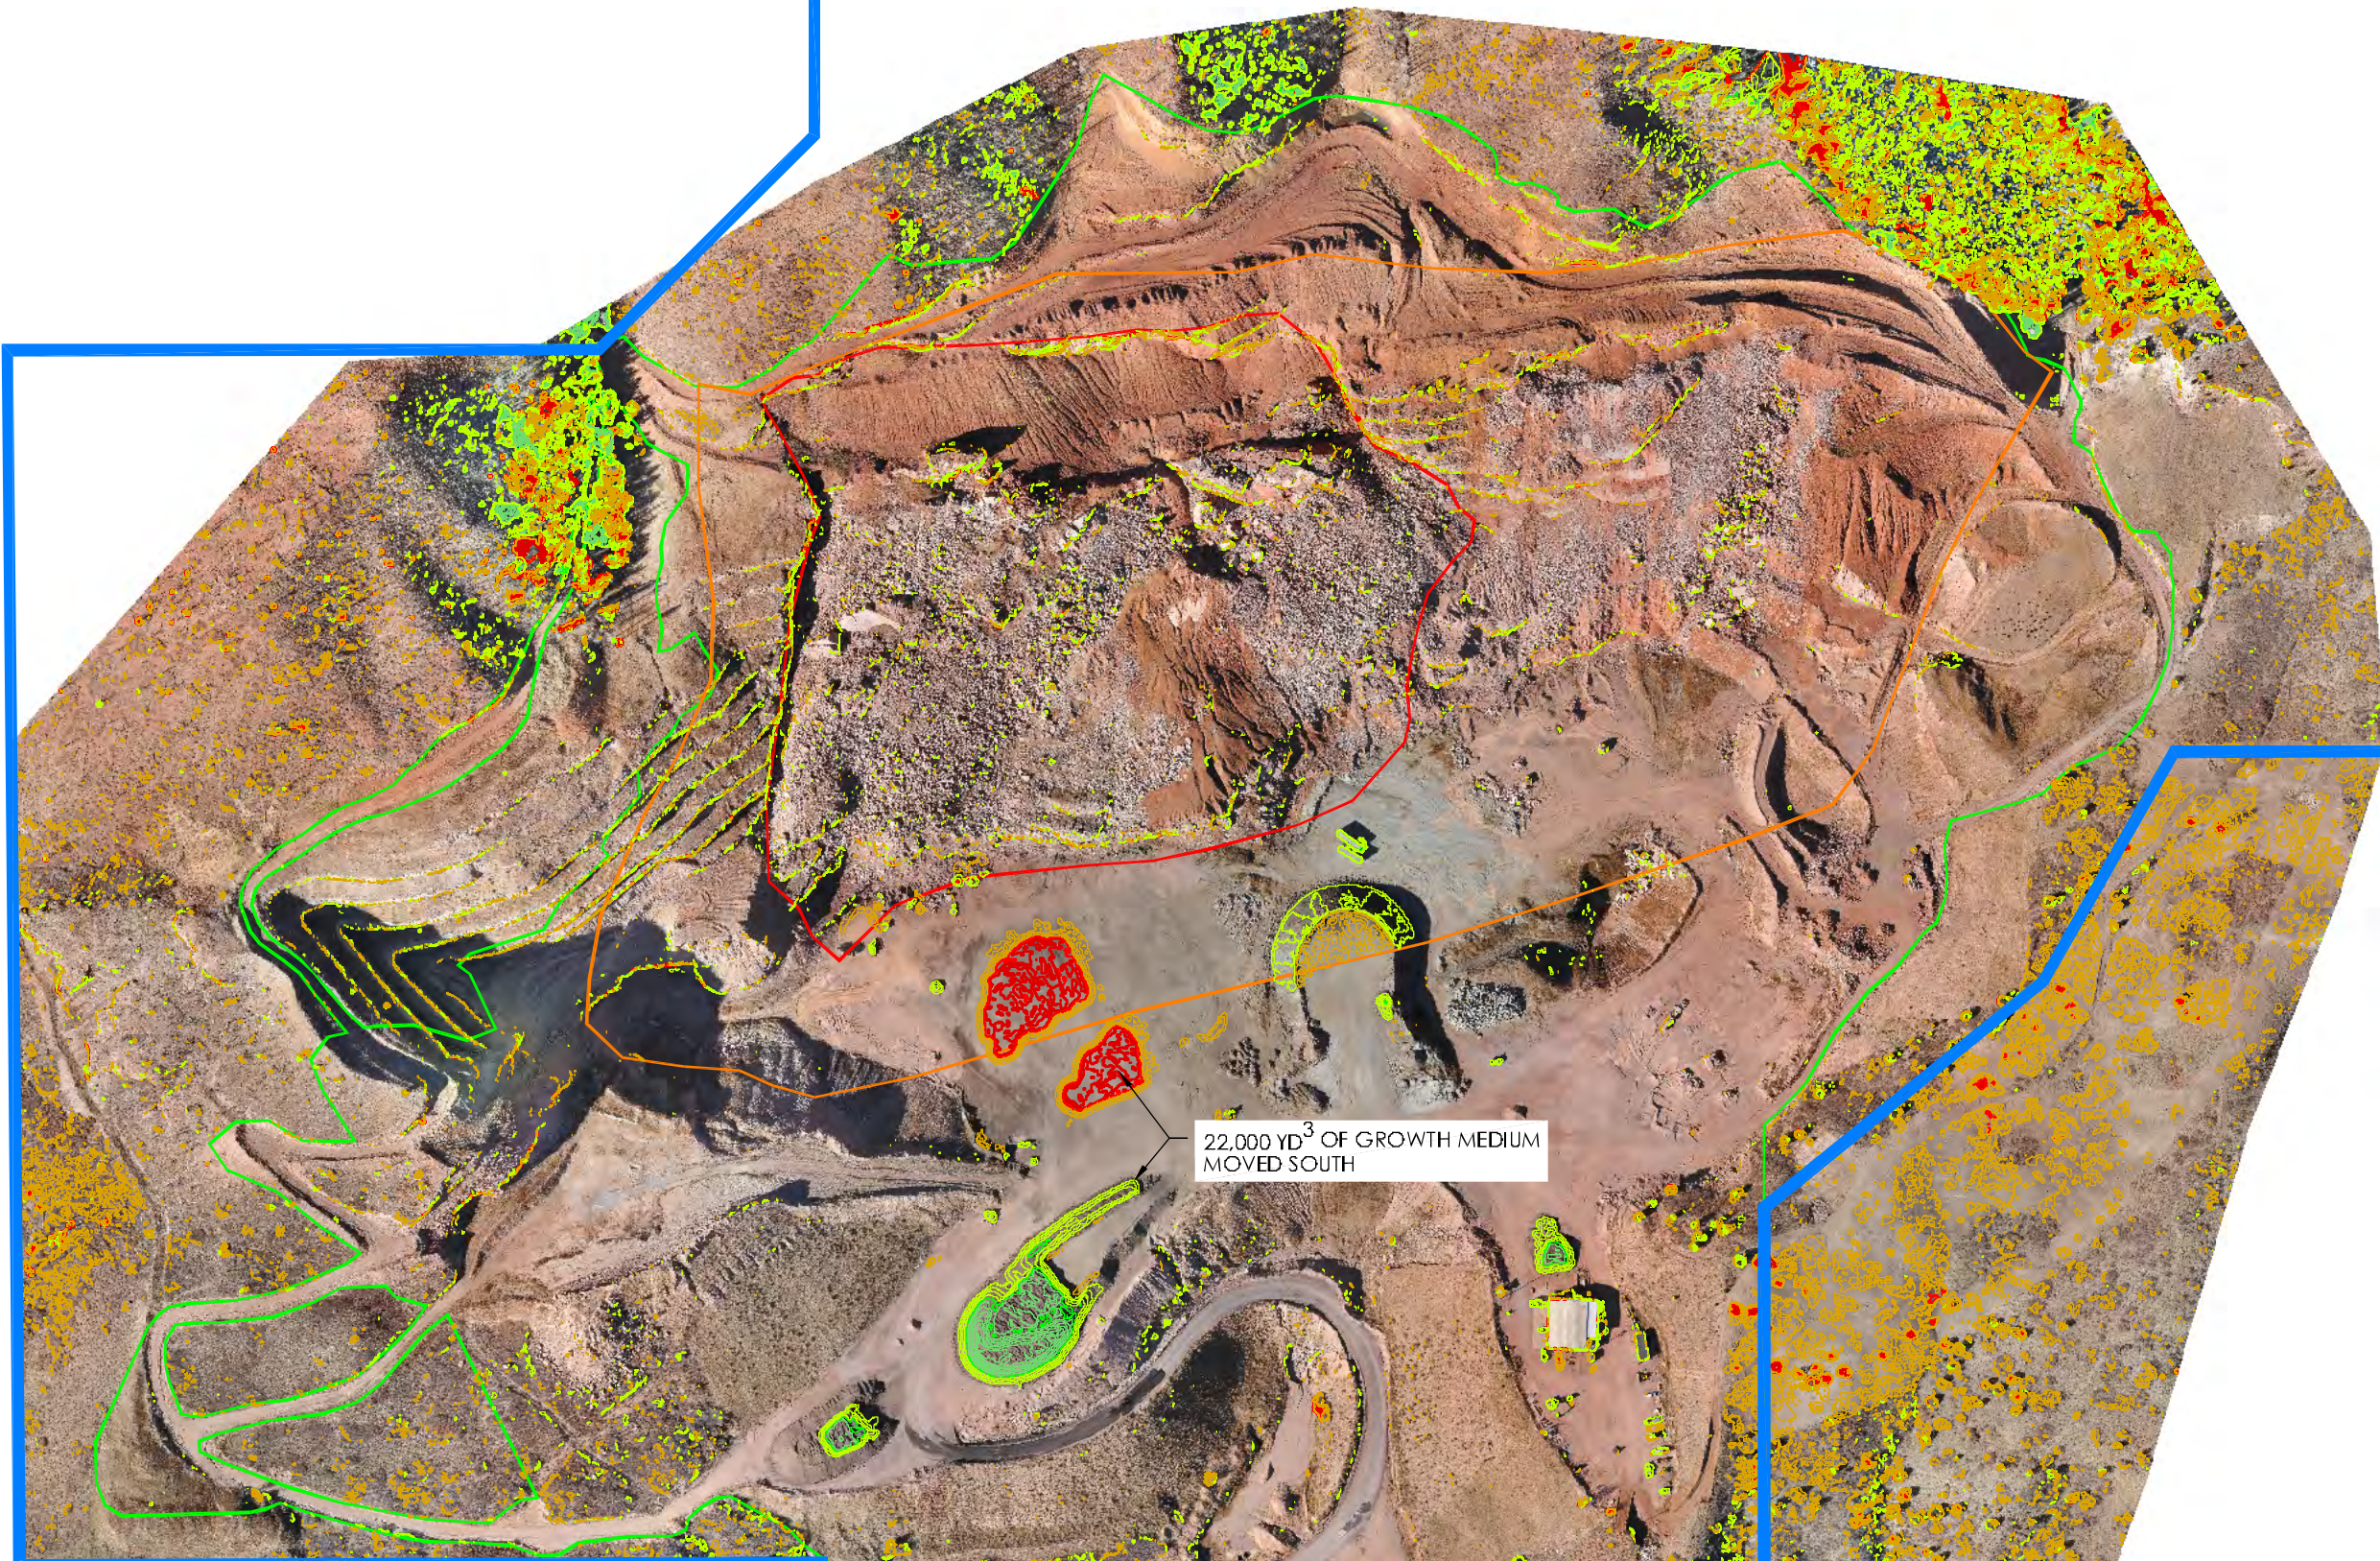
The November topography was also compared to the December topography to identify changes in the site topography. Comparison of the two surveys showed that approximately 3,544 yd³ of fill had been imported and temporarily placed on the stockpile near the top of the ramp. Additionally, a total of 43,498 yd³ of growth medium have been prepared. Approximately 22,000 yd³ of growth medium were moved as a balanced cut/fill from the buttress area to stockpiles on the eastern extent of the production floor. Much of the imported fill was topsoil, and it was added to the growth media pile. No slope movements or other changes in topography were identified. The current imagery and topography are included in Figures 1 and 3, and the comparison surface is included as Figure 5 in Appendix C.

22,000 YD³ OF GROWTH MEDIUM
MOVED SOUTH
