MINERALS PROGRAM INSPECTION REPORT
PHONE: (303) 866-3567

MINE NAME: Nancy Claim	MINE/PROSPECTING ID#: P-1995-005	MINERAL: Silver and gold	COUNTY: San Juan
INSPECTION TYPE: Monitoring	INSPECTOR(S): Lucas J. West	INSP. DATE: August 2, 2017	INSP. TIME: 10:50
OPERATOR: Ernest W Walker	OPERATOR REPRESENTATIVE: None	TYPE OF OPERATION: MP - Mineral Prospecting	
REASON FOR INSPECTION: Normal I&e Program	BOND CALCULATION TYPE: None	BOND AMOUNT: \$6,308.00	
DATE OF COMPLAINT: NA	POST INSP. CONTACTS: None	JOINT INSP. AGENCY: None	
WEATHER: Clear	INSPECTOR'S SIGNATURE:

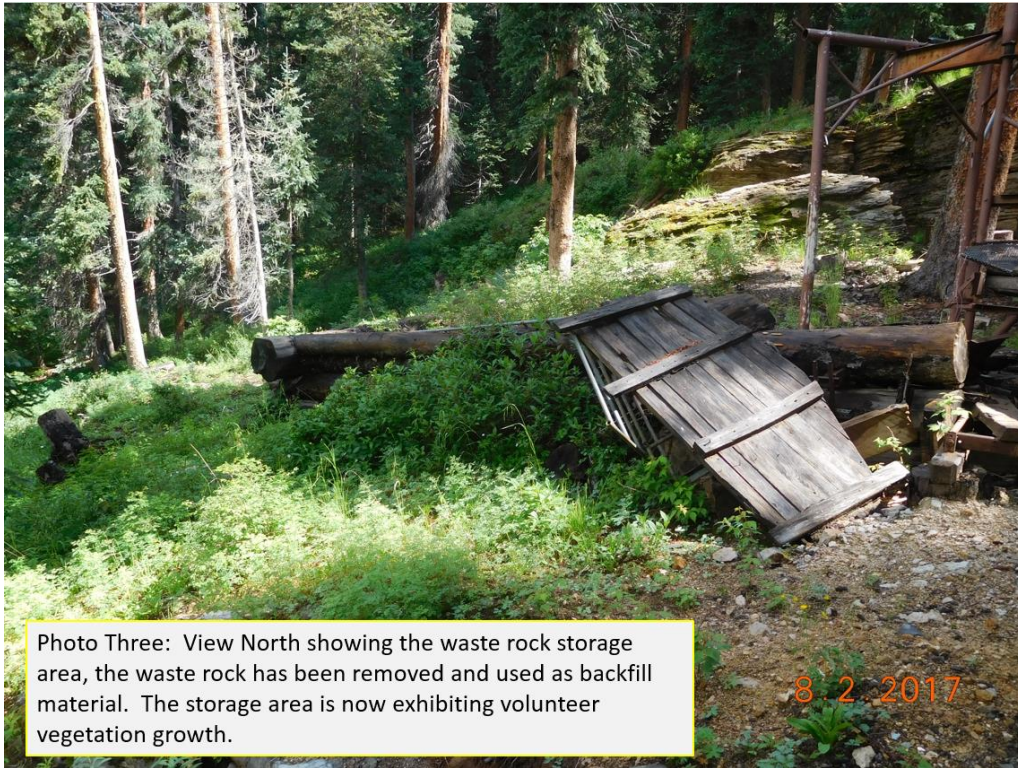
The claim boundaries are clearly marked by a series of rock cairns and no trespassing signs. The trail to the site is obscure, and only accessible on foot. The surface disturbance includes a shaft with makeshift headframe, waste rock storage area, a small portal that has been backfilled and various mining related equipment and tools. The shaft, which can be seen in Photos One and Two, is approximately 4 feet wide, 6 feet long and 30 feet deep. There is a set of large wooden doors over the shaft however they were not secured. Also seen in Photo One is the makeshift head frame constructed around the shaft. The headframe appears to be stable and in working condition. Adjacent to the shaft is a waste rock storage area that is constructed with logs and filled in shown in Photo Three.

Photo Three: View North showing the waste rock storage area, the waste rock has been removed and used as backfill material. The storage area is now exhibiting volunteer vegetation growth.

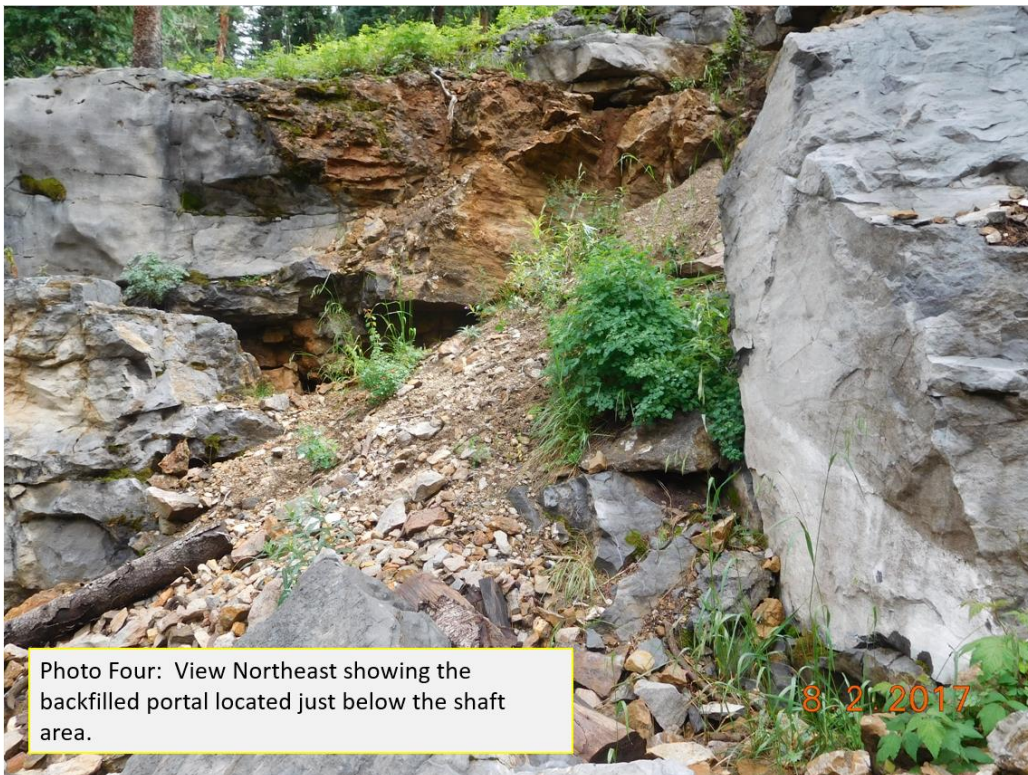
According to records kept by the division it appears that all of the waste rock was removed from this storage area and used to backfill the portal. The backfilled portal can be seen in Photo Four, appears to be stable and in good condition. Adjacent to the portal, a self-propelled rock crusher was observed, and is under a makeshift lean to structure. The crusher, shown in Photo Five, appears to be in good condition and is wrapped and covered with a tarp. Near the shaft and makeshift headframe, a storage area containing tools, equipment, and various other items was noted. The area and most of the tools were covered with a tarp and secured. Among the items was a wheel barrow, generator, oil cans, and several tool boxes with various power and hand tools as well. Photo Six shows the items with the tarp exposed. Upon completion of the inspection the tarp was replaced over the items and secured in the method it was found. Located on opposite ends of the claim are two separate explosives magazines. The West magazine shown in Photo Seven, and the East magazine shown in Photo Eight. Both magazines were unsecured and verified to be empty at the time of the inspection. According to the previous inspection completed by the Division a significant amount of reclamation has been conducted since that time, and minimal reclamation tasks remain. Those tasks include the closure and safeguarding of the shaft, removal of all tools and equipment, as well as some minor revegetation work.

Photo Four: View Northeast showing the backfilled portal located just below the shaft area.

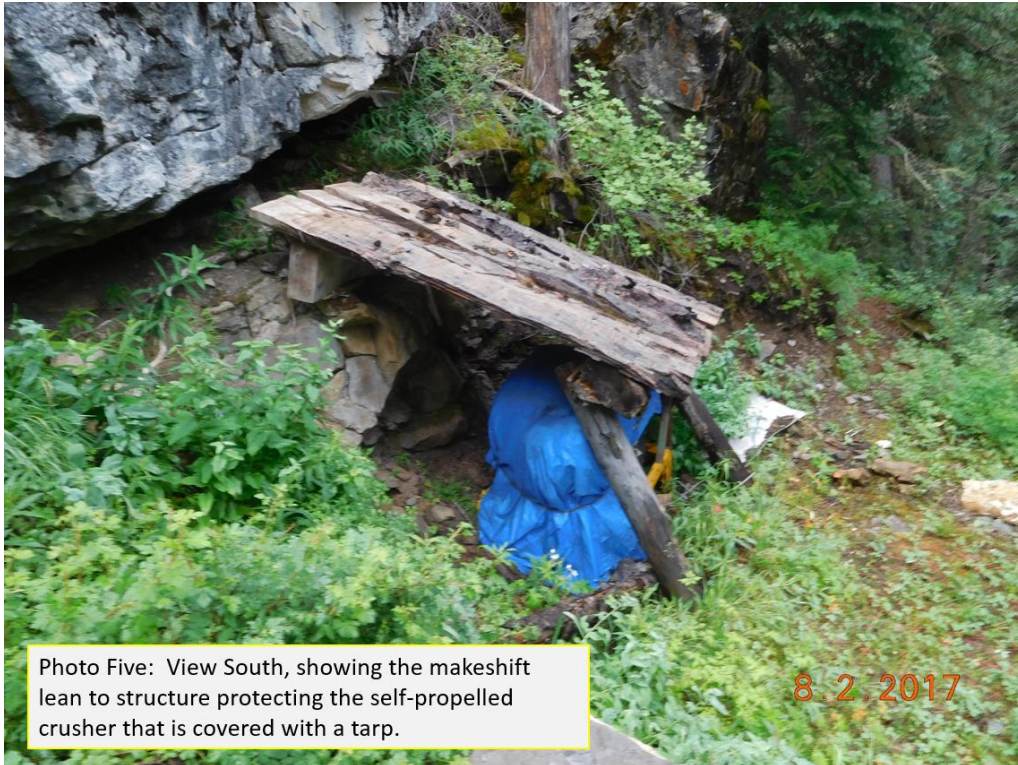
Photo Five: View South, showing the makeshift lean to structure protecting the self-propelled crusher that is covered with a tarp.

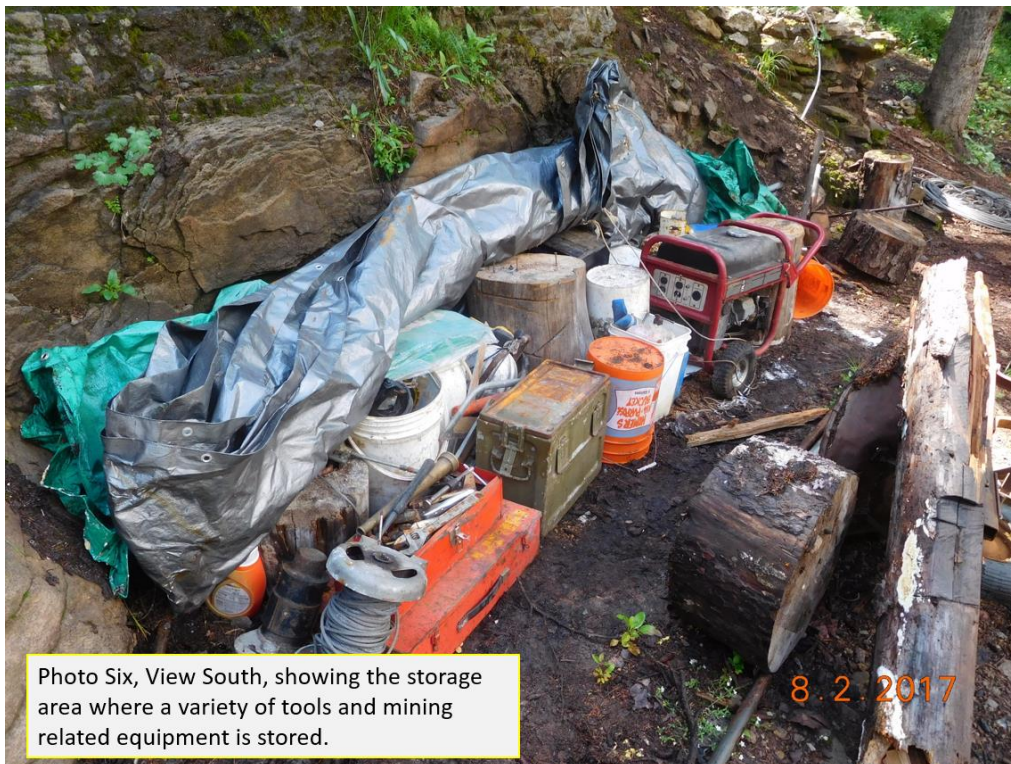
Photo Six, View South, showing the storage area where a variety of tools and mining related equipment is stored.
