MINERALS PROGRAM INSPECTION REPORT

MINE NAME: J&J Stone Pit #1	MINE/PROSPECTING ID#: M-2011-004	MINERAL: Sandstone (silica, stone, quartzite)	COUNTY: Fremont
INSPECTION TYPE: Monitoring	INSPECTOR(S): Timothy Cazier, P.E.	INSP. DATE: June 16, 2021	INSP. TIME: 08:00
OPERATOR: KrauthCo Inc	OPERATOR REPRESENTATIVE: Mike Krauth	TYPE OF OPERATION: 112c - Construction Regular Operation	
REASON FOR INSPECTION: Normal I&E Program	BOND CALCULATION TYPE: Partial Bond	BOND AMOUNT: No Bond Held	
DATE OF COMPLAINT: NA	POST INSP. CONTACTS: None	JOINT INSP. AGENCY: None	
WEATHER: Clear	INSPECTOR'S SIGNATURE:

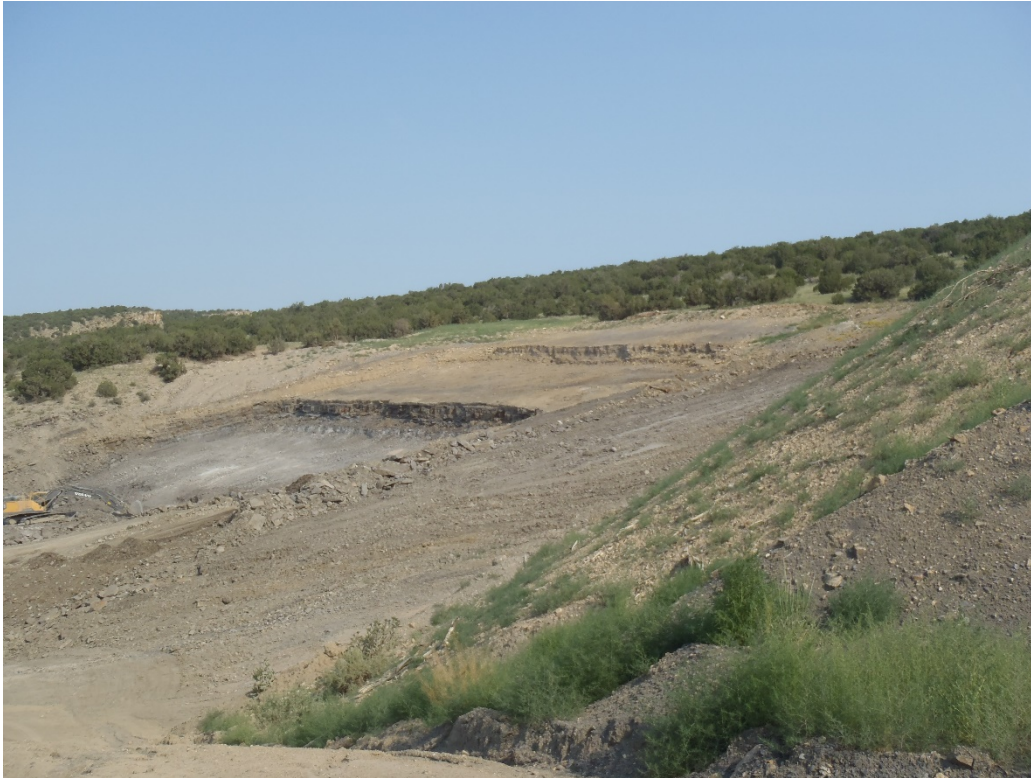
Backfilling and Grading: The phase 2 expansion are is approved to be exposed benches (see **Photo 1**). The limited surface material was being salvaged (see **Photo 2**) for up to 7 acres of the staging and processing areas reclamation.

Gen. Compliance with Mine Plan: The operation's excavation and material removal appeared to be in compliance with the approved mine plan and within the affected area boundary. The maximum allowed disturbed area is 35 acres. The 2021 annual report stated 24.9 acres were affected. Google Earth was used to measure the disturbed area, which was estimated to be approximately 17.55 acres, based on older 2019 imagery. Highwalls were estimated to vary between zero and 20 feet in height and appeared stable (see **Photos 1 and 3**).

Photo 1. Phase 2 highwall benches (looking NW).

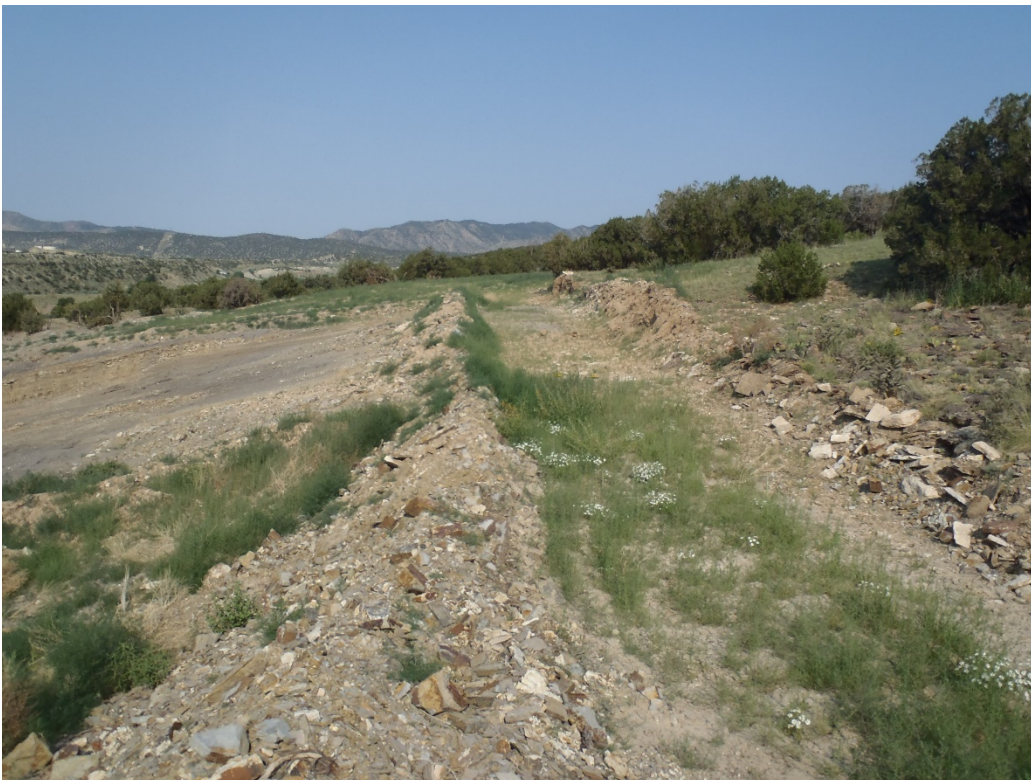
Photo 2. Salvage of limited surface material above phase 2 (looking west).

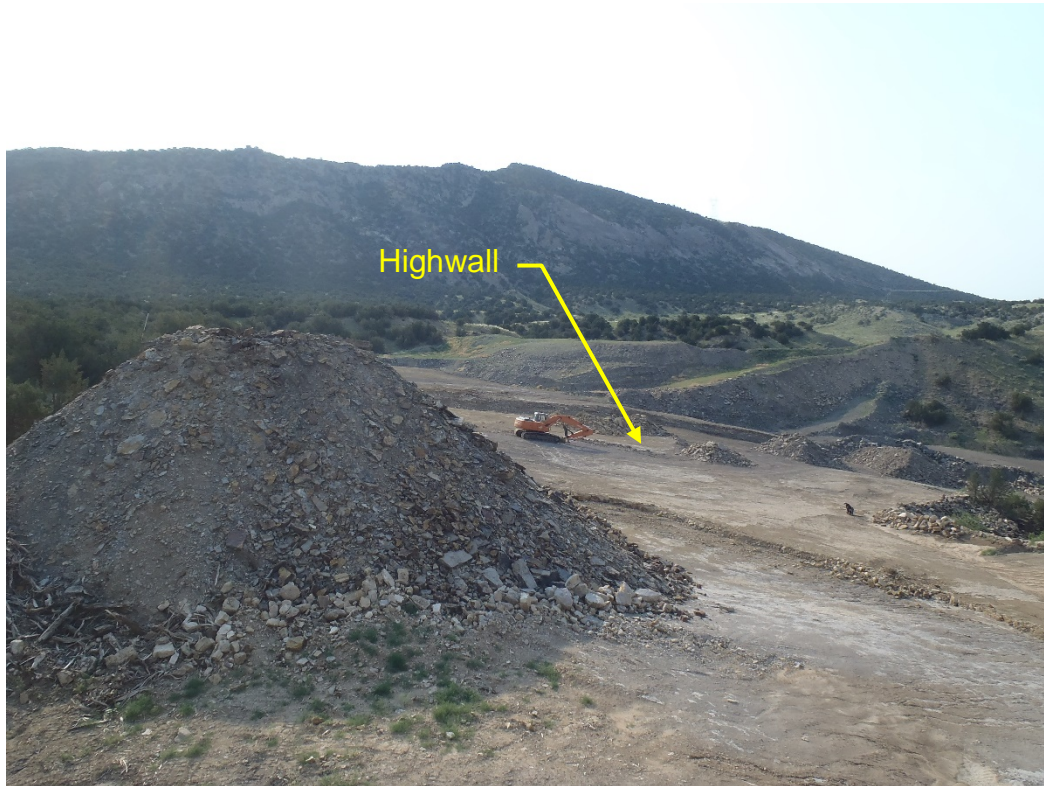
Photo 3. Phase 1 highwall and excavator (looking southeast).

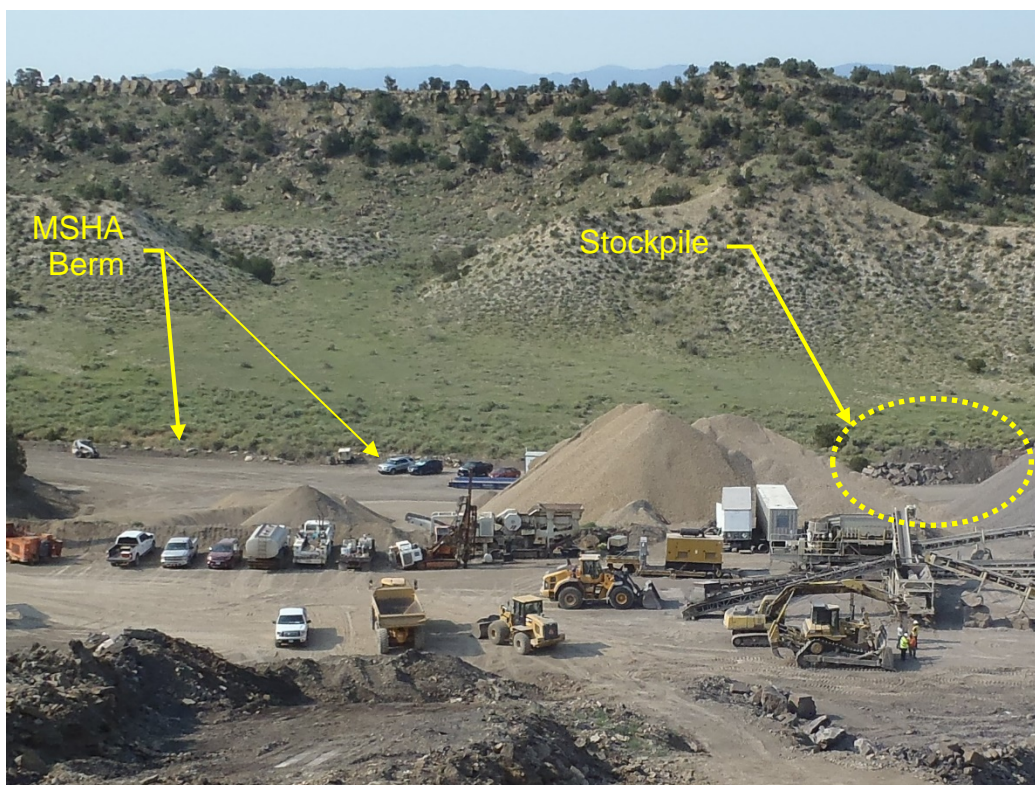
PROBLEM/POSSIBLE VIOLATION: Problem: An area of about an acre (MSHA safety berm and material stockpile) has been affected outside of the approved affected area boundary. This is a possible violation if not addressed in a timely manner. Pursuant to: 1.) C.R.S. 34-32.5-109(1) for failure to first obtain from the board or office a reclamation permit prior to engaging in a new operation. AND/OR 2.) C.R.S. 34-32.5-116(4)(i) for failure to protect areas outside of the affected land from slides or damages occurring during the mining operation. 2.) C.R.S. 34-32.5-116(4)(i) for failure to protect areas outside of the affected land from slides or damages occurring during the mining operation.

Off-site Damage: Two types of disturbance were observed outside the affected area boundary during the inspection: 1) MSHA required the Operator to construct a safety berm (see **Photo 4**) on the south side of the access road (see **Figure 1**); and 2) a stockpile of material (see **Photo 5**) was observed also on the south side of the access road and west of the MSHA safety berm. The MSHA safety berm is related to mining and considered a significant road improvement. Therefore, it needs to be included in the affected area boundary. The observed stockpile south of the road was estimated to be 50 feet by 200 feet (less than a quarter of an acre) and also outside the affected area boundary. The MSHA berm and stockpile combine to roughly an acre of disturbance

and are cited as a Problem for disturbing area outside the affected area boundary on p. 1 of this report.

Photo 4. Crusher area equipment; and out-of-bounds MSHA berm & stockpile (looking south).

CORRECTIVE ACTIONS: This problem may result in a possible violation if an amendment application to incorporate this affected area into the permit is not submitted by the corrective action due date. Failure to submit the amendment will require a hearing before the Mined Land Reclamation Board.

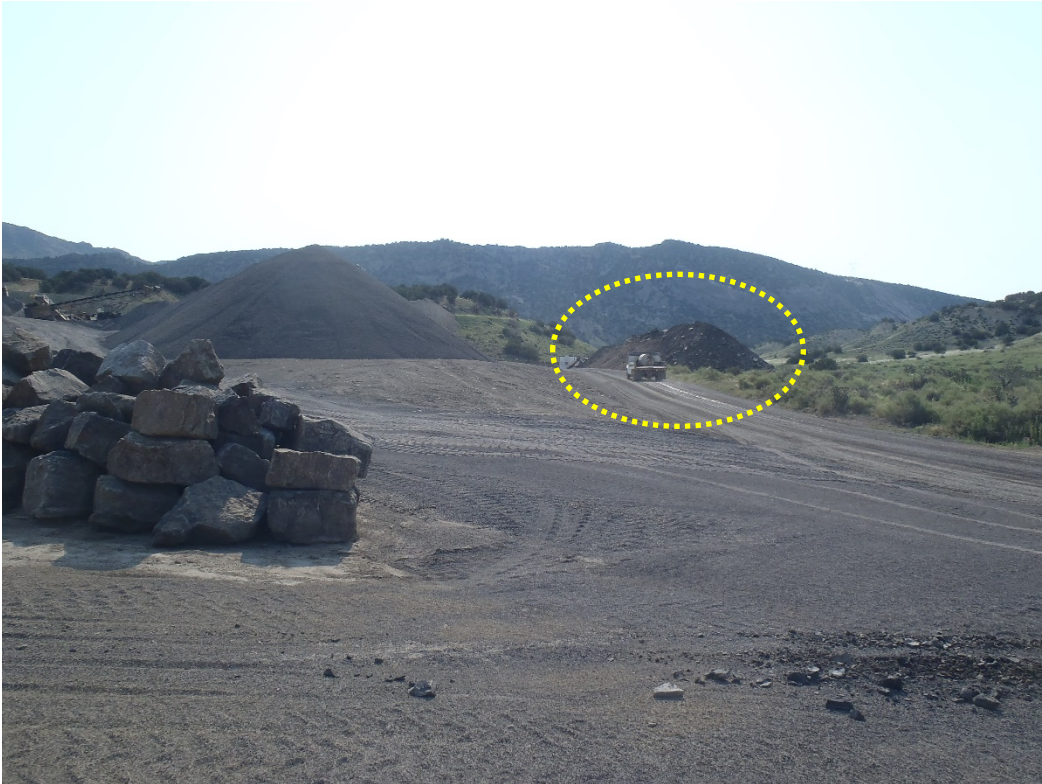
Photo 5. Stockpile outside affected area boundary (looking east from SW corner).

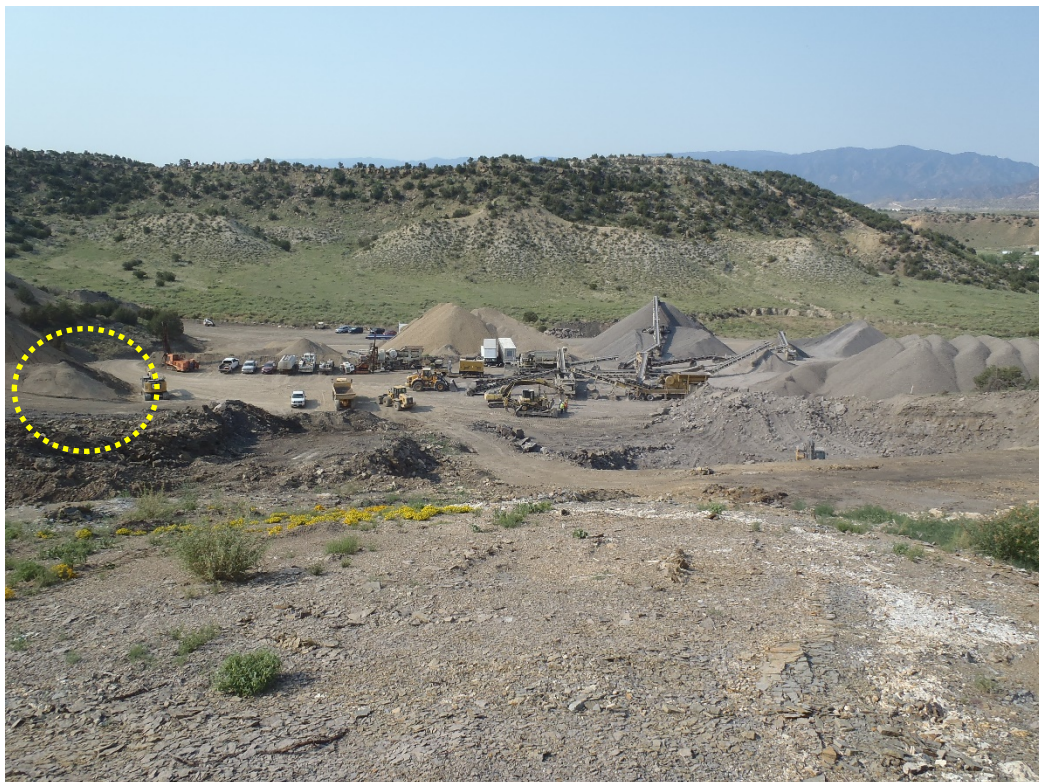
Processing Waste: A stockpile of crusher fines was observed east of the crusher area (see **Photo 6**).

Support Facilities On-site: A truck scale, scale house, screen plant, excavators, loaders, and haul trucks were observed on the phase 2 side (see **Photo 6**). Only an excavator was observed on the phase 1 side.

Photo 6. Phase 2 stage area and fines stockpile (looking south).

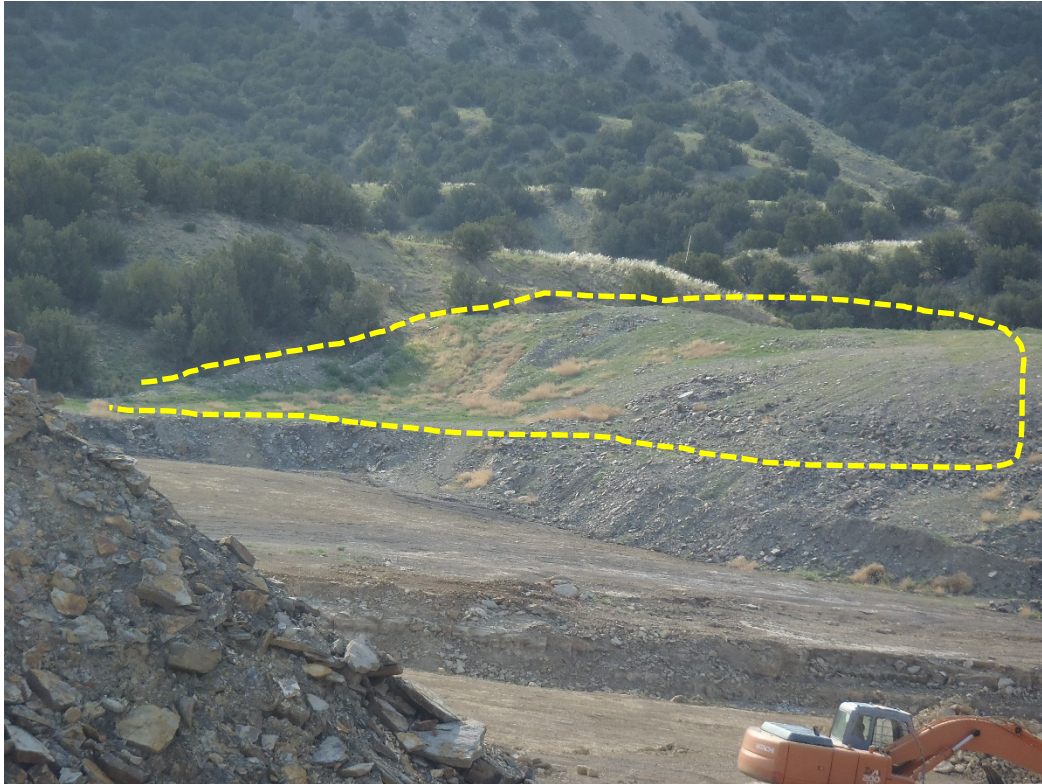
Reclamation Success: Site representatives pointed out the completed reclamation of the buffer berm on the southeast side of phase 1 (see **Photo 7**).

Photo 7. Buffer visual berm under final reclamation (looking SE from between phases 1 and 2).

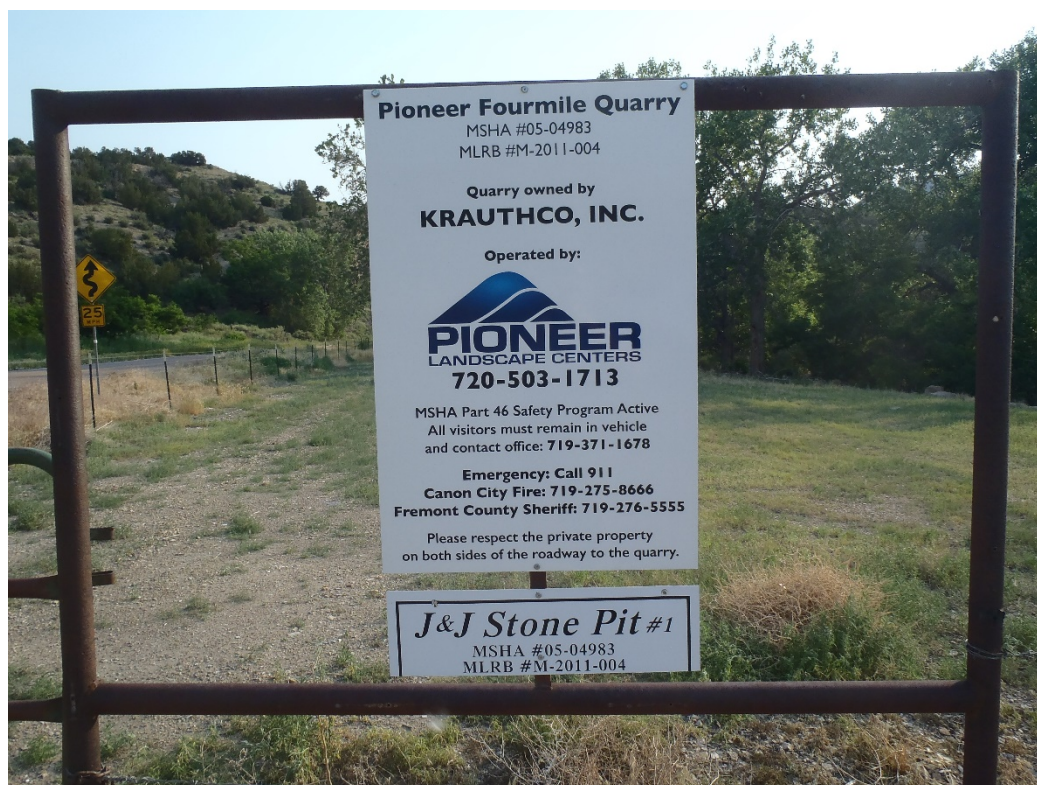
Signs and Markers: The permit sign was properly posted (see **Photo 8**) and boundary markers were observed to delineate the permit boundary (see **Photo 9**).

Photo 8. Permit sign at entrance off FCR9.

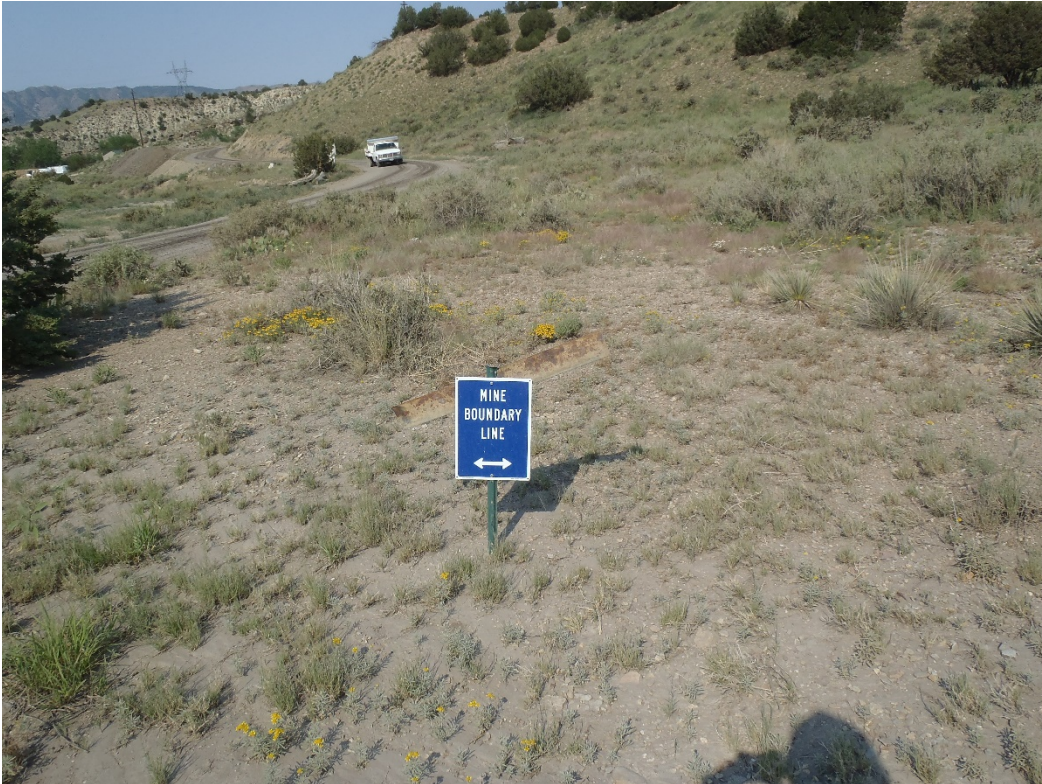
Photo 9. Typical boundary sign (looking WSW from SW corner of Phase 2).

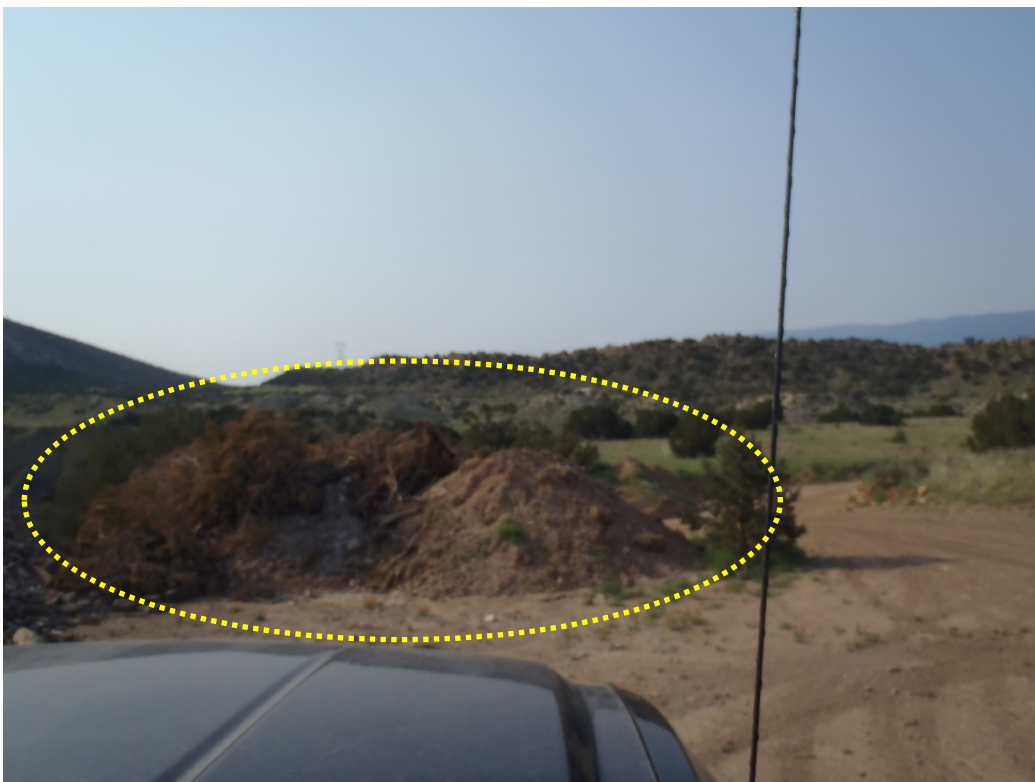
Topsoil: A small topsoil stockpile was observed between phases 1 and 2 (see **Photo 10**).

Photo 10. Topsoil stockpile between phases 1 and 2.
