**MINERALS PROGRAM INSPECTION REPORT**  
**PHONE: (303) 866-3567**

<b>MINE NAME:</b> SH 69 Gravel Pit	<b>MINE/PROSPECTING ID#:</b> M-2018-010	<b>MINERAL:</b> Sand and gravel	<b>COUNTY:</b> Fremont
<b>INSPECTION TYPE:</b> Monitoring	<b>INSPECTOR(S):</b> Timothy Cazier, P.E.	<b>INSP. DATE:</b> July 21, 2021	<b>INSP. TIME:</b> 13:30
<b>OPERATOR:</b> Fremont County	<b>OPERATOR REPRESENTATIVE:</b> Tony Adamic & Paul Garrett	<b>TYPE OF OPERATION:</b> 110c - Construction Limited Impact	
<b>REASON FOR INSPECTION:</b> Normal I&E Program	<b>BOND CALCULATION TYPE:</b> None	<b>BOND AMOUNT:</b> \$0.00	
<b>DATE OF COMPLAINT:</b> NA	<b>POST INSP. CONTACTS:</b> U.S.BLM	<b>JOINT INSP. AGENCY:</b> U.S.BLM	
<b>WEATHER:</b> Clear	<b>INSPECTOR'S SIGNATURE:</b>

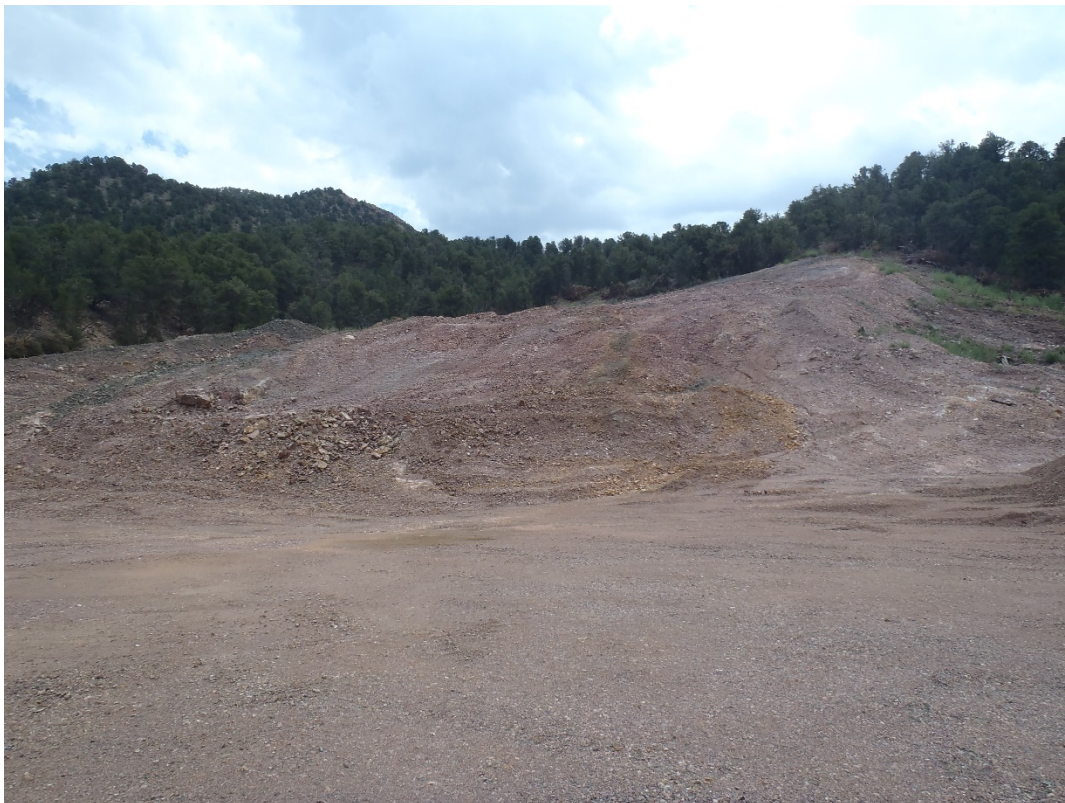
Gen. Compliance with Mine Plan: The operation appeared to be in compliance with the approved mine plan. The maximum allowed disturbed area is 8.27 acres. The 2021 annual report stated 1.8 acres were affected. Google Earth was used to measure the disturbed area, which was estimated to be 1.26 acres, based on older 2019 imagery. The highwall was estimated to 2H:1V at the bottom, 3H:1V at the top and appeared stable (see **Photo 1**).

Photo 1. Active highwall on south side of pit (looking south).

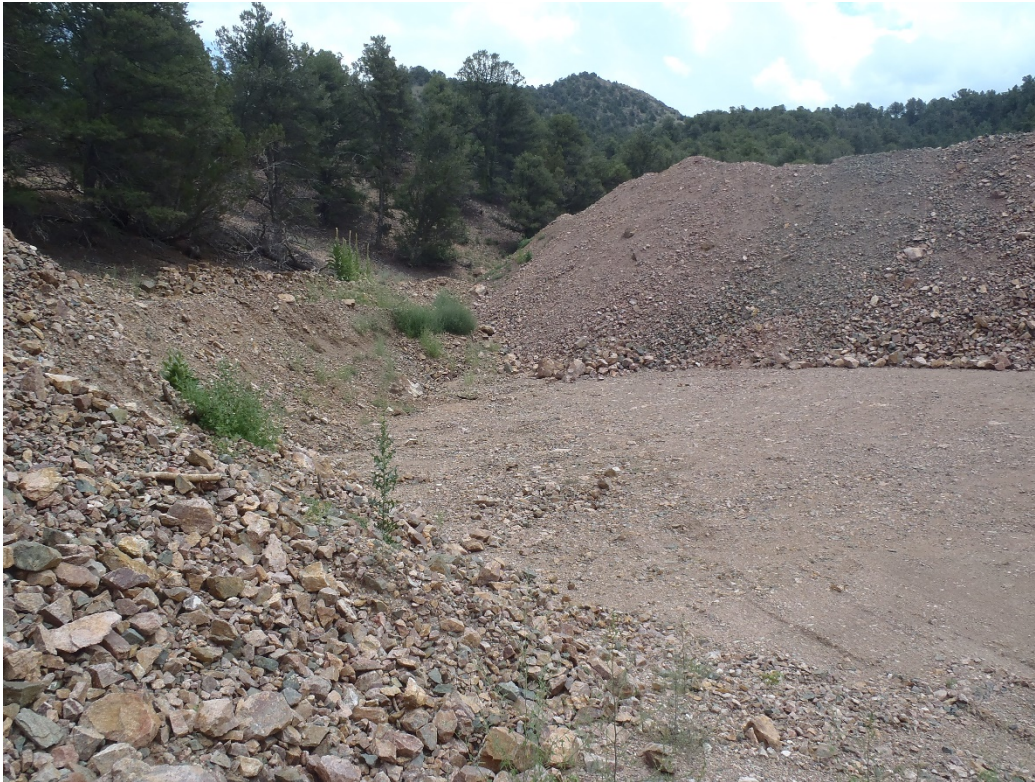
Processing Waste: A stockpile of reject material was observed in the northeast corner of the pit (see **Photo 2**).

Photo 2. Reject pile on east side of pit (looking SE).

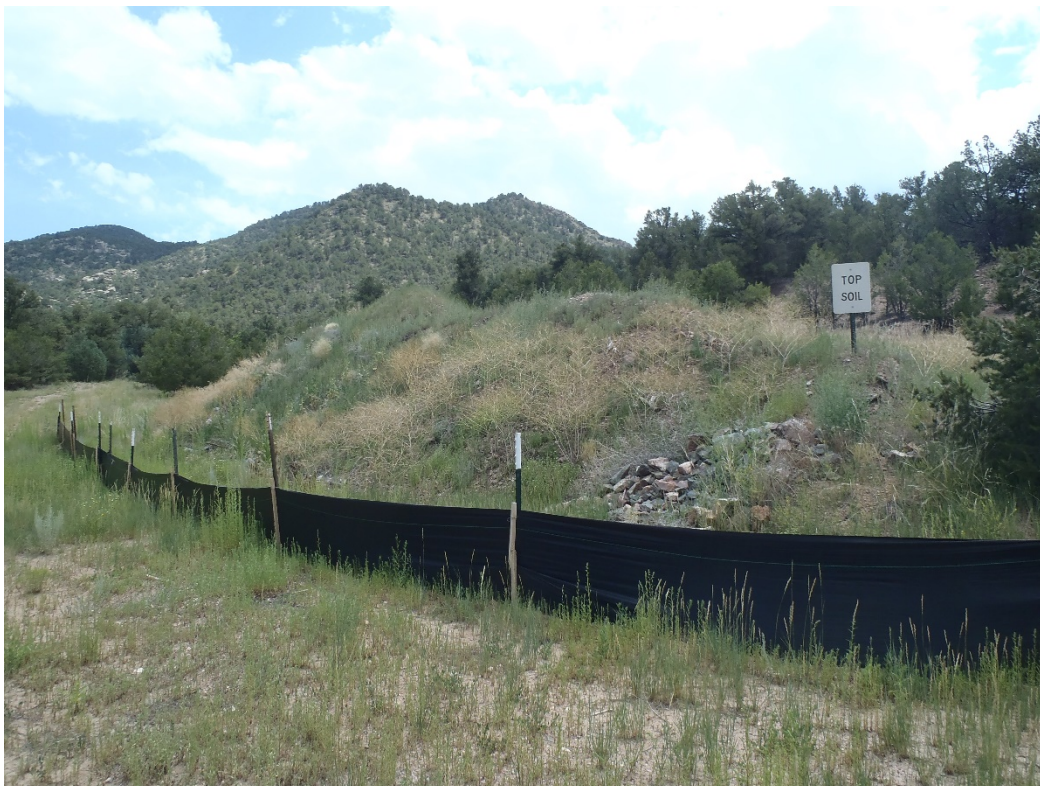
The Operator had placed silt fence at the edge of the topsoil stockpile (see **Photo 3**).

Topsoil: A topsoil stockpile was in the northeast corner of the site and labeled as such (see **Photo 3**).

Photo 3. Topsoil stockpile with sign (NE corner, looking SE, note silt fence).

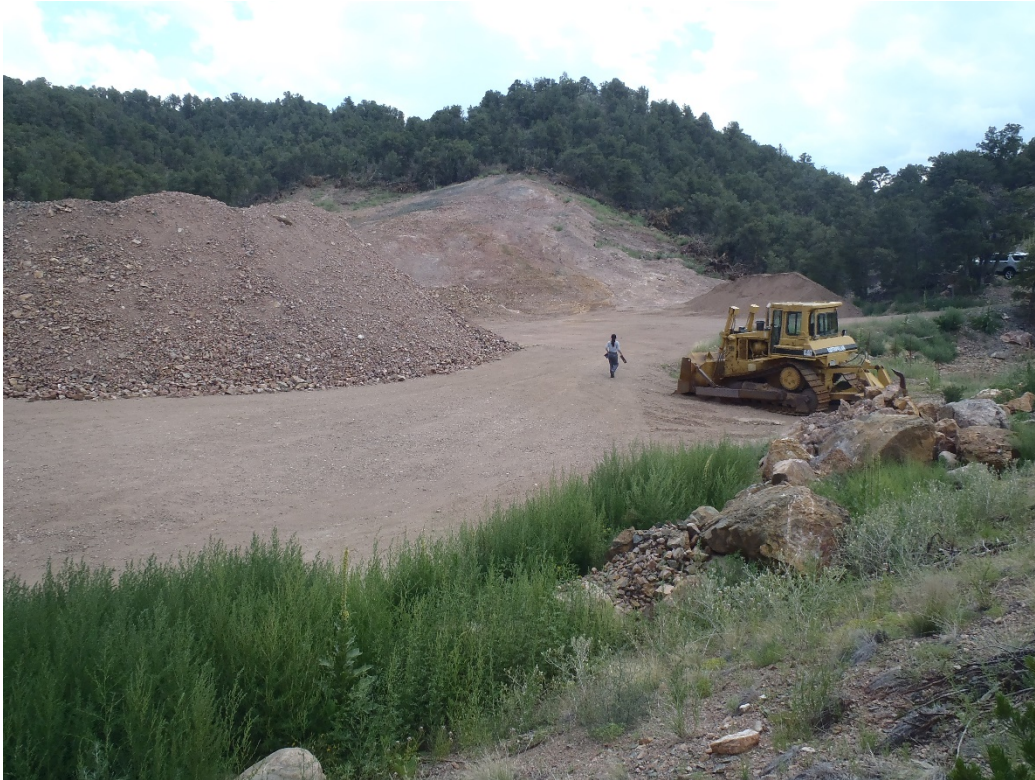
Support Facilities On-site: A D6 dozer was observed on site (see **Photo 4**).

Photo 4. D6 dozer on pit floor, product stockpile on left, highwall beyond (looking SW).

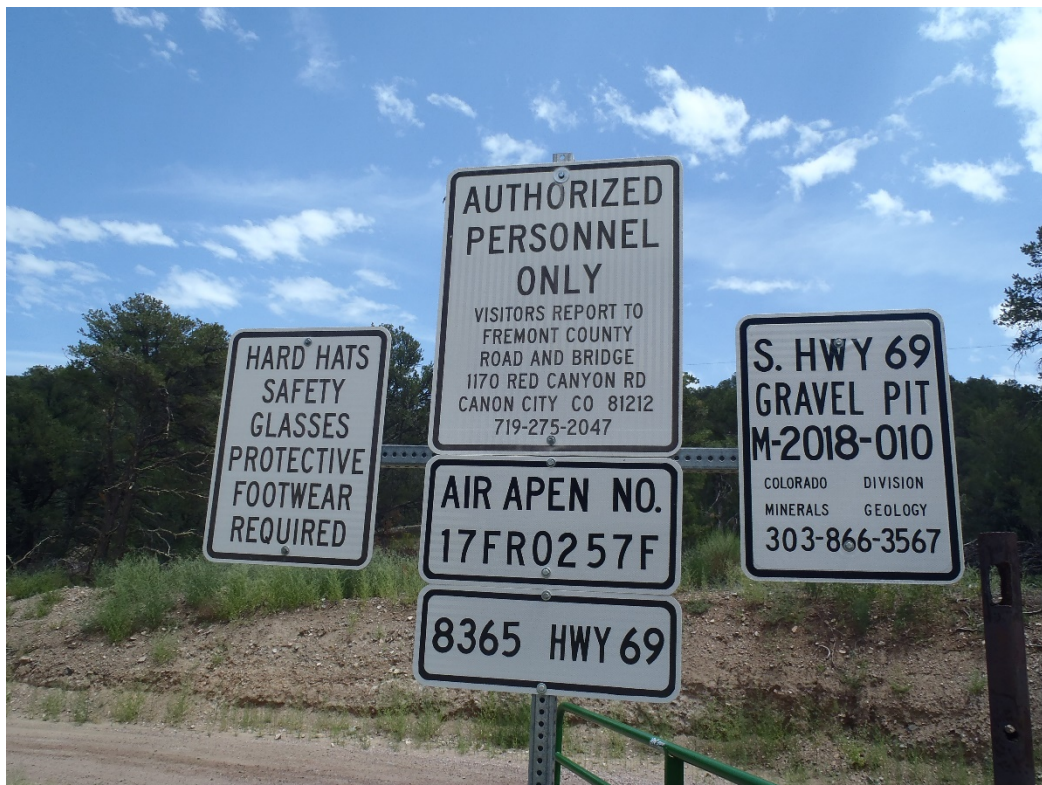
Signs and Markers: The permit sign was properly posted (see **Photo 5**) and boundary markers were observed to delineate the permit boundary (see **Photo 6**).

Photo 5. Permit sign at entrance of Hwy 69.

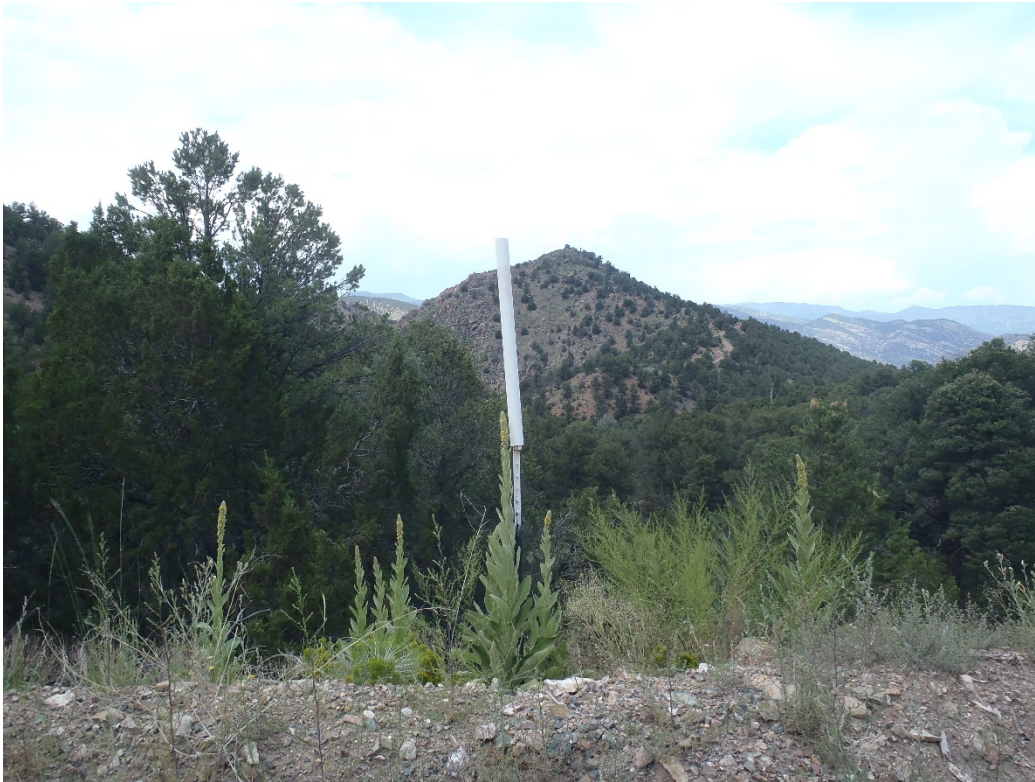
Photo 6. Typical permit boundary marker (NW corner).

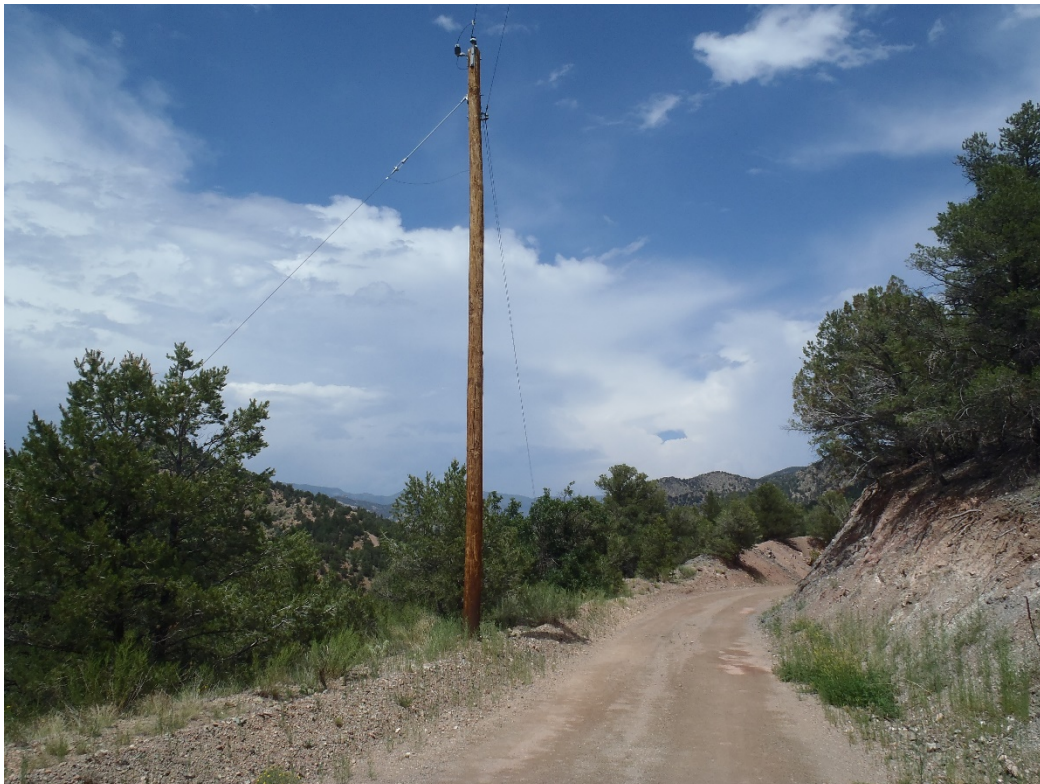
Structures: Two utility poles were observed adjacent to the access road. GPS coordinates were collected using a hand-held Trimble Juno 3B unit to determine proximity to the permit boundary. The closest pole (see **Photo 7**) was found to be 231 feet away from the permit boundary.

Photo 7. Closest utility pole to permit boundary {231 ft away} (along access road, looking NE).
