MINERALS PROGRAM INSPECTION REPORT
PHONE: (303) 866-3567

MINE NAME: SR-13A Mine	MINE/PROSPECTING ID#: M-1977-311	MINERAL: Uranium and vanadium	COUNTY: San Miguel
INSPECTION TYPE: Surety Release Inspection	INSPECTOR(S): Lucas West	INSP. DATE: December 9, 2021	INSP. TIME: 14:11
OPERATOR: Highbury Resources Inc.	OPERATOR REPRESENTATIVE: Scott Potorff	TYPE OF OPERATION: 110d - Designated Limited Impact	
REASON FOR INSPECTION: Surety Release Requested	BOND CALCULATION TYPE: None	BOND AMOUNT: \$200.00	
DATE OF COMPLAINT: NA	POST INSP. CONTACTS: None	JOINT INSP. AGENCY: None	
WEATHER: Snowing	INSPECTOR'S SIGNATURE:

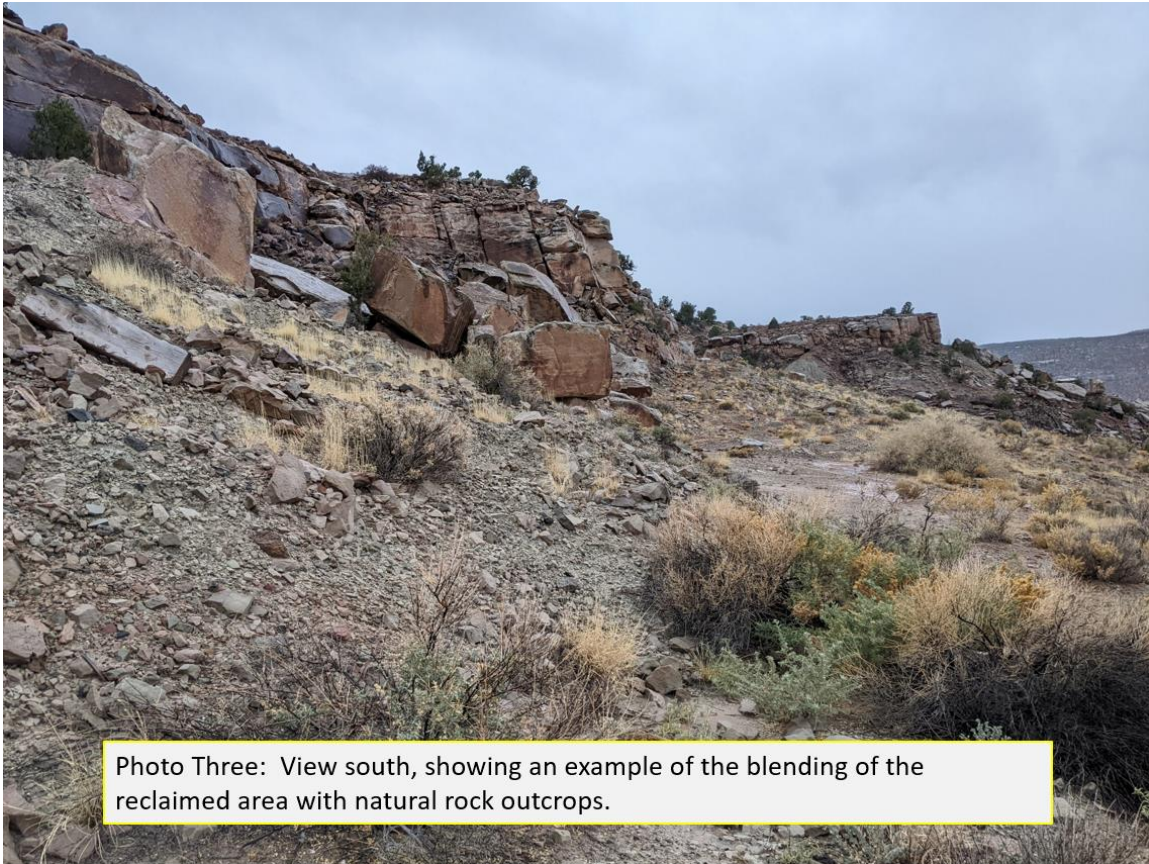
The proper mine identification signage was posted at the entrance to the site. There was no equipment on site and the site was not active during the inspection. Final reclamation had been completed at the site some years ago, with ongoing monitoring and active weed control. All grading and dirt work was stable at the time of the inspection. The waste piles have on site have been graded to a 2H: 1V or shallower configuration and appear to be stable and in good condition. Examples of the reclaimed slopes can be seen in Photos One and Two. The slopes were all "pocked" to prevent erosion and assist the vegetation growth. The slopes show no significant signs of erosion and the vegetation appears to be as good as or better than surrounding undisturbed areas. The vegetation is adequate in both density and diversity, and multiple years biomass was observed indicating it is self-sufficient. Other disturbed areas have been blended to match the existing rock outcrops and are also in excellent condition. Photo Three shows the blended areas.

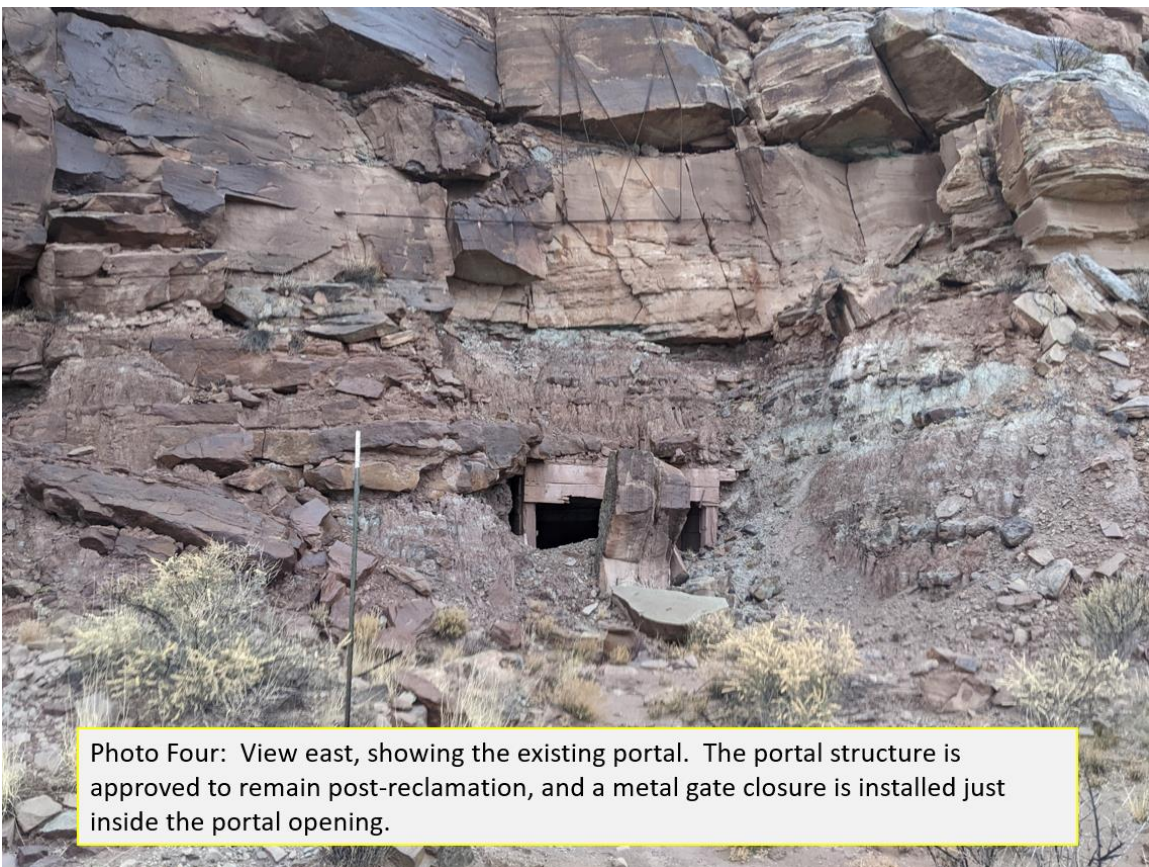
All but one of the access portals have been backfilled and secured on site. The backfilled portals have blended with the reclaimed lands so well, the Division was unable to locate the portals. The one portal that was not backfilled has been secured with a steel grated closure. The closure is very secure and shows no signs of vandalism or attempted unauthorized entry. The portal can be seen in Photo Four.
